# CVUSD | *Facilities Master Plan*

## Acacia Elementary School | *Survey*

55 W Norman Ave | Thousand Oaks, CA 91360

December 9th, 2016

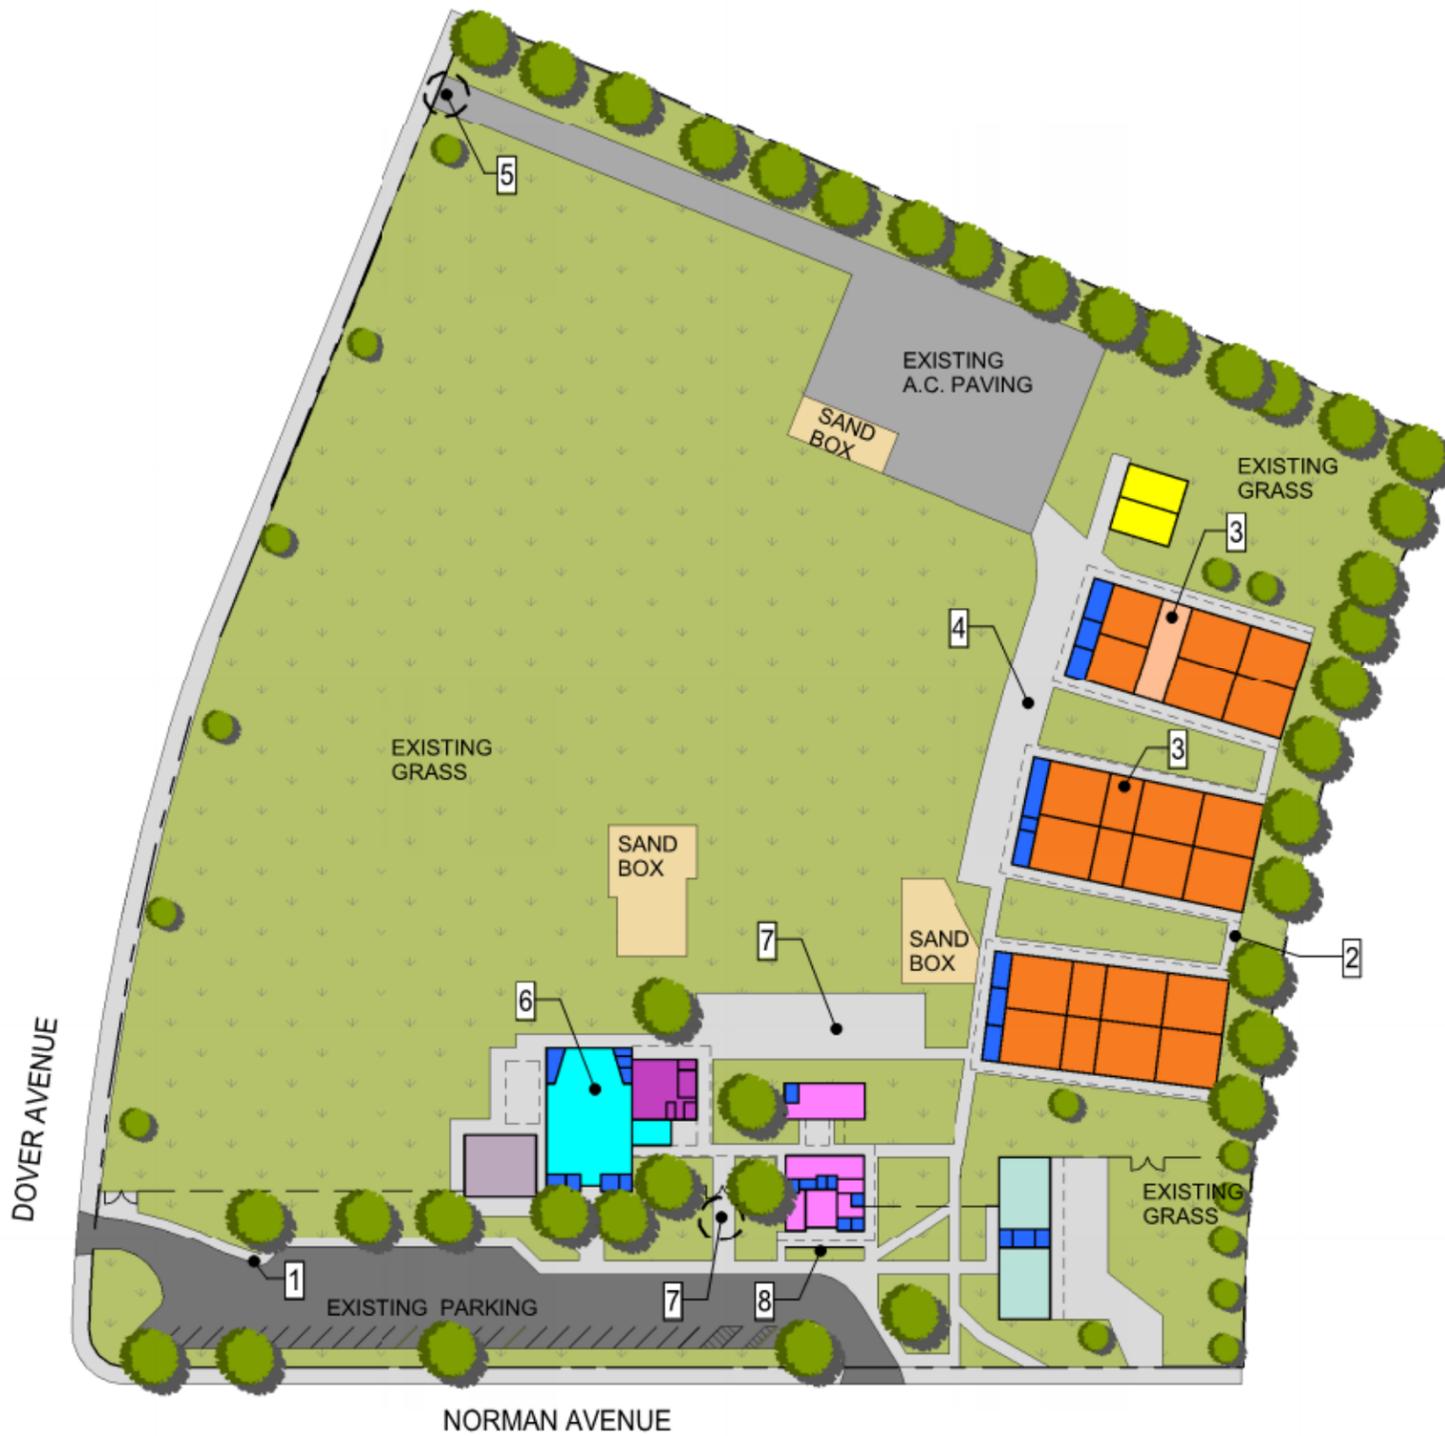
**EXISTING SITE PLAN | ACACIA ELEMENTARY SCHOOL BUILDING USE**

- 1 DRAINAGE AND CONCRETE SETTLEMENT ISSUES
- 2 DRAINAGE ISSUES AND PONDING, LOCATION NEED TO BE REWORKED
- 3 BREEZEWAY CONVERTED TO CLASSROOM WINDOWS ARE MISSING SETTING BLOCK AND HAVE LARGE GAPS
- 4 SLOPE OF GROUND TOO STEEP FOR WHEELCHAIR ACCESS TO PLAYGROUND
- 5 MAJOR ACCESS POINT TO SCHOOL NOT ACCESSIBLE. NEED TO CHANGE GATE ORIENTATION
- 6 CONCRETE SLAB SETTLEMENT AND VISIBLE CRACKING IN SLAB AND WALLS
- 7 CONCRETE WALKWAY SETTLEMENT ISSUES
- 8 PRIMARY OPORTUNITY LOCATION: REMOVE WALL AND RE-DESIGN ENTRANCE

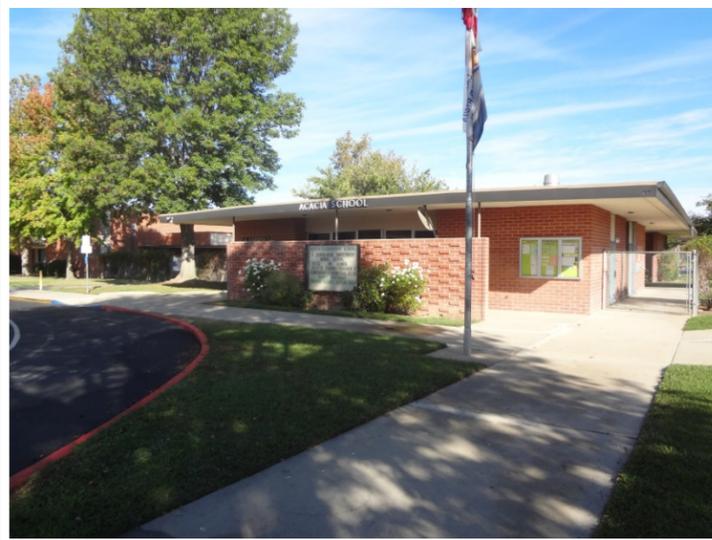
**Photo - 1**  
**Administration Building: Building 1**  
 Administration building is made of brick masonry construction with a planar roof condition.

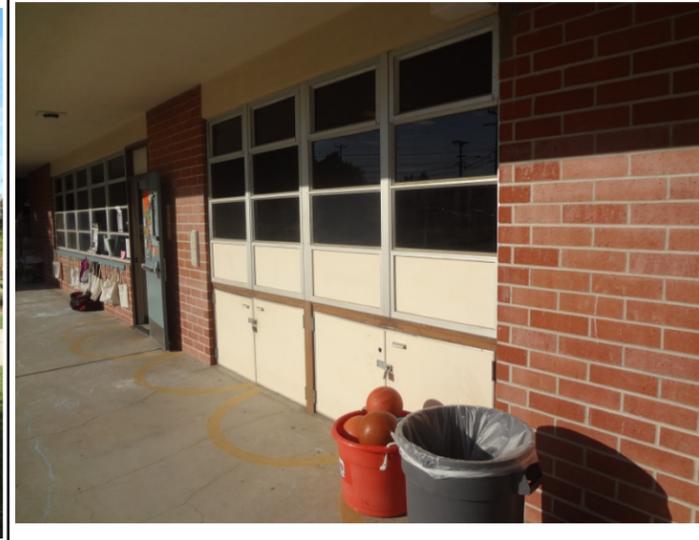
**Photo - 2**  
**Typical Classroom Building Facade**  
 Typical classroom façade has a primary brick structure with a large glazing system between support walls

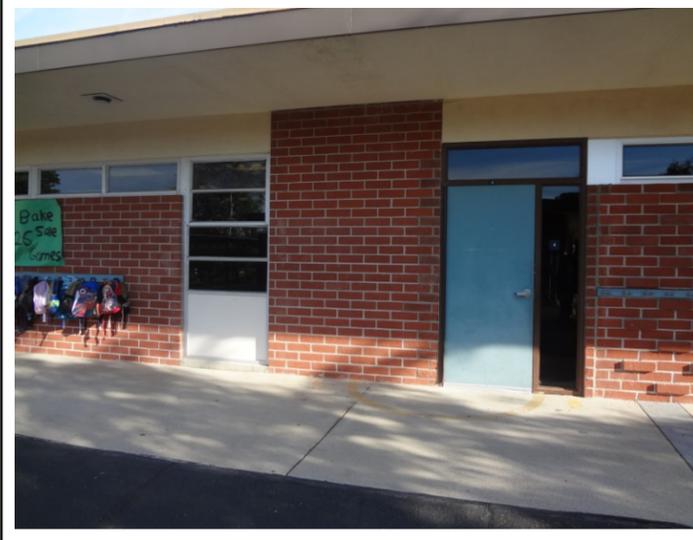
**Photo - 3**  
**Typical Classroom Building Facade**  
 Typical classroom façade has a primary brick structure with a clearstory glazing system between support walls

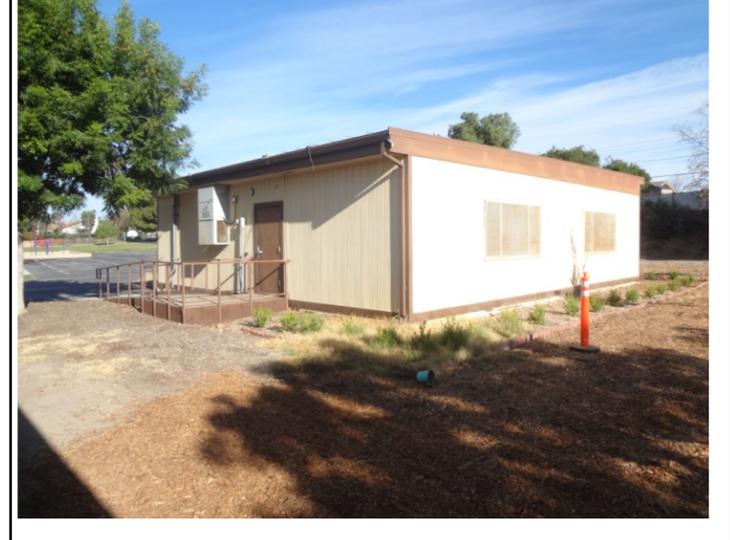
**Photo -4**  
**Portable Classroom: Building 6**  
 Typical portable classroom with no water hook up.

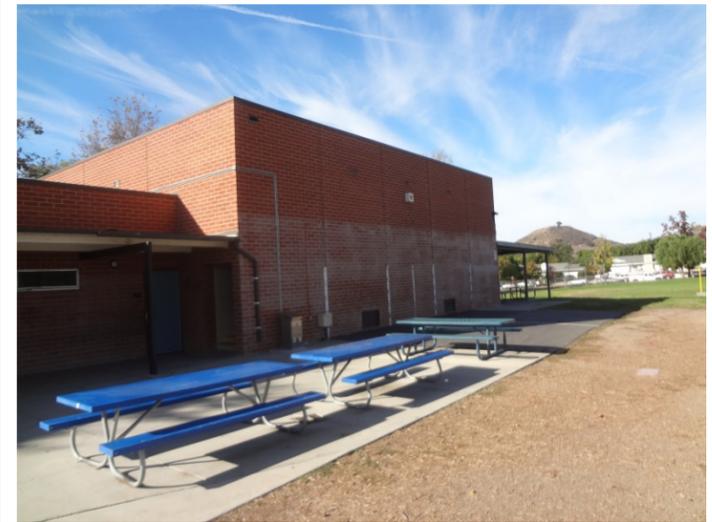
**Photo -5**  
**Multi Purpose Building: Building 7**  
 Brick Masonry construction with no windows besides doorway windows

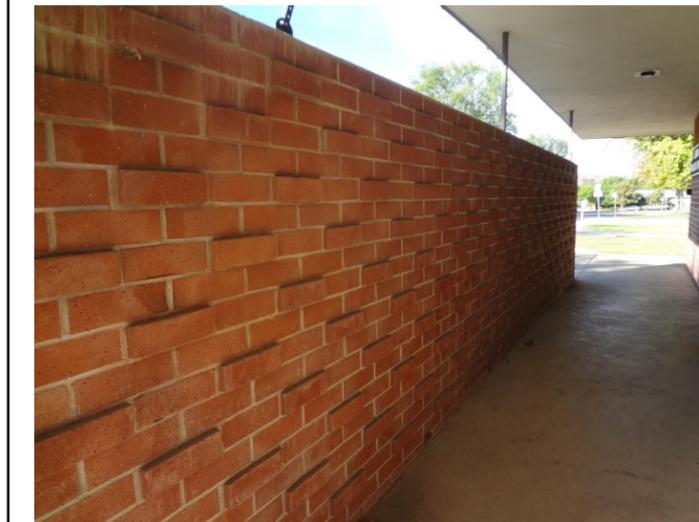
**Photo -6**  
**Administration Front Wall: Building 1**  
 Primary area of desired changed to remove existing wall in the front of the administration building

Administration space is adequate for the school's needs and is in overall good condition. Some minor accessibility issues at the thresholds are present. The primary concern of the principal and staff is the removal of the large brick wall in the front of the administration building because it blocks all line of sight to the parking lot and makes finding the entrance to the office difficult.

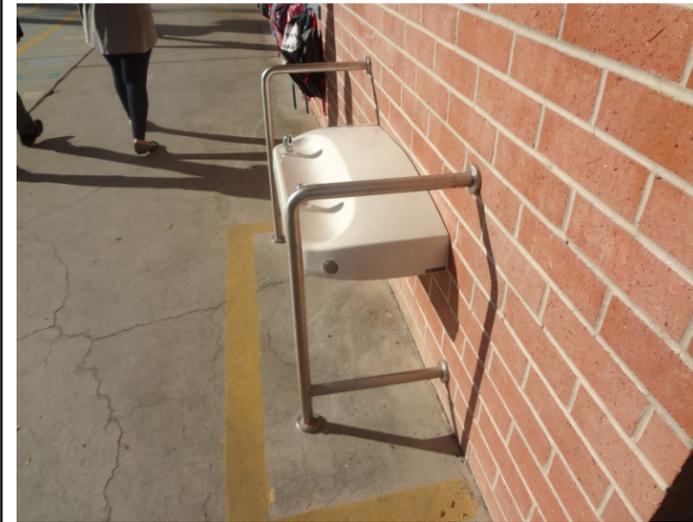
**Photo -7**  
**Typical Exterior Drink Fountain:**  
 Original drinking fountain needing to be upgraded for accessibility

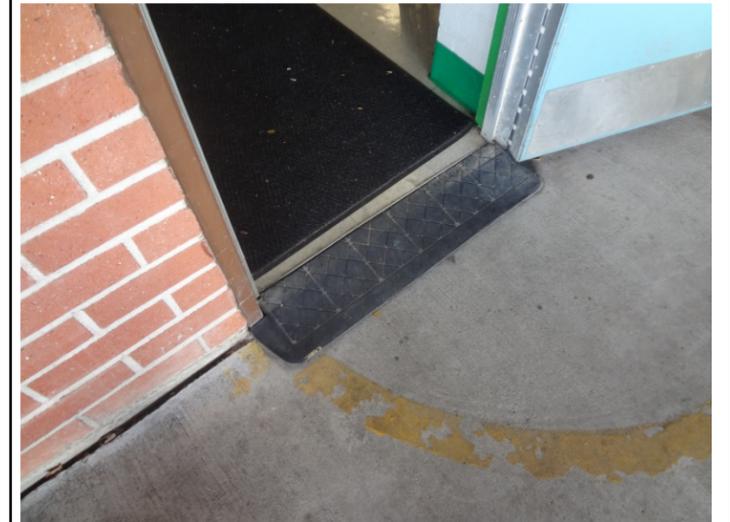
**Photo -8**  
**Typical Door Threshold**  
 Older door threshold no longer accessible by today's accessibility standards

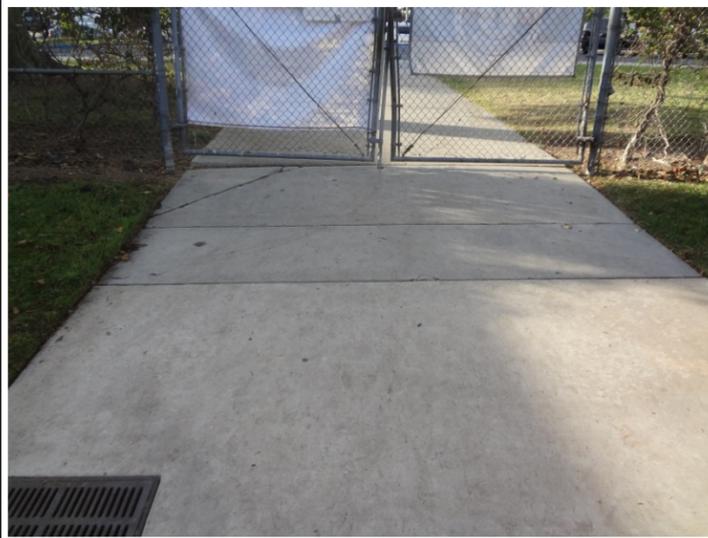
**Photo -9**  
**Main Entry Concrete Settlement:**  
 Concrete sidewalk is cracking and sinking throughout campus but is especially bad at the main point of entry for the school

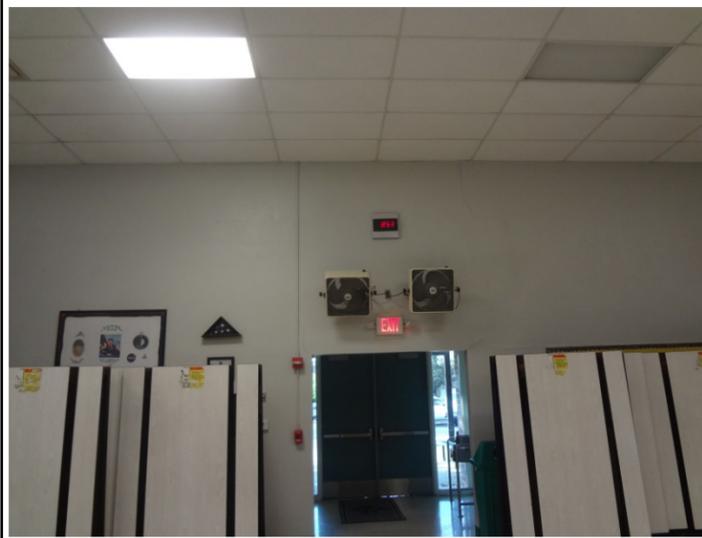
Overall condition of the buildings is acceptable. Some minor maintenance issues are throughout the site. However there is a concrete slab settling issue occurring in the multi purpose building that is causing cracks in the floor and walls. In addition the settling issue continues on the exterior walkways around the same location. Further investigation should be undertaken.

**Photo -10**  
**Multi Purpose Building: Building 7**  
 Building Settlement is causing cracking in the walls and concrete floors

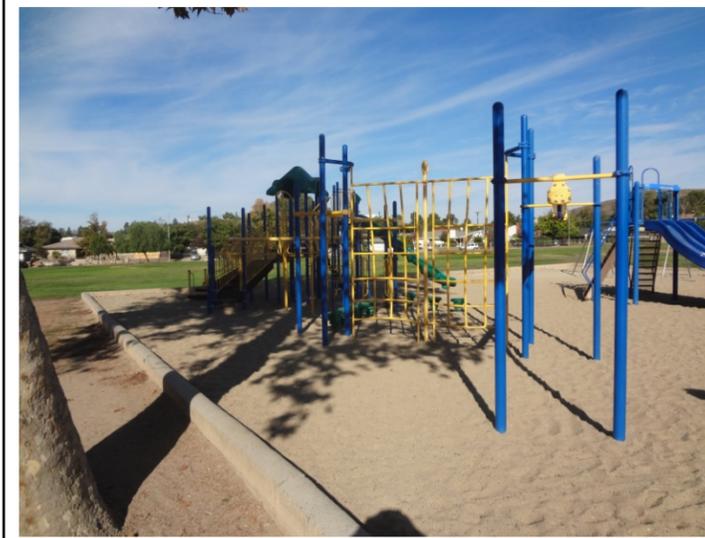
**Photo -11**  
**Playground Equipment:**  
 Existing playground equipment with sand fall protection and CMU wall around perimeter.

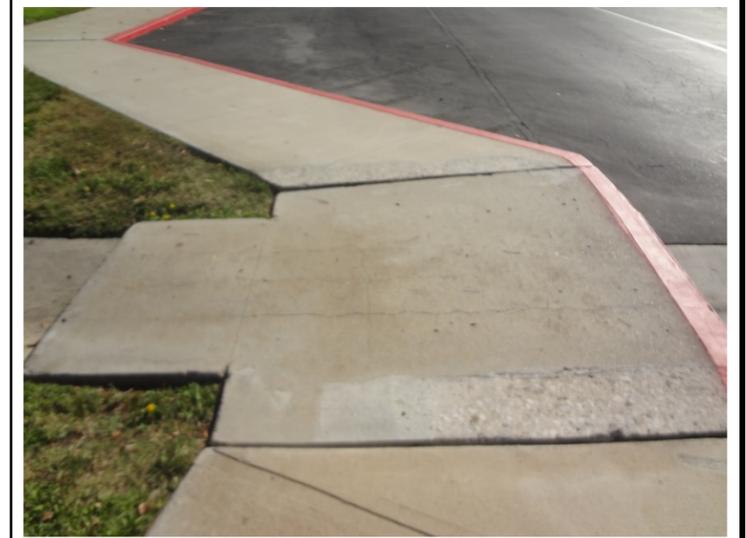
**Photo -12**  
**Concrete Settlement at Drainage Areas:**  
 Concrete path is settling in the parking lot where the main drainage from the site is located

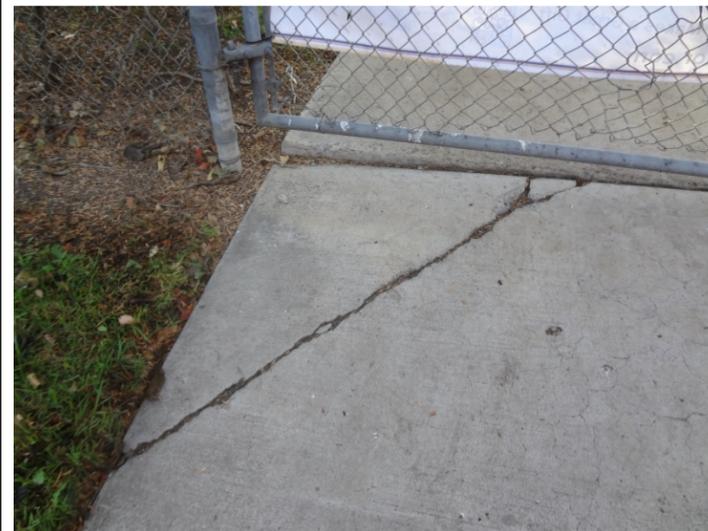
**Photo -13**  
**Main Entry Concrete Settlement:**  
 Concrete sidewalk is cracking and sinking throughout campus but is especially bad at the main point of entry for the school

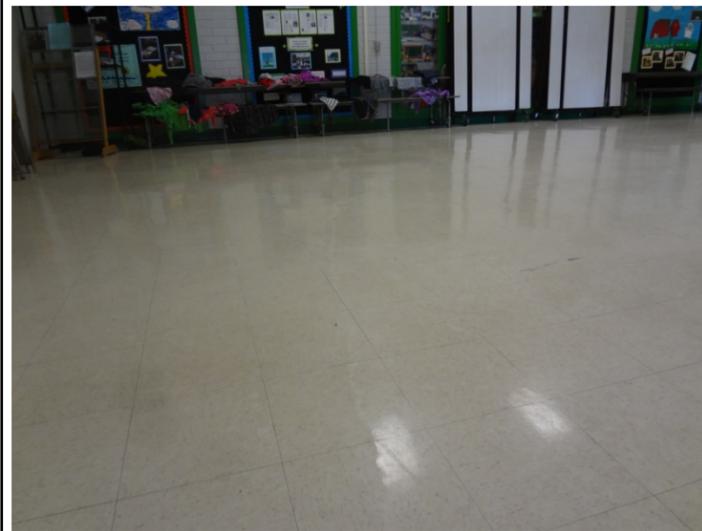
**Photo -14**  
**Multi Purpose Building: Building 7**  
 Building Settlement is causing cracking in the walls and concrete floors

The school has a large multi purpose space with a stage. The space is used for assemblies both school and extra curricular periodically throughout the month. The multipurpose building is showing settling cracks in the concrete floors and walls however the rest of the space is in good condition.

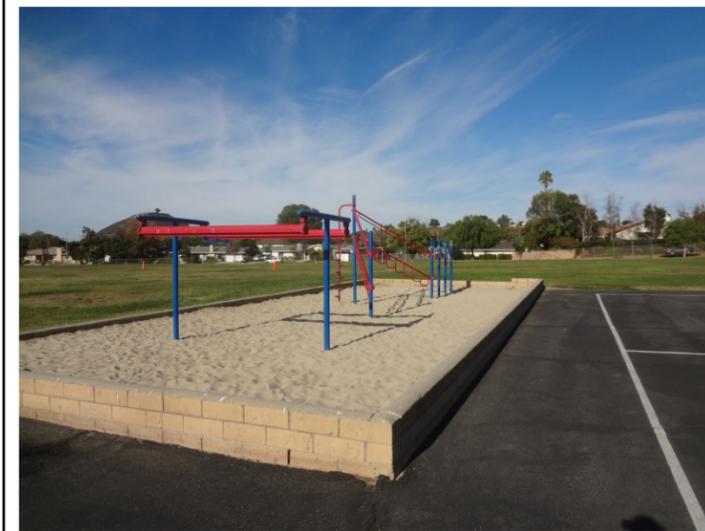
**Photo -15**  
**Playground Equipment**  
 Existing playground equipment with sand fall protection and CMU wall around perimeter.

The remaining improvements are primarily maintenance related with the exception for the need of new playground equipment. The current playground equipment is over 20 years old and is in need of replacement. Shade structures over the playground area will also provide an area for the students to enjoy the exterior playground environment without feeling the intense heat during the peak hours of the day.

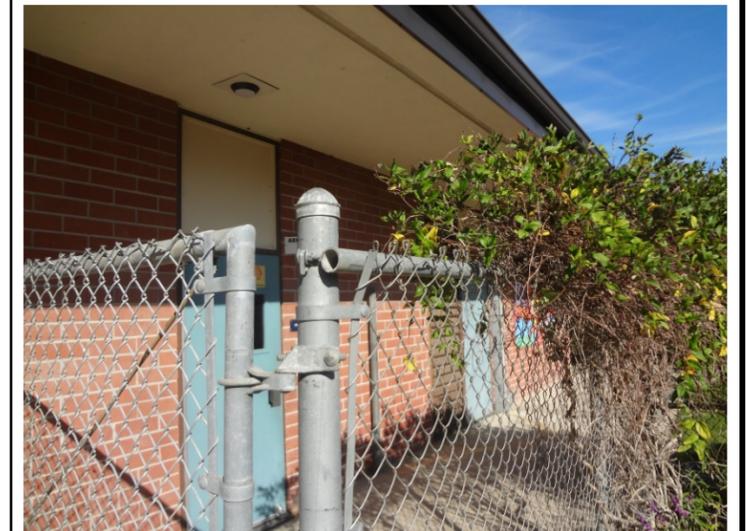
**Photo -16**  
**Administration Building: Building 1**  
 Current Fencing is old and at entry to campus in need of replacement.

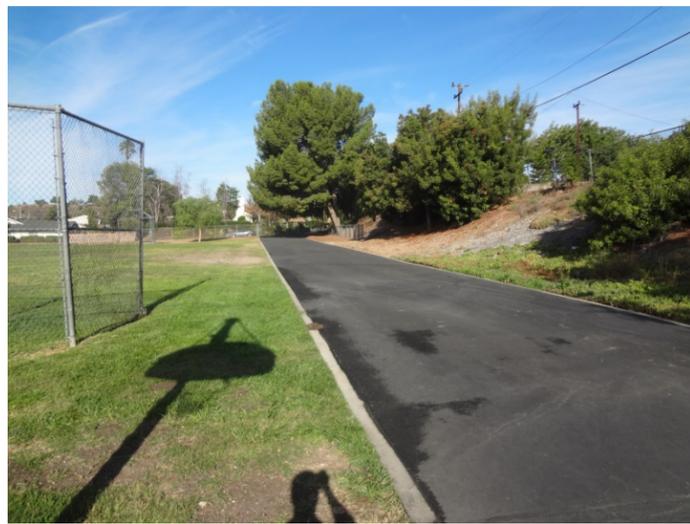
**Photo -17**  
**Alternate Point of Entry :**  
 Long A.C. Paving walkway from alternate entry location.

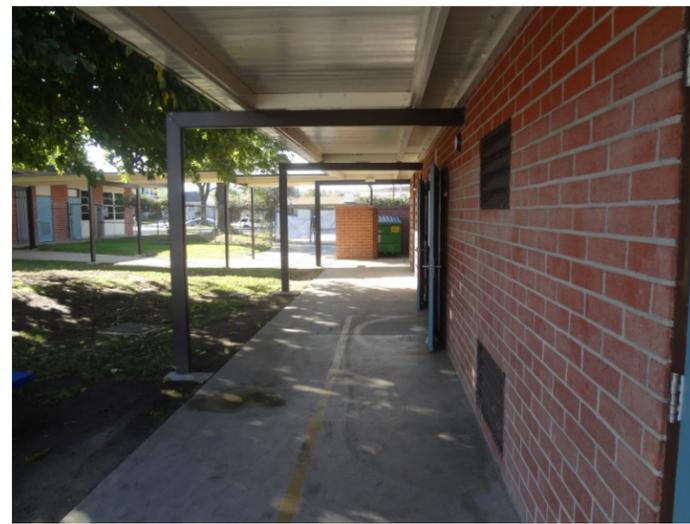
**Photo -18**  
**Covered Walkway: Building 7**  
 Covered walkways are in good condition and have wonderful site work and foliage

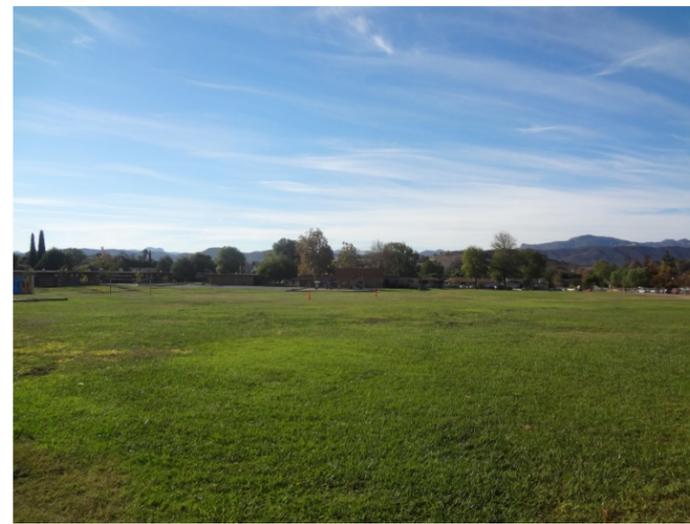
**Photo -19**  
**Playground Playfield:**  
 Large open field, issues with gophers which has created hazards in the field

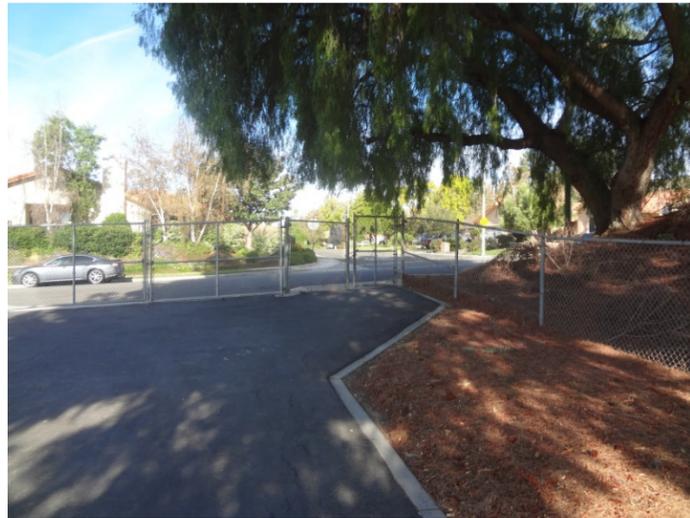
**Photo -21**  
**Alternate Point of Entry Gate:**  
 Slope at pedestrian gate location is too steep. Gate should be reversed to other side where slope would be within the tolerance for accessibility standards

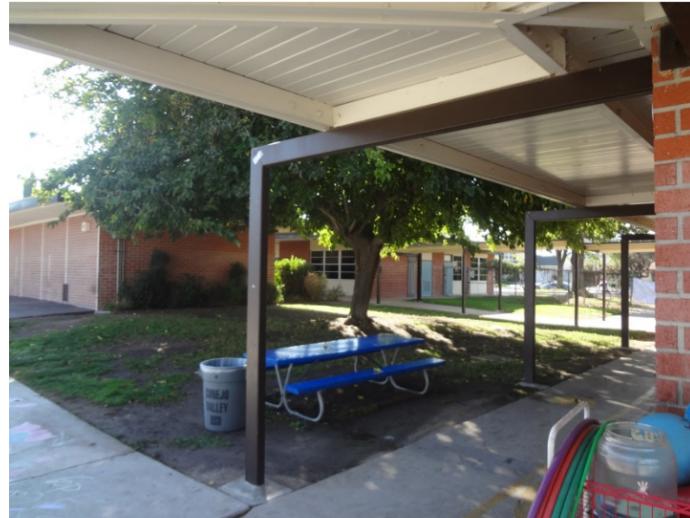
**Photo -22**  
**Covered Walkway: Building 7**  
 Covered walkways are in good condition and have wonderful site work and foliage

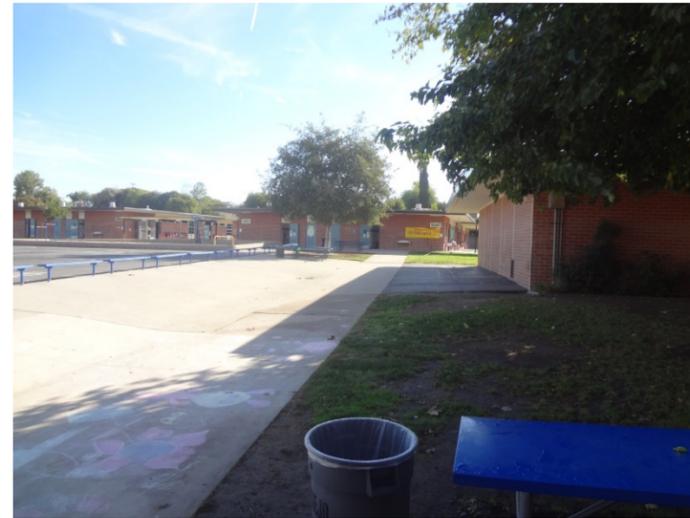
**Photo -23**  
**Playground Concrete Area:**  
 Existing concrete playground area with settlement issues.

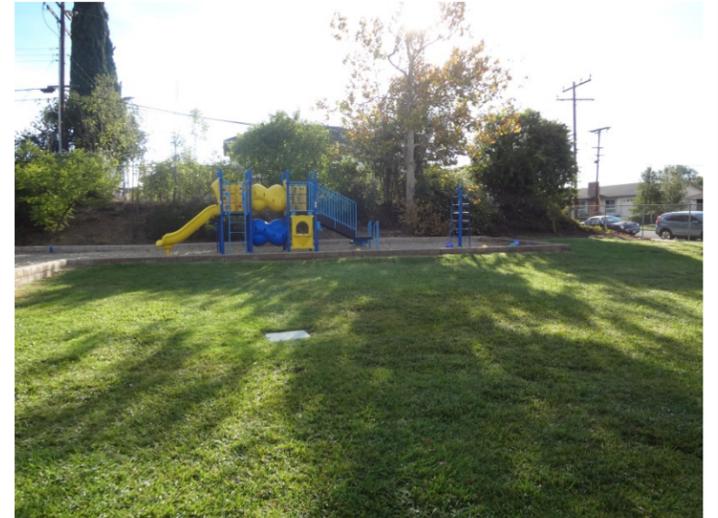
**Photo -24**  
**Kindergarten Playground Area:**  
 Exterior playground equipment with sand for fall protection and a CMU brick perimeter wall.

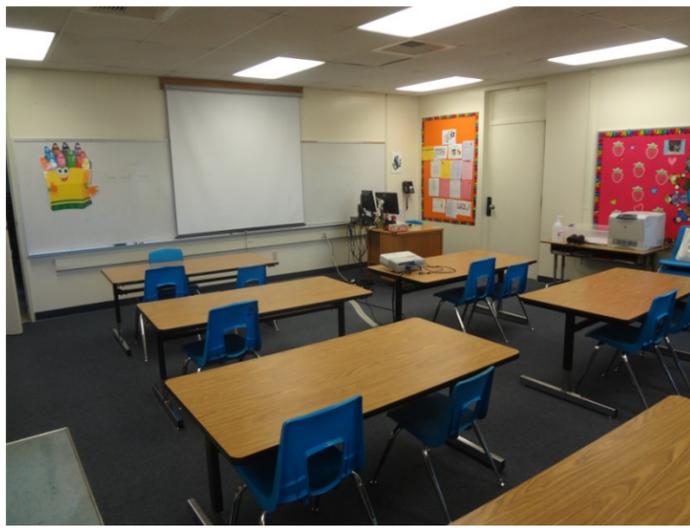
**Photo -25**  
**Typical Updated Classroom: Building 3**  
Typical classroom that has already been updated has newer carpet, casework and updated accessible sink

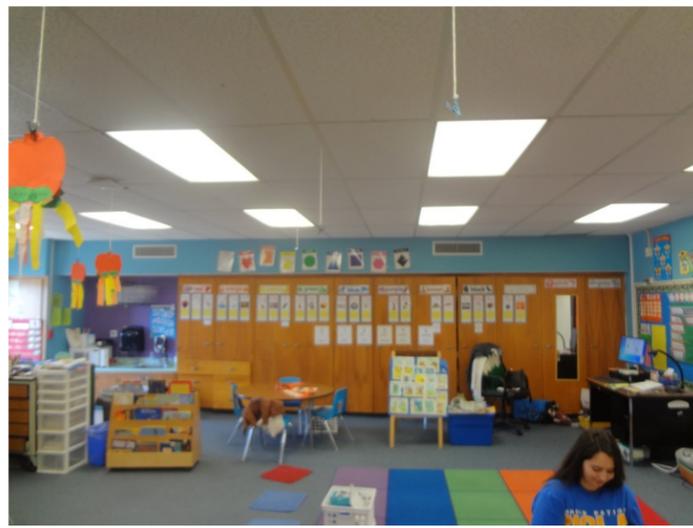
**Photo -26**  
**Typical Original Classroom: Building 3**  
Typical classroom in original condition. Carpets and finishes in decent condition sinks are not accessible.

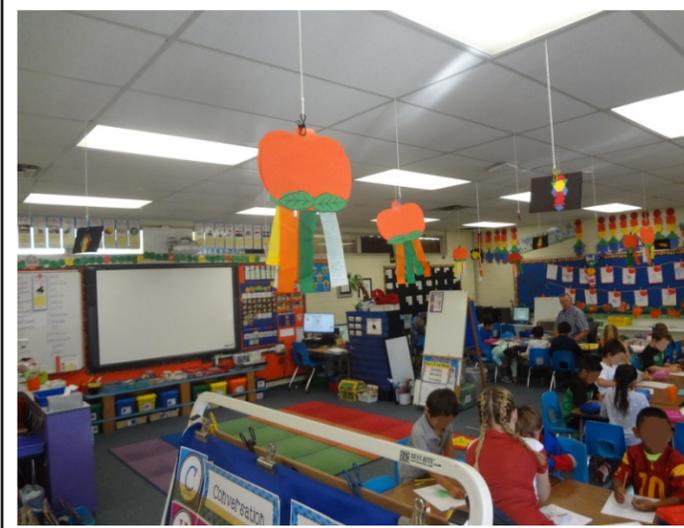
**Photo -27**  
**Kindergarten Classroom: Building 2**  
Typical kindergarten classroom in good condition, finishes in decent condition, bathrooms and sinks are accessible

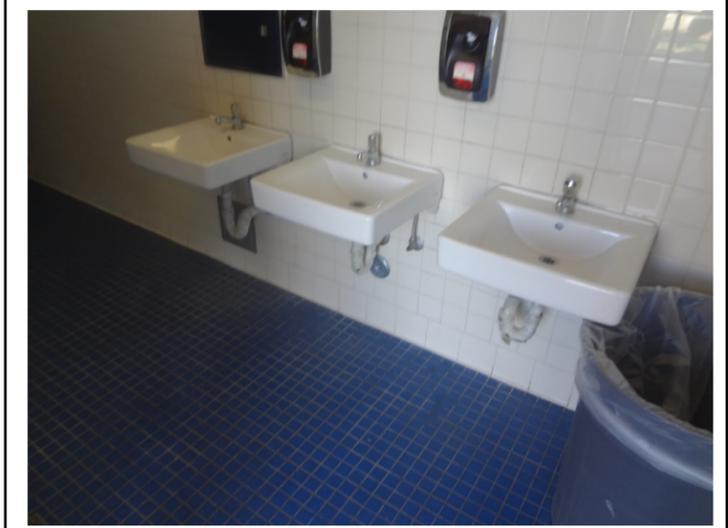
**Photo -28**  
**Typical Boys and Girls Bathroom:**  
Bathrooms in good condition with updated accessible fixtures

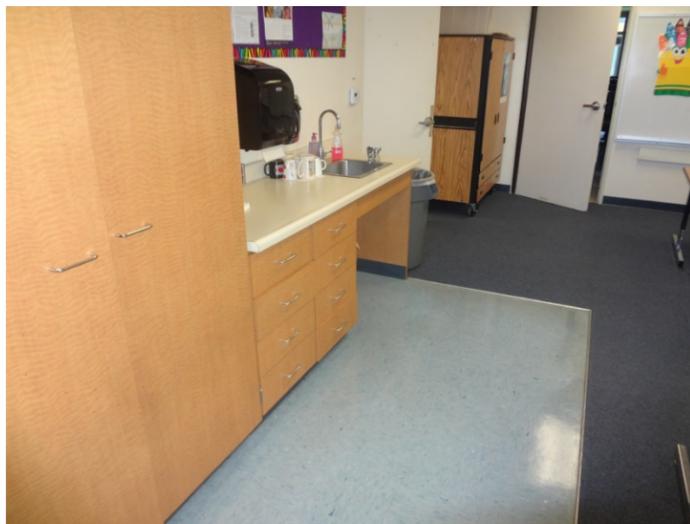
**Photo -29**  
**Typical Updated Classroom: Building 3**  
Typical classroom that has already been updated has newer carpet, casework and updated accessible sink

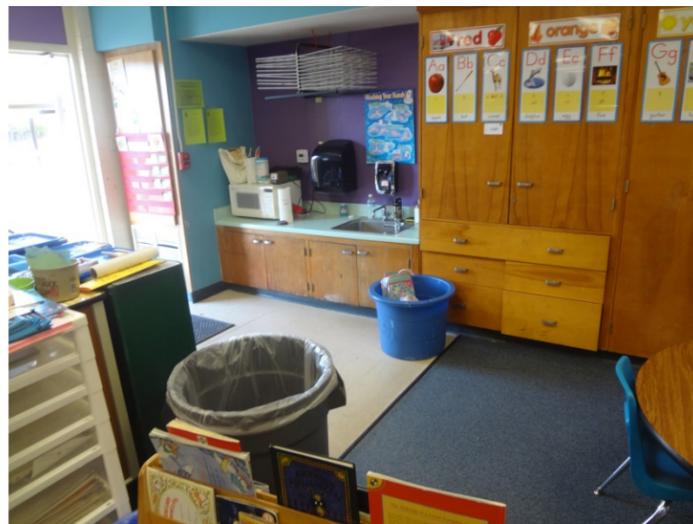
**Photo -30**  
**Typical Original Classroom: Building 3**  
Typical classroom in original condition. Carpets and finishes in decent condition sinks are not accessible.

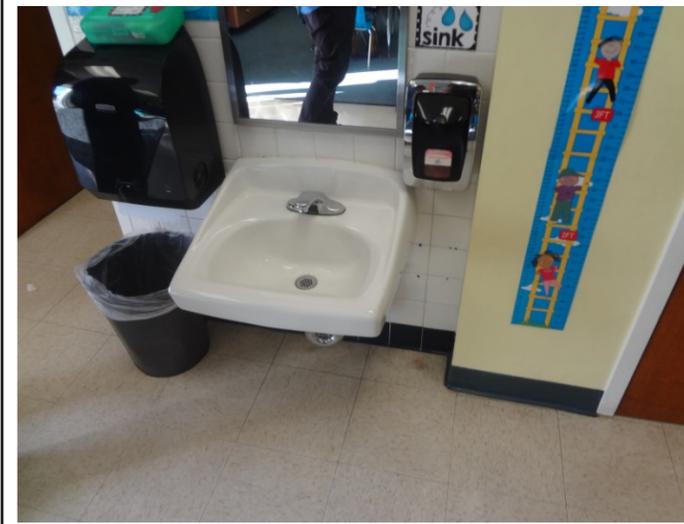
**Photo -31**  
**Kindergarten Classroom: Building 2**  
Typical kindergarten classroom in good condition, finishes in decent condition, bathrooms and sinks are accessible

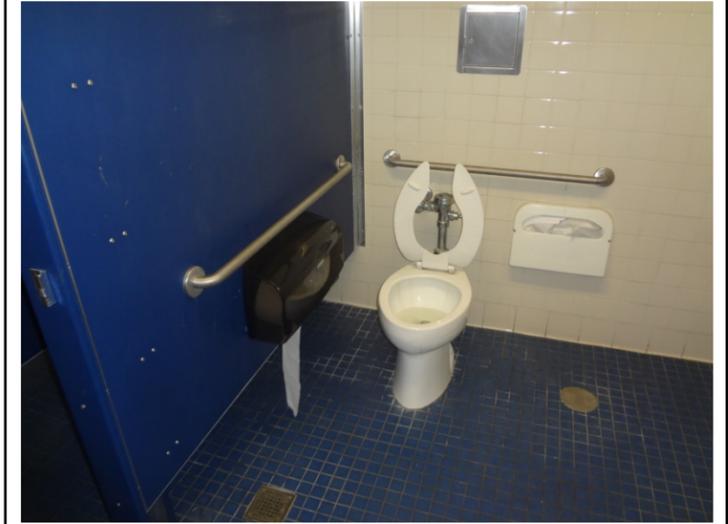
**Photo -32**  
**Typical Boys and Girls Bathroom:**  
Bathrooms in good condition with updated accessible fixtures

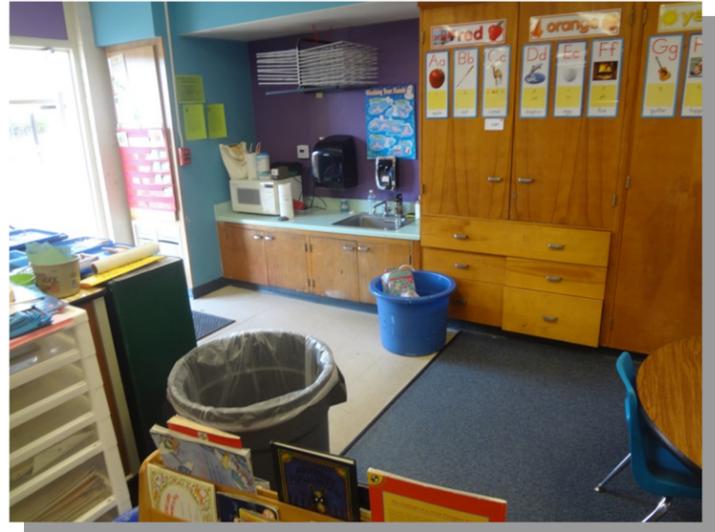
Photo -1  
Most of the classroom sinks have not been upgraded to current accessibility standards

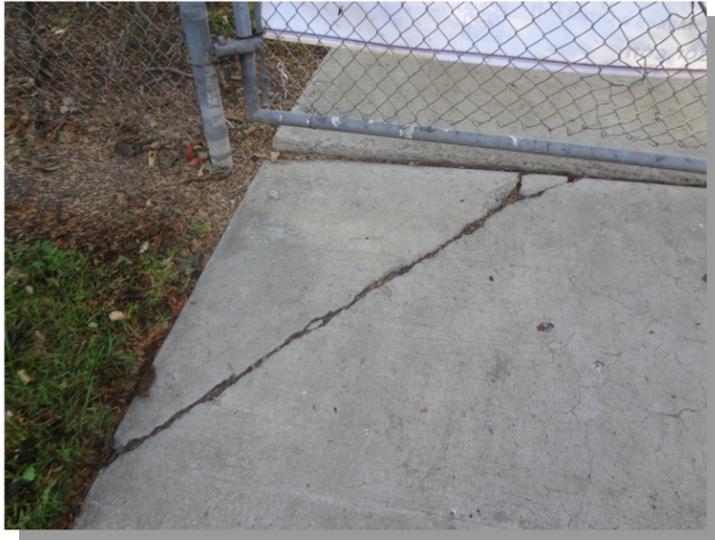
Photo -2  
Concrete slab settlement throughout the site is causing accessibility issues and tripping hazards

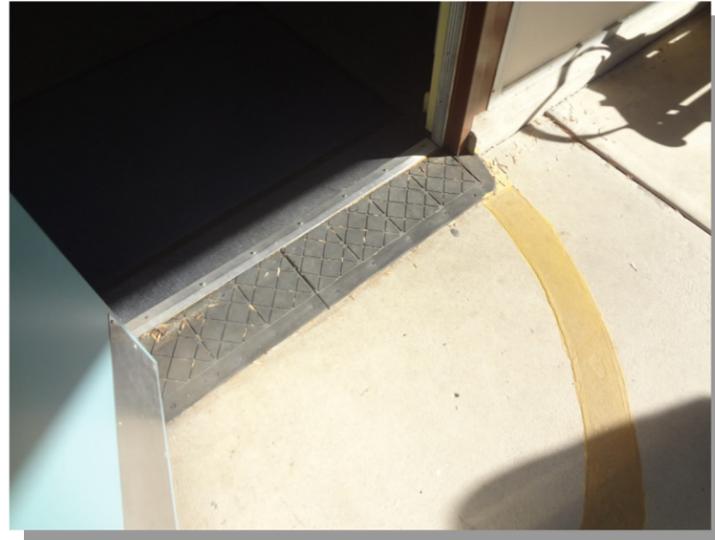
Photo -3  
The building does not have current accessibility compliant thresholds

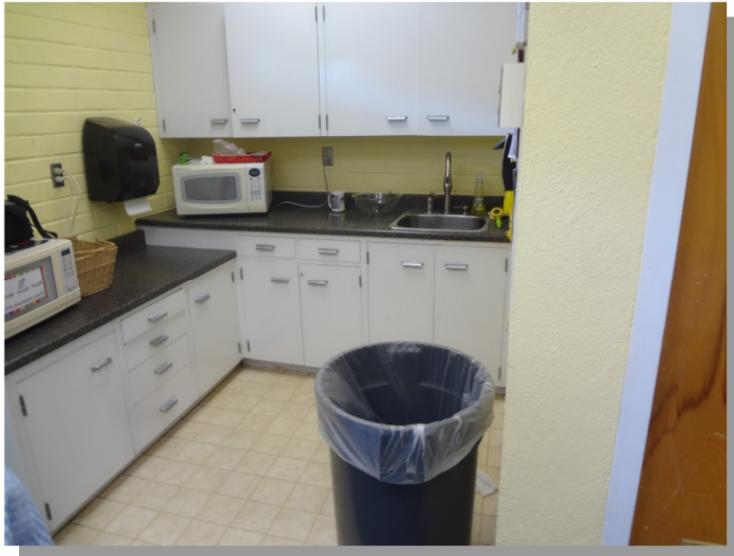
Photo -4  
Faculty sinks are not current with accessibility standards
