# CVUSD | *Facilities Master Plan*

CVUSD – THOUSAND OAKS CLUSTER SURVEY

## Conejo Valley Unified School District Office | *Survey*

December 9, 2016

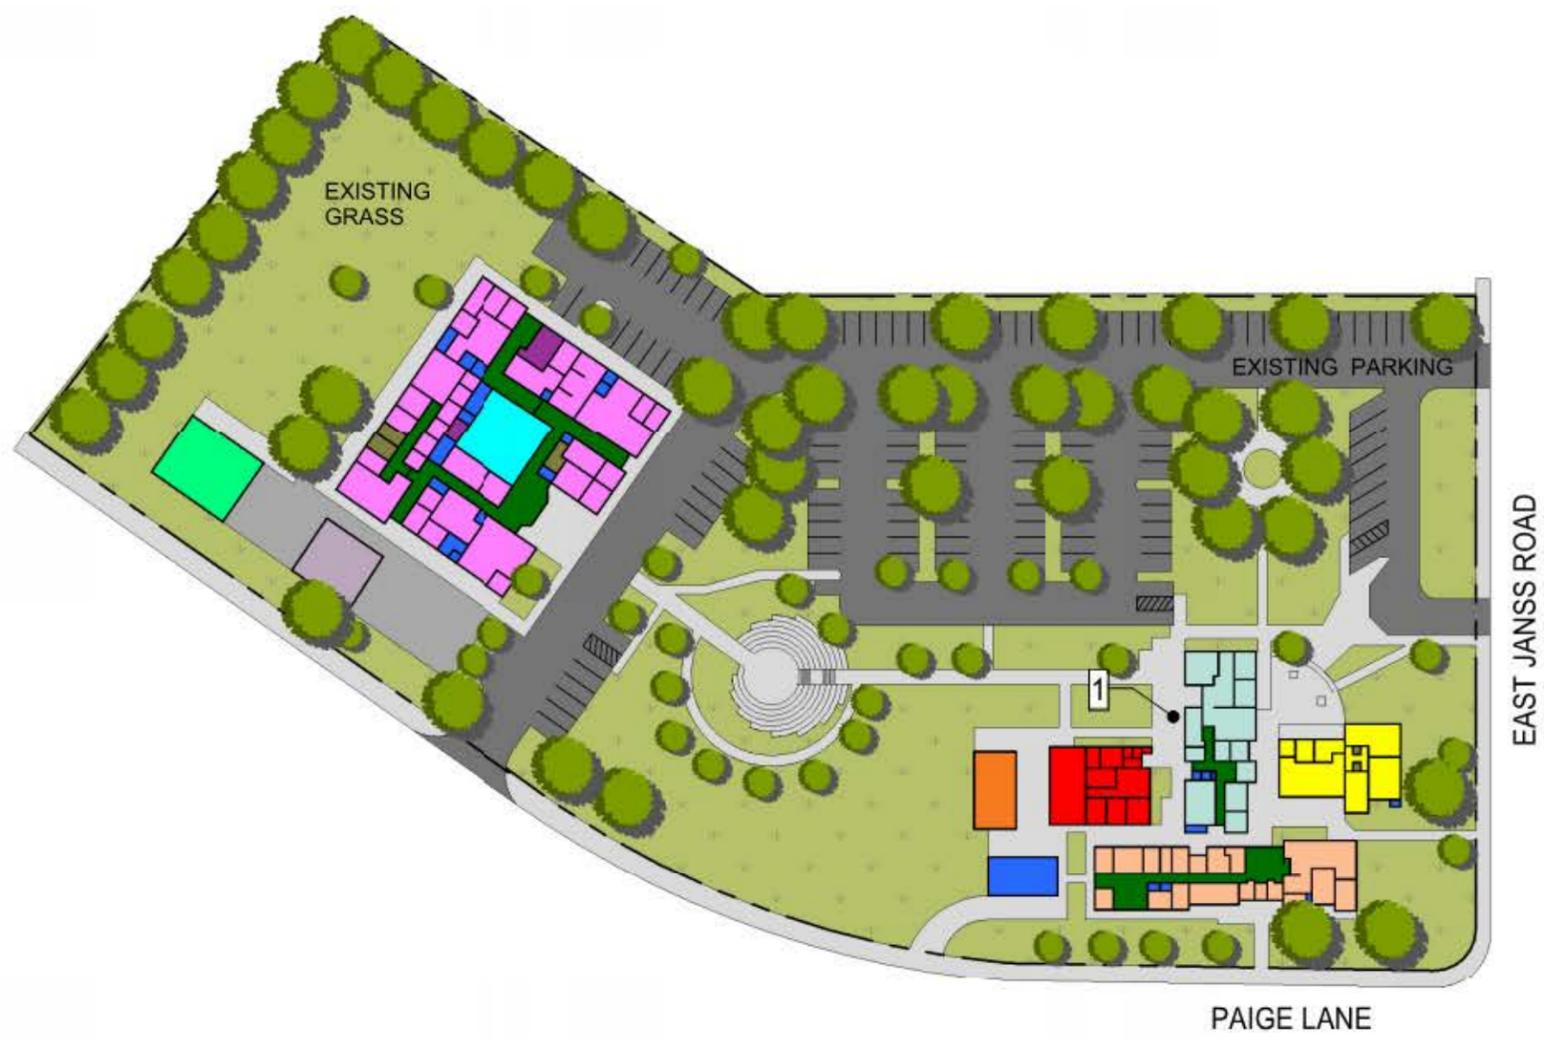
**EXISTING SITE PLAN | CONEJO VALLEY SCHOOL DISTRICT OFFICE BUILDING USE**

- 1** NO ACCESSIBLE PATH FROM PARKING LOT, SLOPE OF CONCRETE IS TOO STEEP

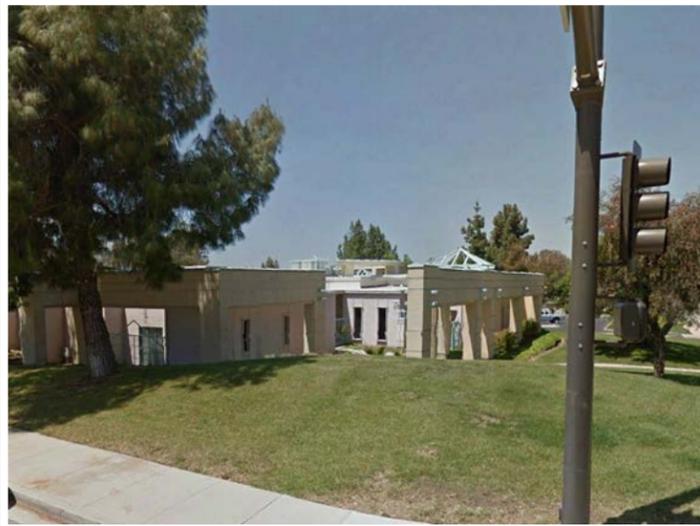
**Photo -1**  
**Building 1 and 2**  
Exterior view of main buildings constructed in 1968. Overall well maintained and in good condition.

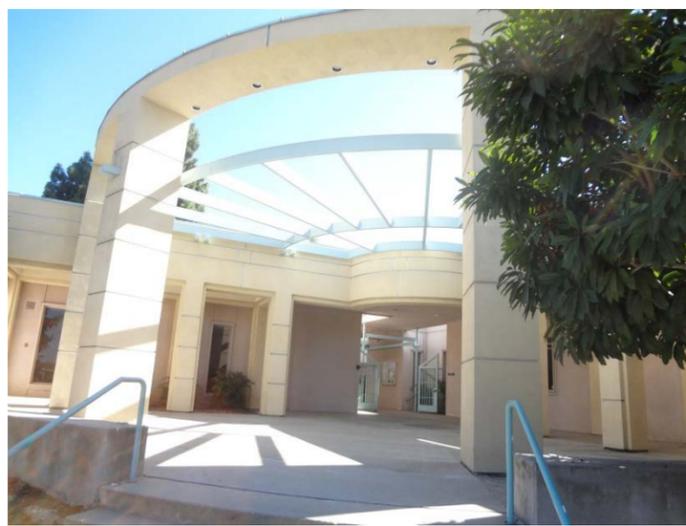
**Photo -2**  
**Building 2**  
Primary entrance to the district office facility is in good condition, but has some accessibility issues.

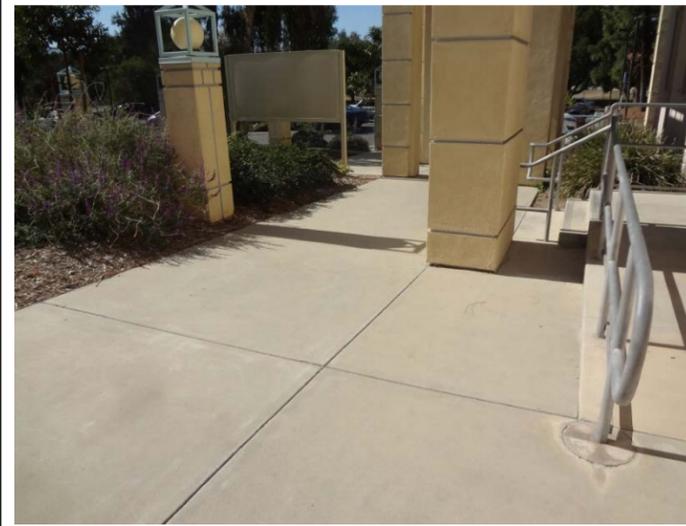
**Photo -3**  
**Building 3**  
Secondary entrance location has too great a slope to comply with accessibility standards, but is in overall has aged well.

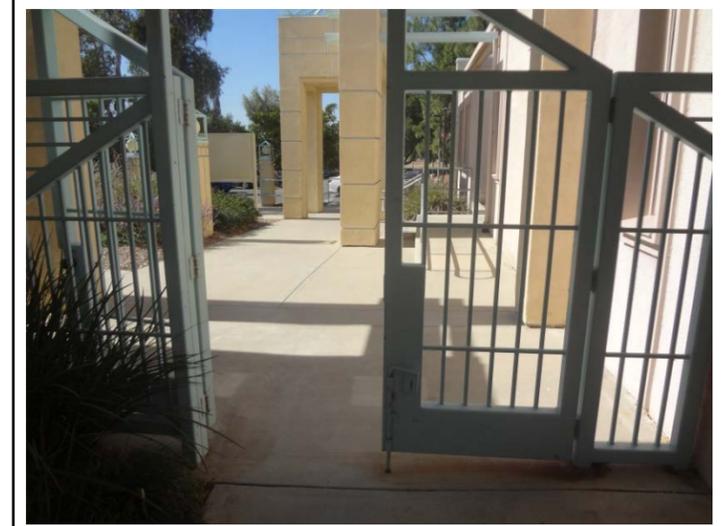
**Photo -4**  
**Building 3**  
One of the 4 entry gates that secure the building. They are in good condition but are not current with accessibility standards.

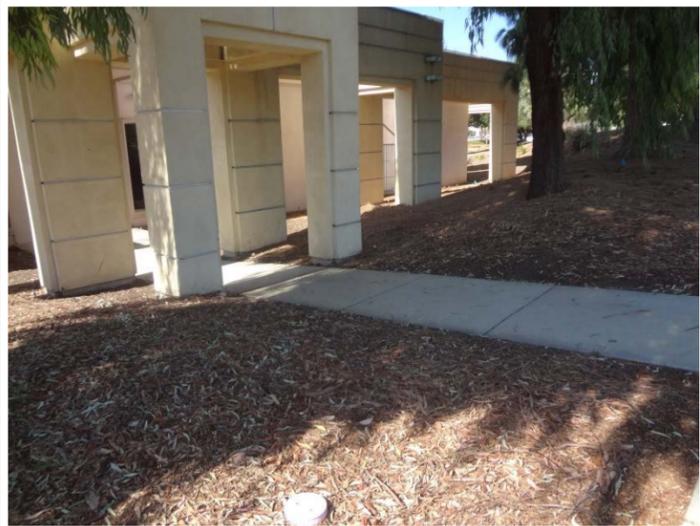
**Photo -5**  
**Building 2**  
Back entry to the facility off of Lynn Road. There is no public access from this location and the ramp does not comply with accessibility standards.

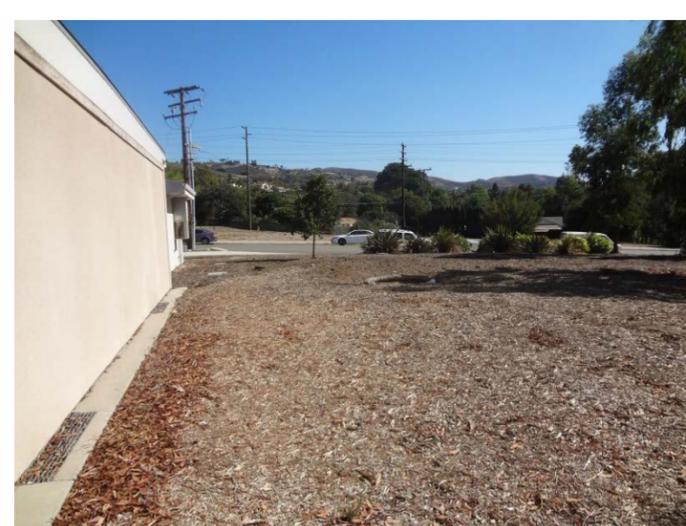
**Photo -6**  
**Building 9**  
Back of modular building looking at Lynn road. Current modular buildings have aged well.

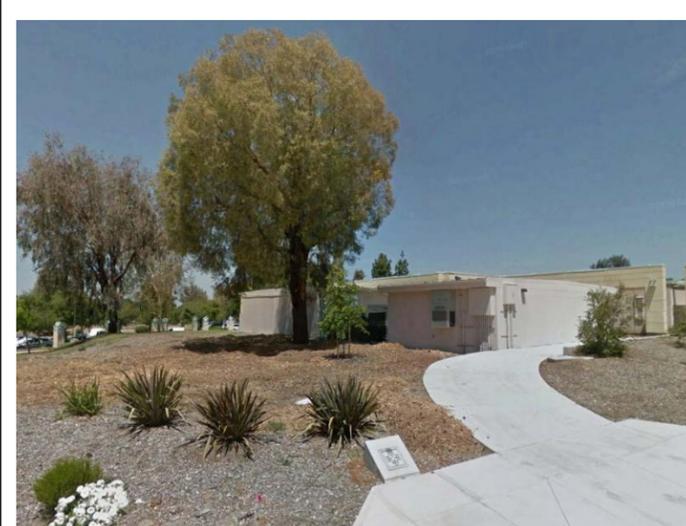
**Photo -7**  
**Building 9**  
View of modular buildings from Lynn Road including the most recent addition from after 2013.

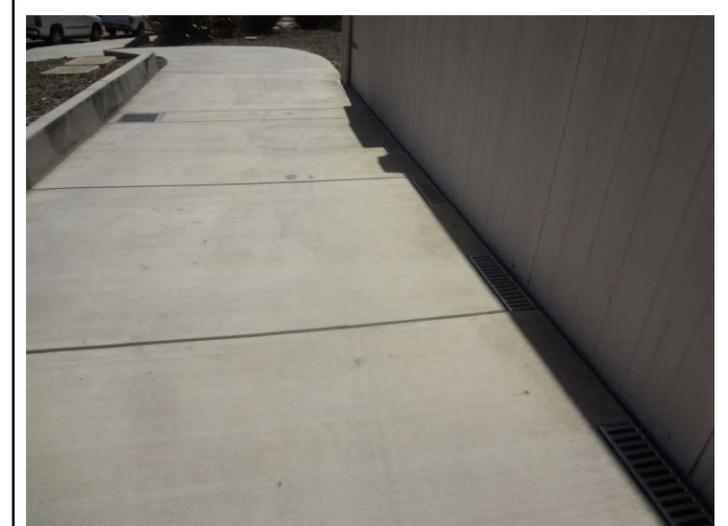
**Photo -8**  
**Building 9**  
Concrete driveway of new modular building.

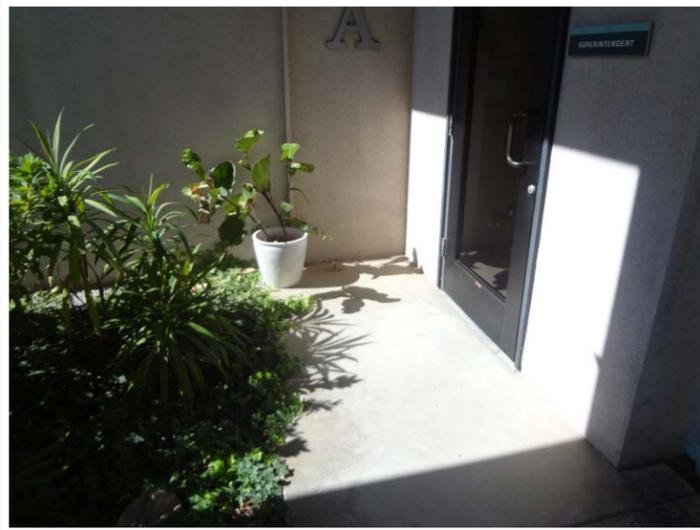
**Photo -9**  
**Building 1**  
 Main entry to building A (1) , or the superintendent. Landing is not accessible.

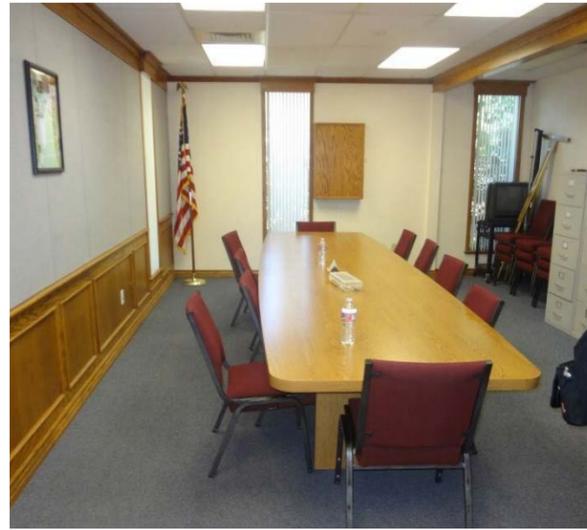
**Photo -10**  
**Building 1**  
 Conference room in Building 1. Finishes have aged well.

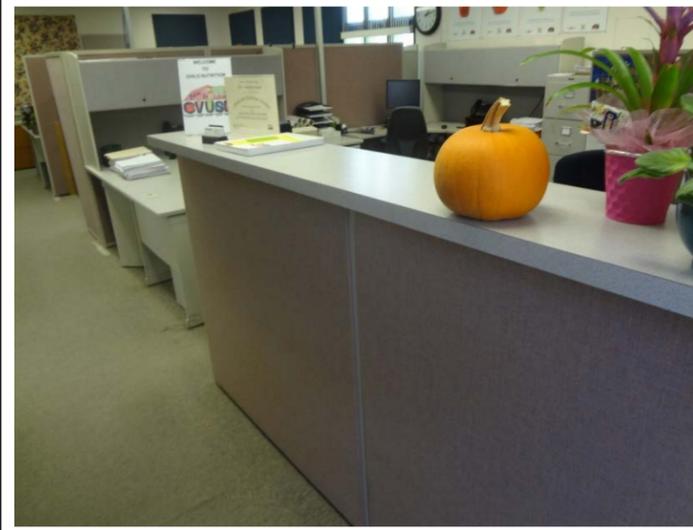
**Photo -11**  
**Building 1**  
 Offices in Building 1, Finishes have aged well.

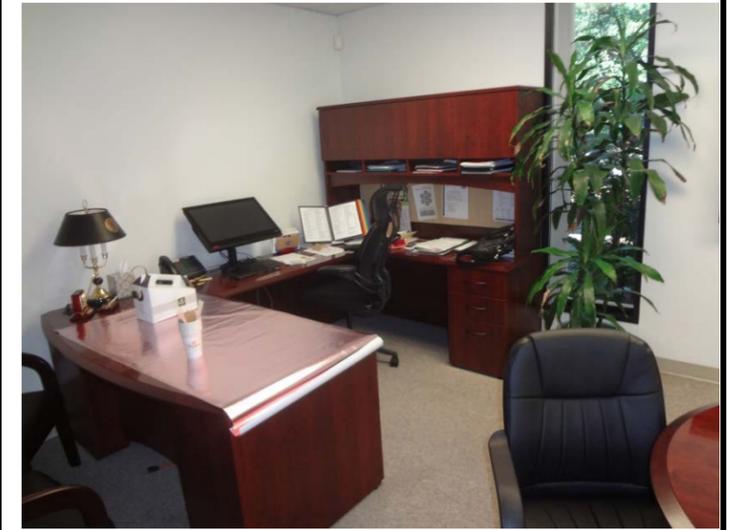
**Photo -12**  
**Building 1**  
 Superintendents office.

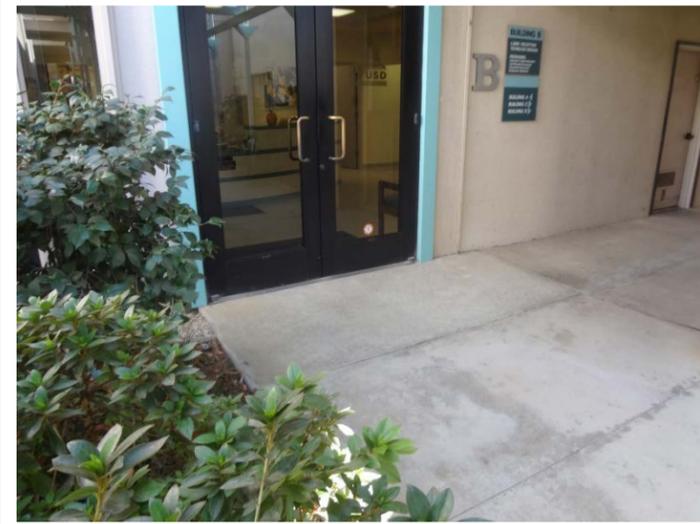
**Photo -13**  
**Building 2**  
 Main entry to Building B (2) typical of all other entry points. Finishes have aged well.

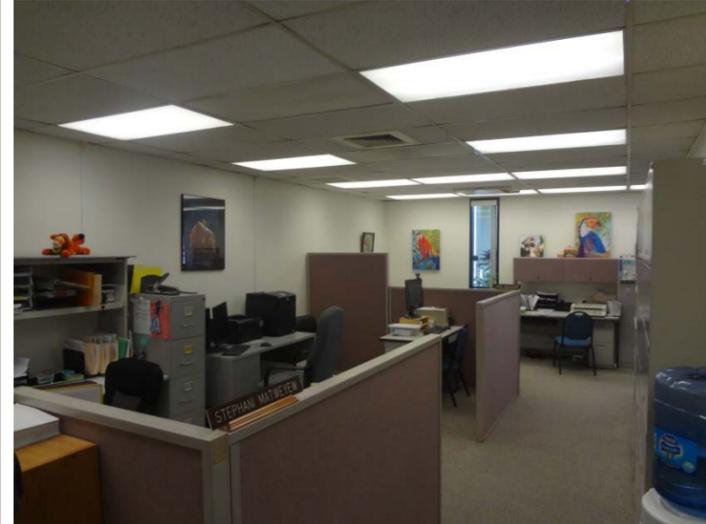
**Photo -14**  
**Building 2**  
 Typical interior office condition. Finishes have aged well. Carpet is showing wear and in need of replacement.

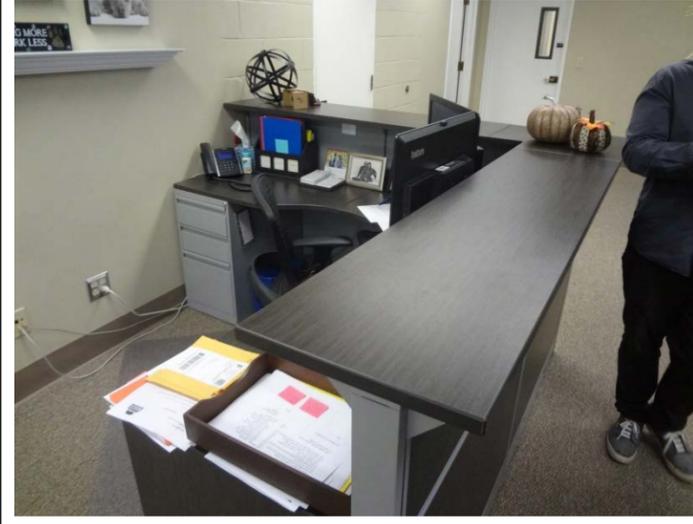
**Photo -15**  
**Building 4**  
 New work station at entry location in building C (3). Some of the work stations have been upgraded

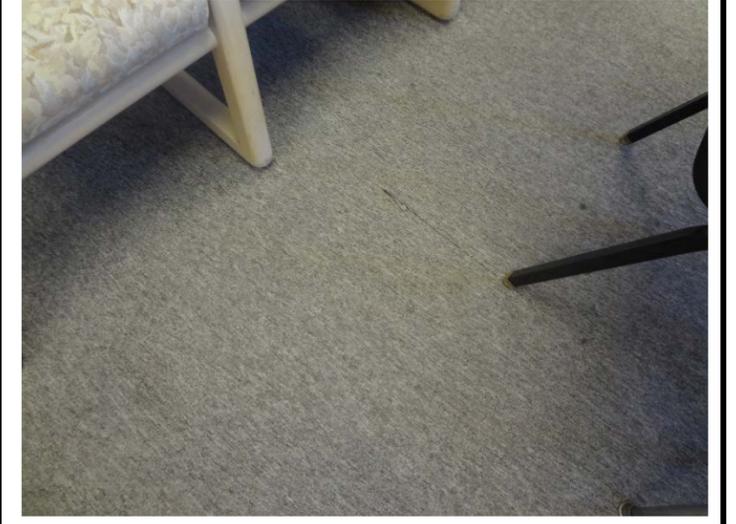
**Photo -16**  
**Building 2**  
 Current carpet throughout facility is in need of replacement.

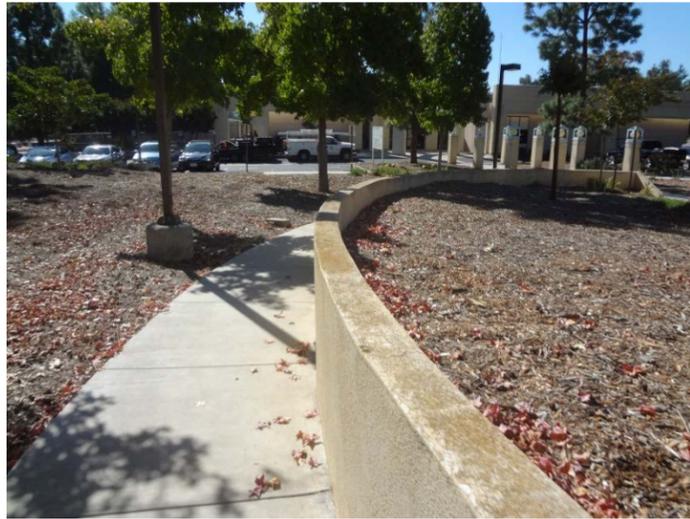
**Photo -17**  
**Exterior Amphitheatre Ramp**  
 Exterior ramp next to amphitheater has aged well.

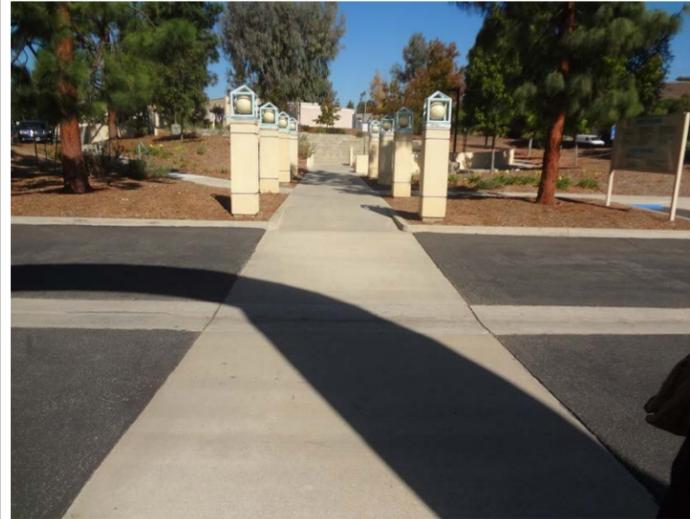
**Photo -18**  
**Building 8**  
 View from South Building (8) looking at amphitheater. Finishes have aged well and well maintained.

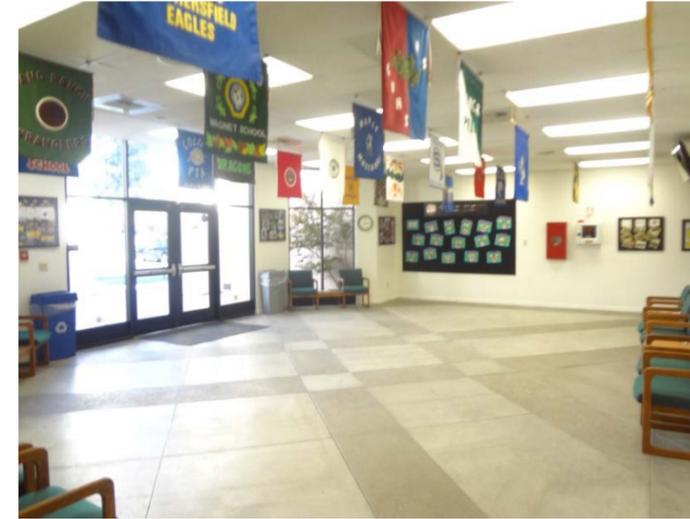
**Photo -19**  
**Building 8**  
 Main entry of building 8, finishes have aged well.

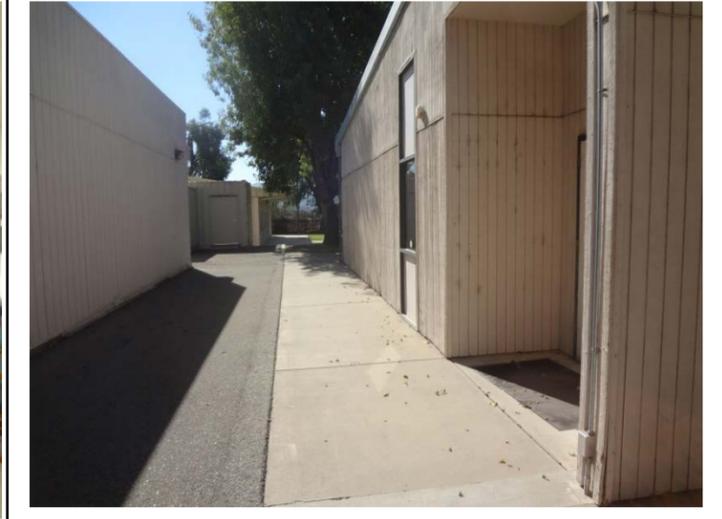
**Photo -20**  
**Building 8**  
 Exterior of building 8 next to modular buildings. Wood finish has some wood rot but over all has aged well.

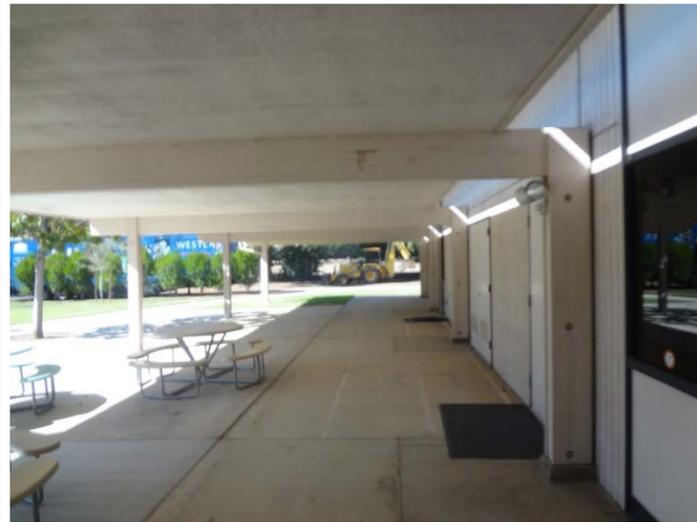
**Photo -21**  
**Building 8**  
 Covered patio area behind building 8 has aged well, however space is underutilized.

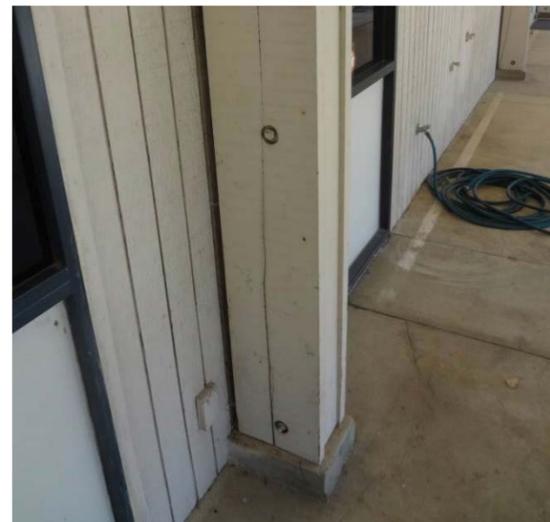
**Photo -22**  
**Building 8**  
 Column support of patio roof is in have aged well.

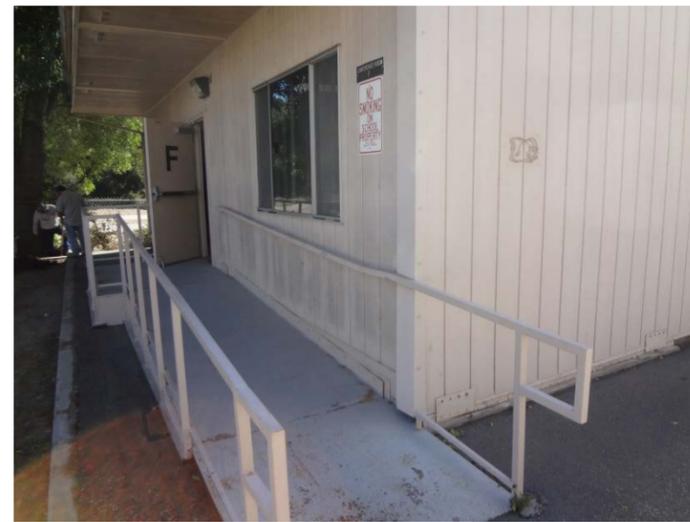
**Photo -23**  
**Building 6**  
 Modular buildings have aged well.

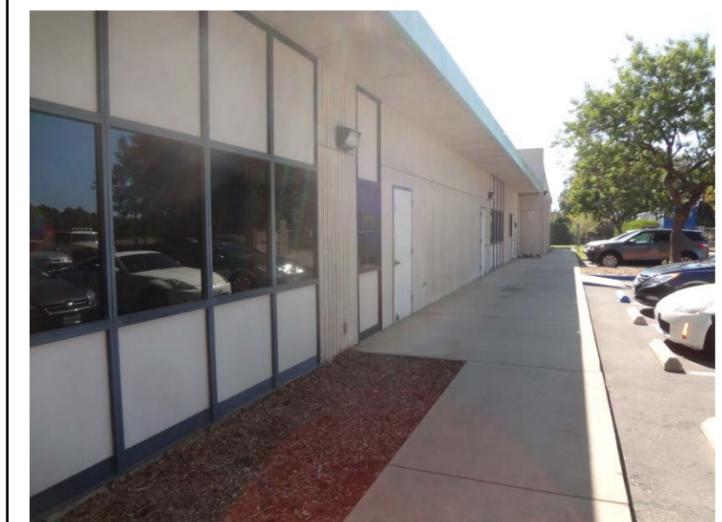
**Photo -24**  
**Building 8**  
 Western side of building 8 in overall have aged well.

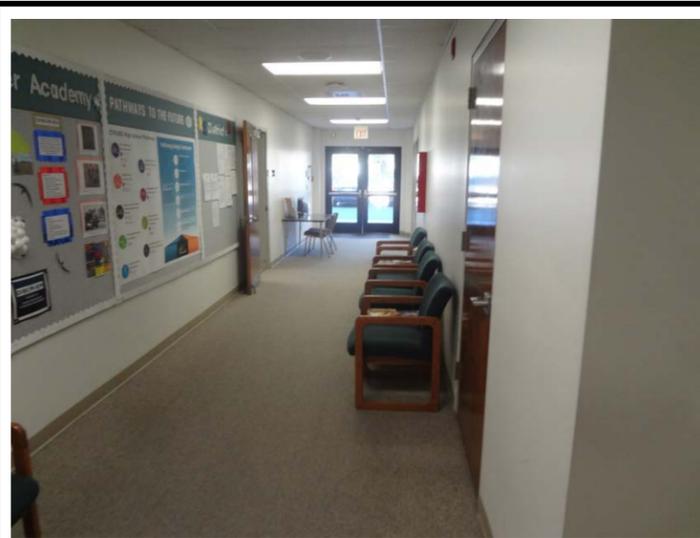
**Photo -25**  
**Building 8**  
Hallways of building 8. Finishes have aged well.

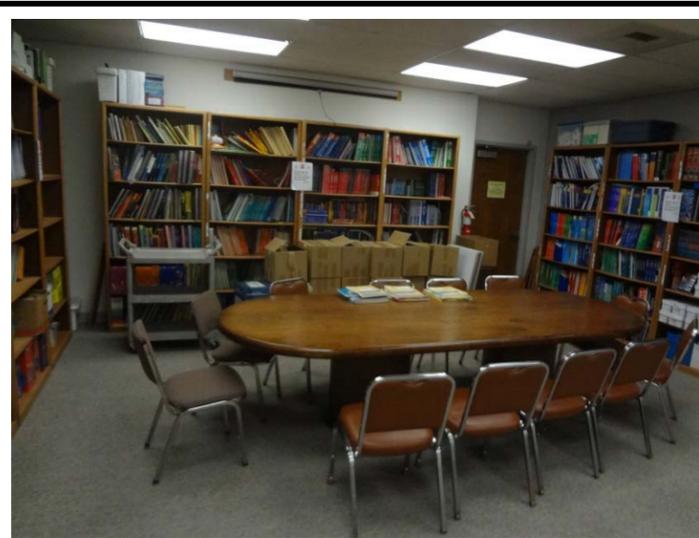
**Photo -26**  
**Building 8**  
Meeting rooms are building 8, finishes have aged well.

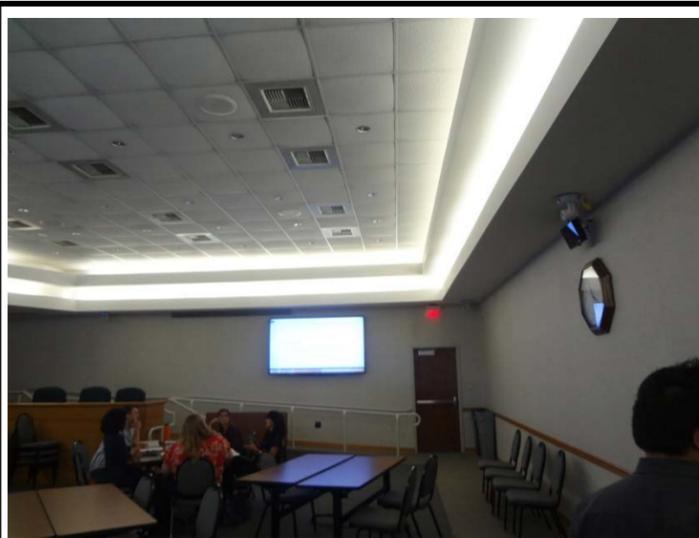
**Photo -27**  
**Building 8**  
Board room in building 8. Finishes have aged well.

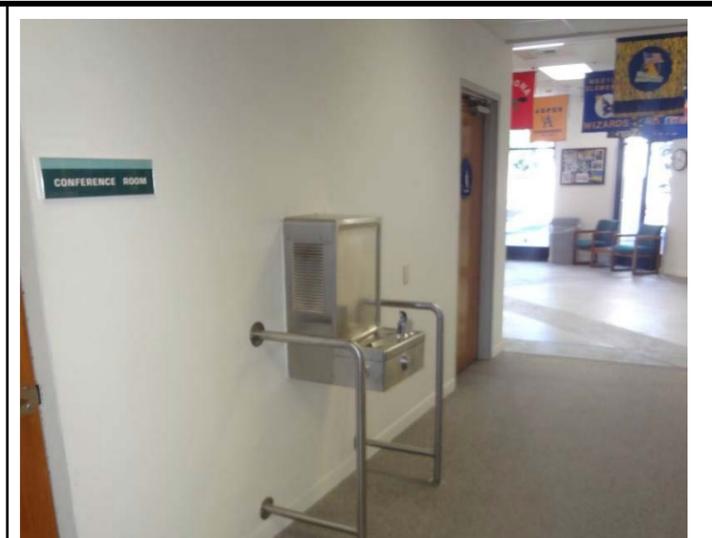
**Photo -28**  
**Building 8**  
Typical drinking fountains have been upgraded to comply with previous accessibility standards, but are not up to current standards.

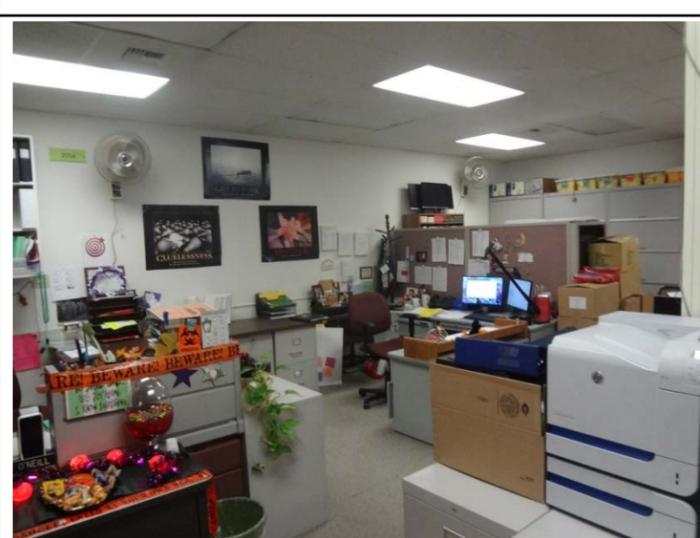
**Photo -29**  
**Building 8**  
Typical office space is cramped, finishes have aged well.

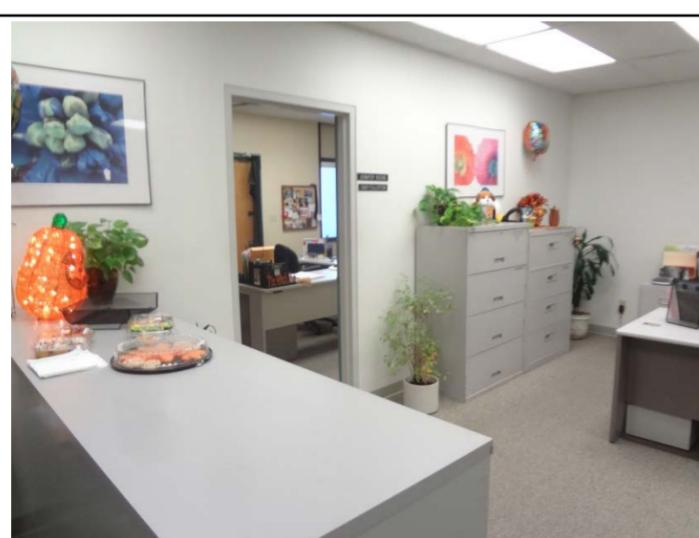
**Photo -30**  
**Building 8**  
Typical office space is cramped, finishes have aged well.

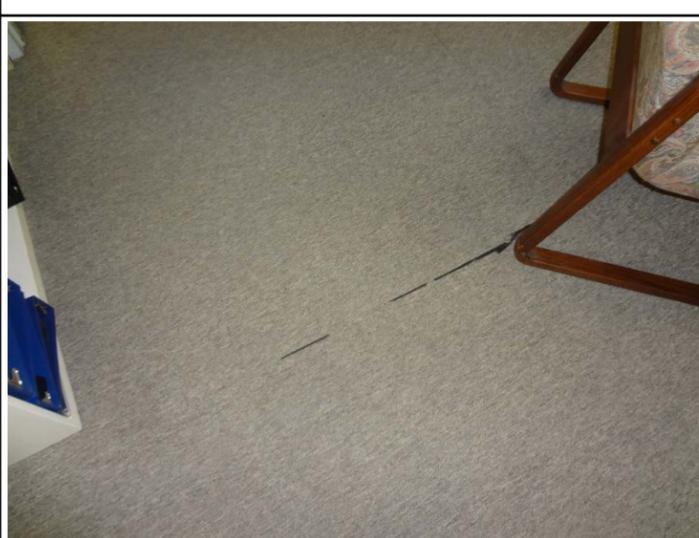
**Photo -31**  
**Building 8**  
Carpets in building 8 are in similar condition as the rest of the facility and are in need of replacement

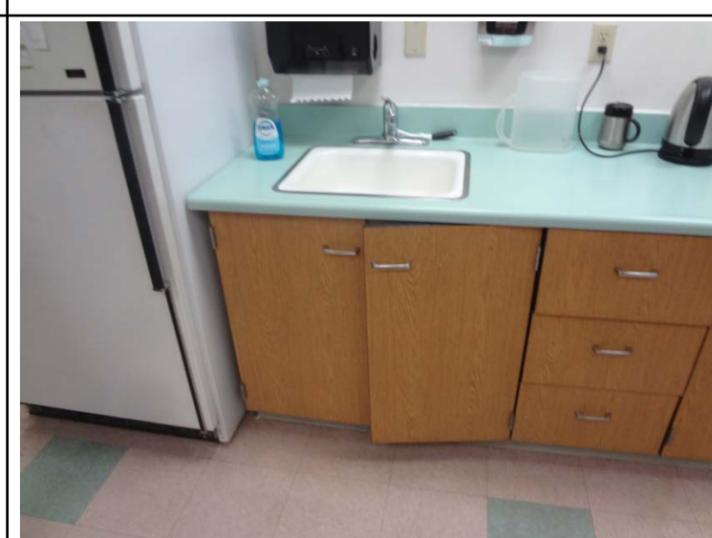
**Photo -32**  
**Building 8**  
Faculty lounge sink is old and does not comply with current accessibility standards.

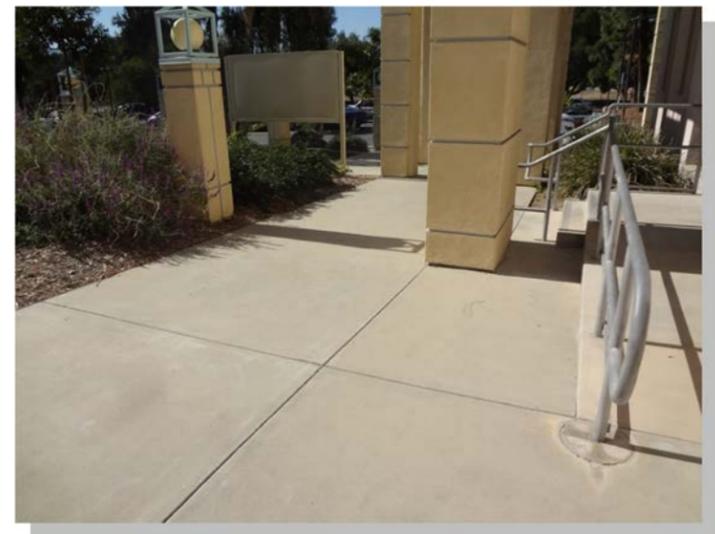
Photo -1  
The Northern complex of buildings has no accessible path of travel from the parking lot to the complex because it is not current to accessibility standards. The concrete slopes are greater than 5% and require handrails

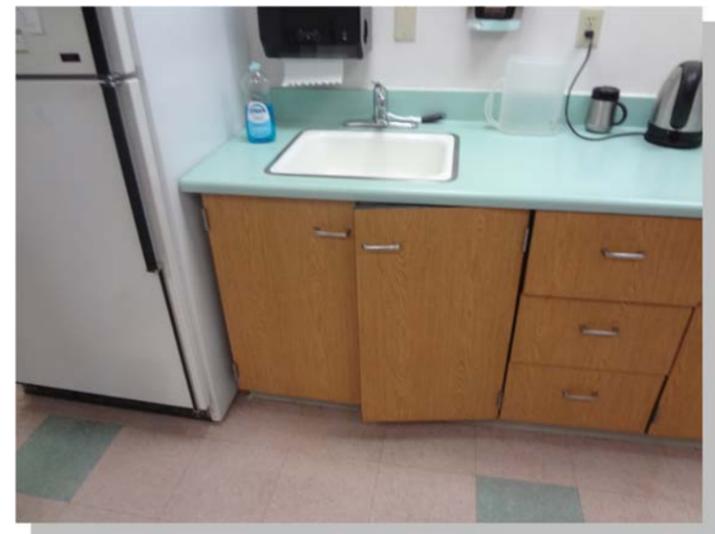
Photo -2  
The sinks in the staff lounge areas are not currently accessible

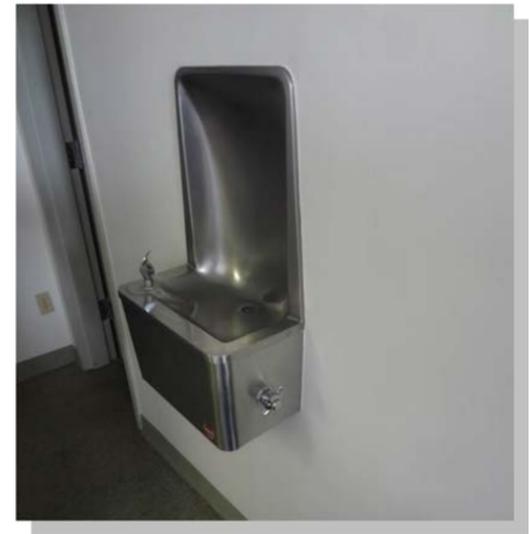
Photo -3  
All drinking fountains are also not current with accessibility standards

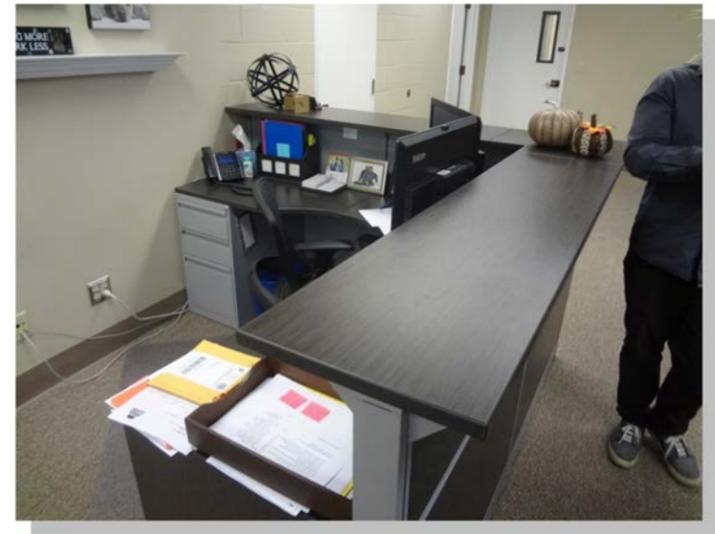
Photo -4  
All lobby and entry reception area do not have counter top heights that are current with accessibility standards.
