CVUSD – THOUSAND OAKS CLUSTER SURVEY

Ladera Elementary School | *Survey*

December 9th, 2016 – DRAFT v1

Dougherty + Dougherty
Architects

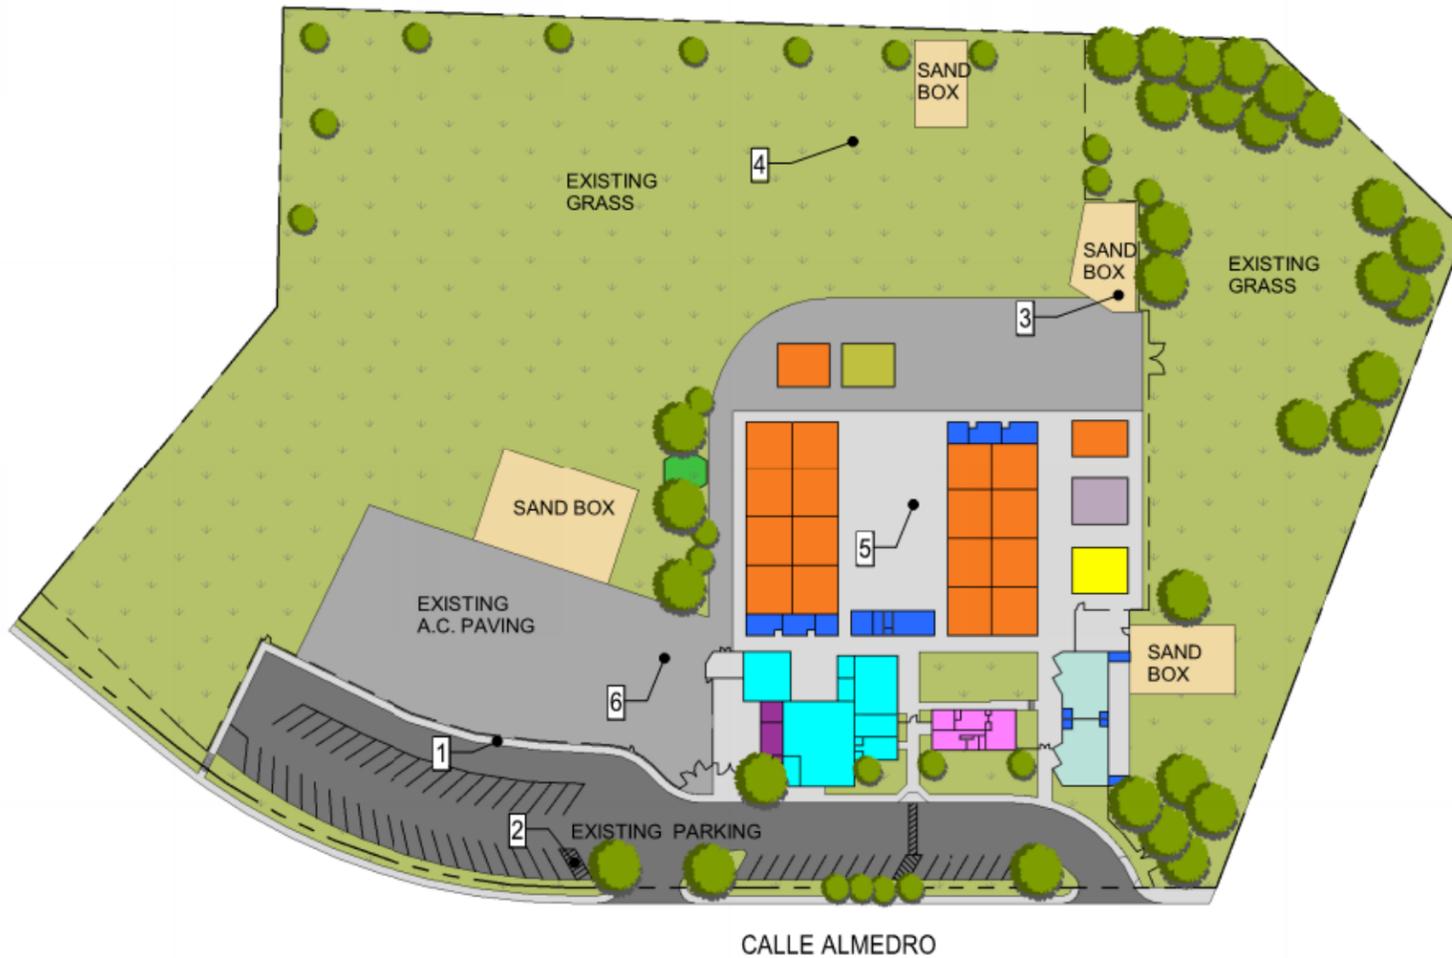
EXISTING SITE PLAN | LADERA ELEMENTARY SCHOOL
BUILDING USE

- 1 CURRENT DROP OFF LOCATION IS NOT ADA ACCESSIBLE
- 2 ADA PARKING STALLS WITH NO ACCESSIBLE PATHWAY TO SCHOOL
- 3 REPLACEMENT OF PLAYGROUND EQUIPMENT NEEDED
- 4 DESIRED LOCATION FOR JOGGING TRACK
- 5 POTENTIAL NEW SHADE STRUCTURE NEEDED
- 6 CURRENT LUNCH SHELTER INSUFFICIENT, NEW LUNCH SHELTER DESIRED IN THIS LOCATION

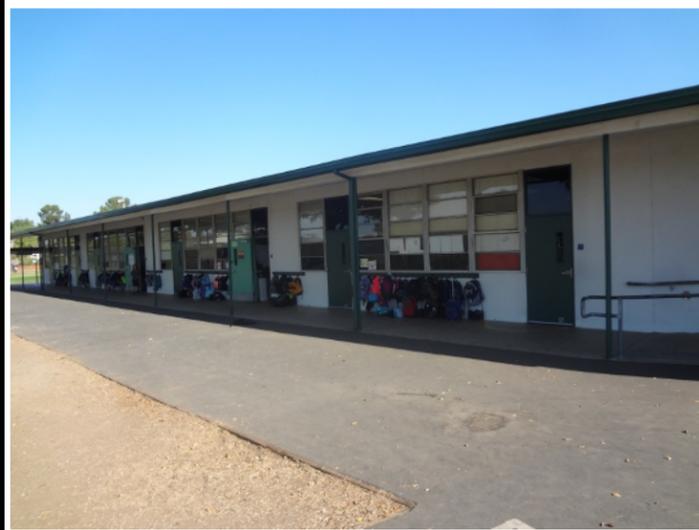
Photo -1
Building 11
Typical permanent classroom building

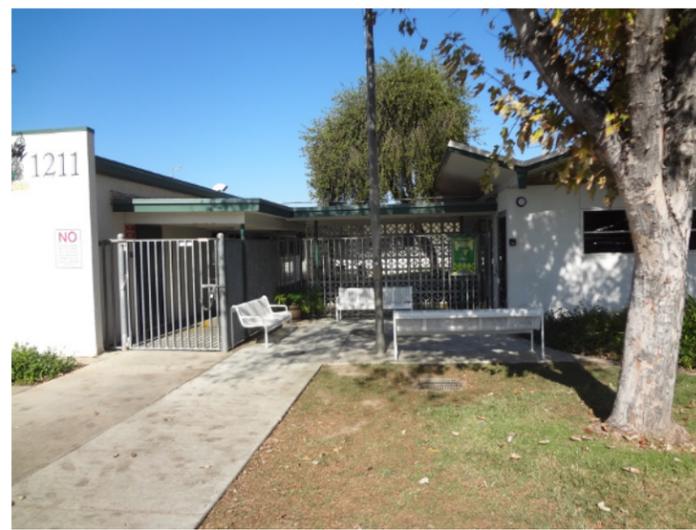
Photo -2
Building 1
Primary Entry to school next to administration office

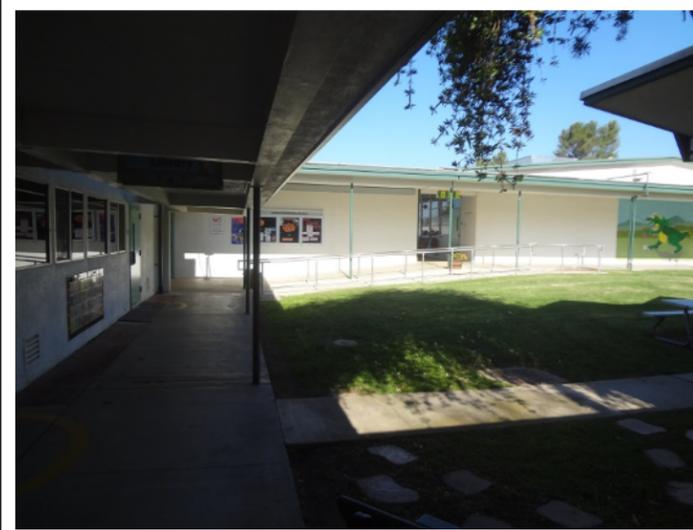
Photo -3
Building 11
Interior courtyard and covered walkway between building 7 and 11. Nicely shaded and landscaped

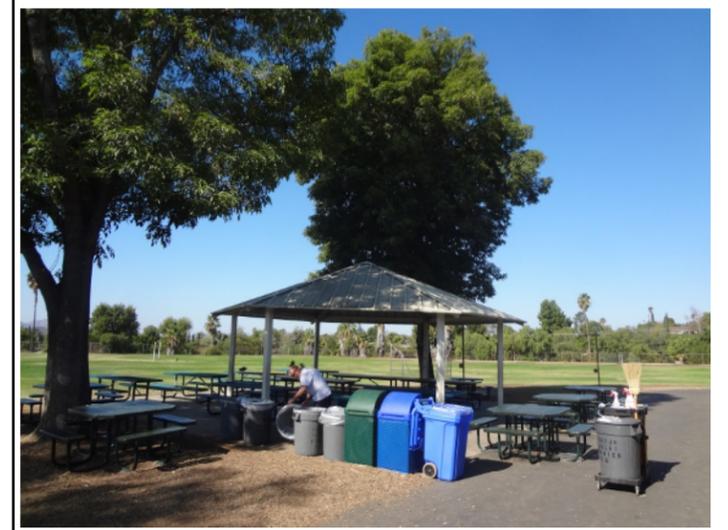
Photo -4
Building 10
Lunch shelter. Currently too small for existing population of students

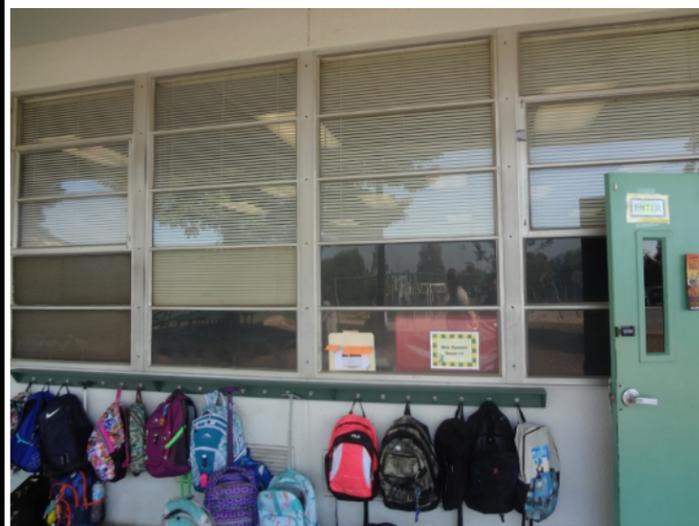
Photo -5
Building 11
Typical window condition in classroom buildings on campus. Windows have been replaced over the years with miss matched glass

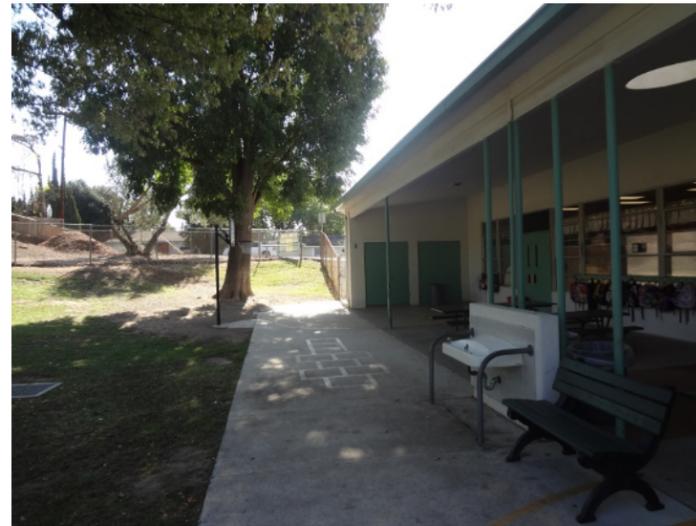
Photo -6
Building 2
Kindergarten back patio and playground area. Well shaded, drinking fountain is not meeting current accessibility standards.

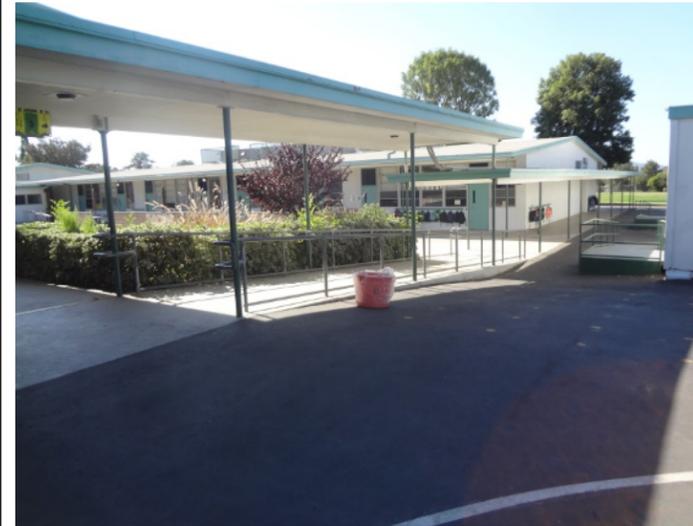
Photo -7
Building 8
Covered walkway between building 8 and 11

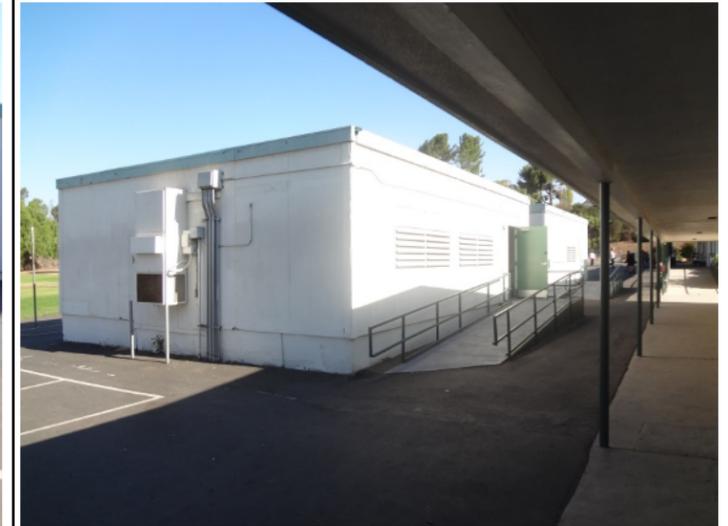
Photo -8
Building 9
Existing portable greater than 30 years old

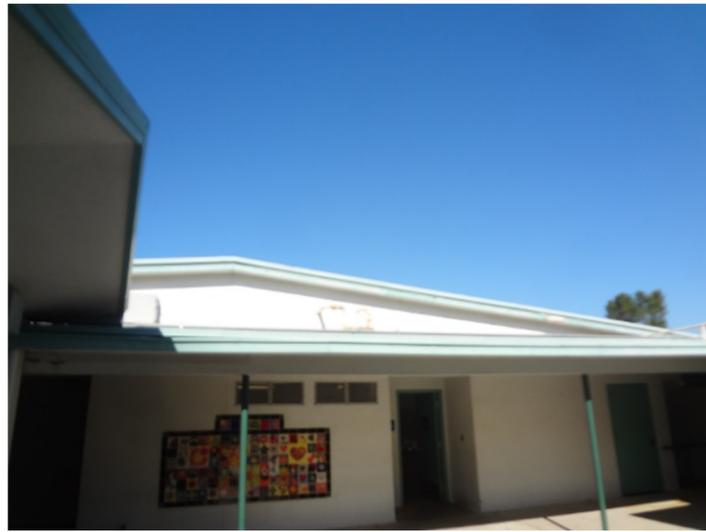
Photo -9
Building 12
Courtyard behind multi purpose building

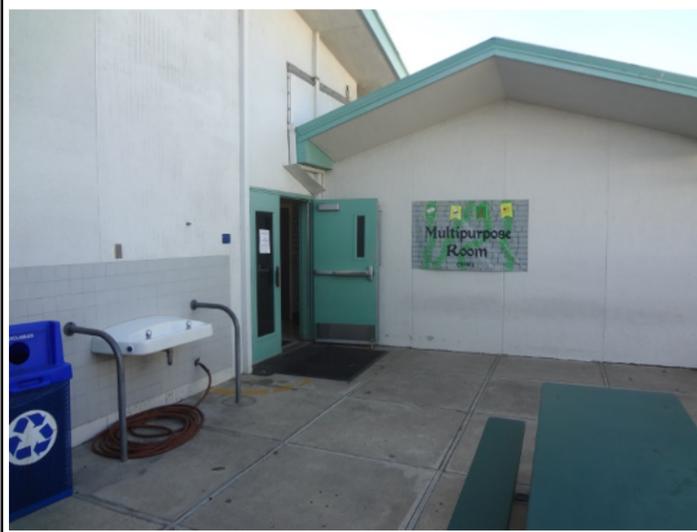
Photo -10
Building 12
Courtyard behind multi purpose building

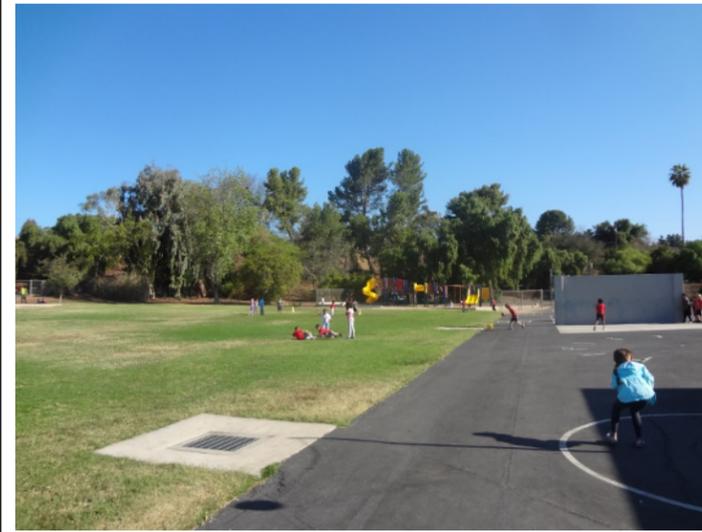
Photo -11
Playground Area
Existing playground area is large with extensive grass area for the kids

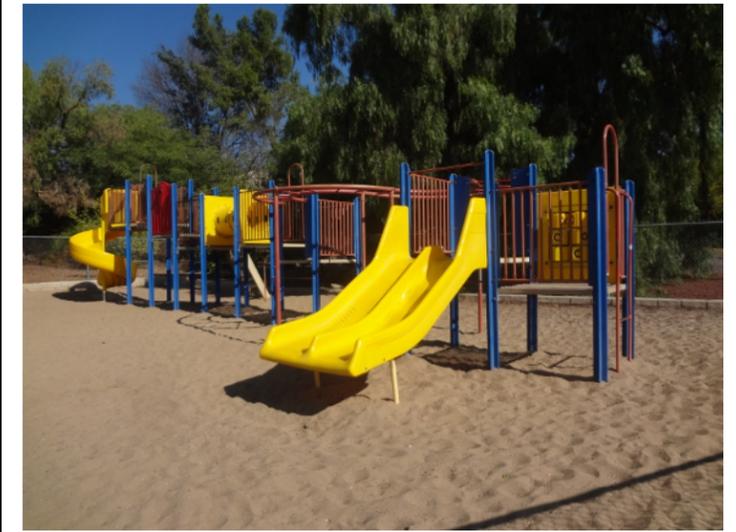
Photo -12
Play Equipment
Play equipment is very old and in need of replacement. Currently being maintained with parts from non compatible play equipment

There is a large playground, with a large grass area. The equipment is in need of replacement and a jogging track is desired.

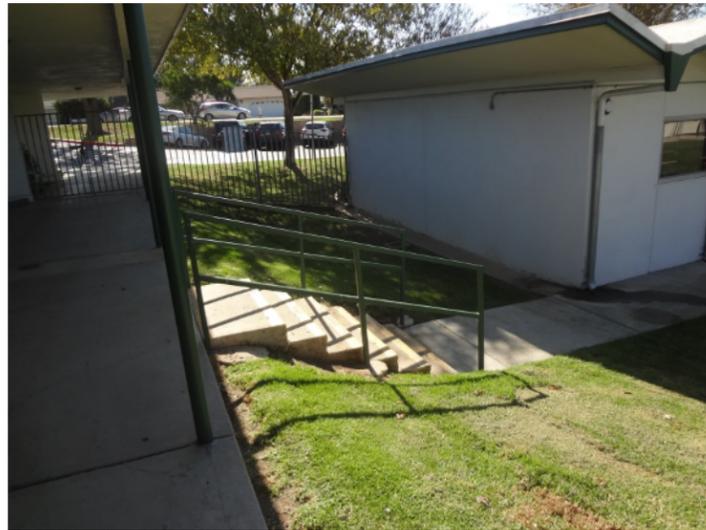
Photo -13
Building 2
Walkway and stairs between building 2 and building 1

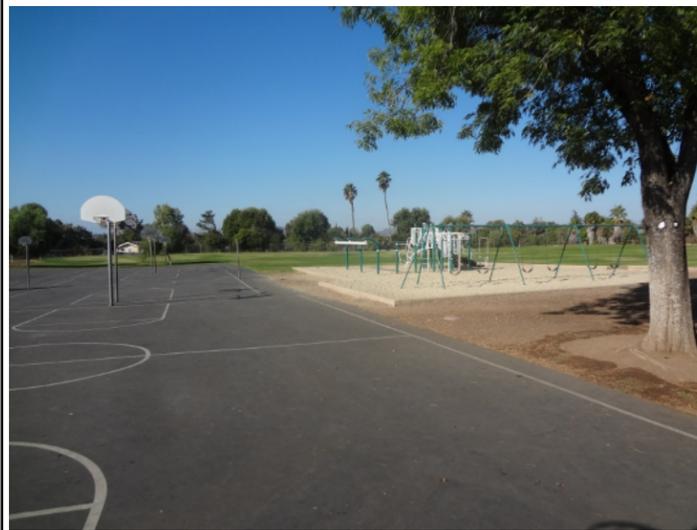
Photo -14
Playground Area: Black Top
AC paving has been recently redone, principal requested leveling and new lunch shelter in this location. Still highly desired project.

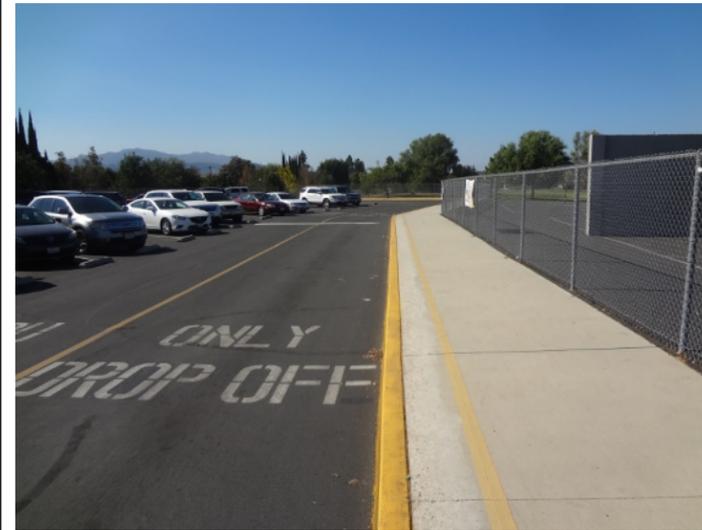
Photo -15
School Drop-off Area
Current drop off location for school does not have direct access to campus, students must walk back to main entrance. No wheel chair access.

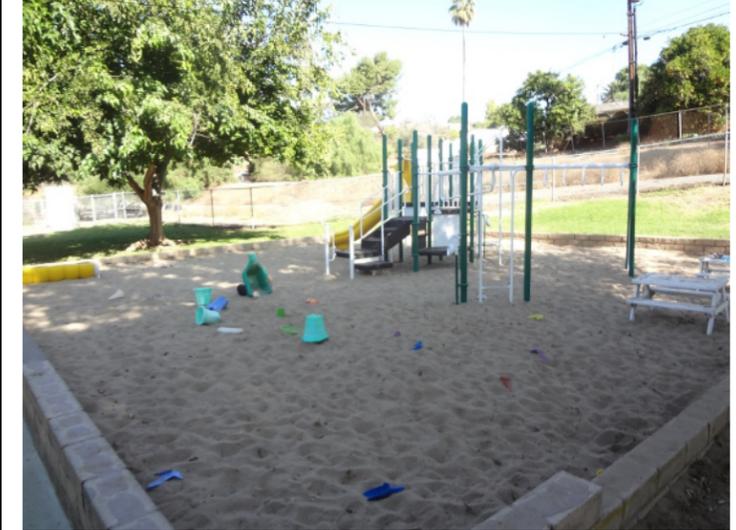
Photo -16
Building 2
Kindergarten play equipment area, is newer than main play equipment but is still very old and in need of upgrading.

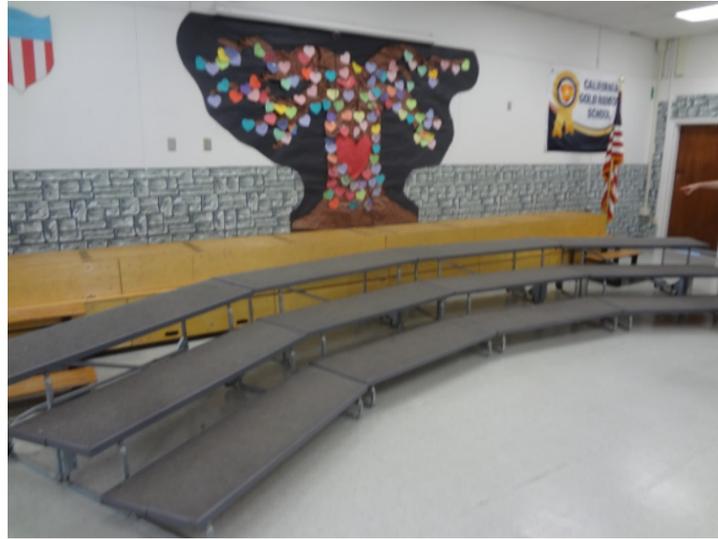
Photo -17
Building 12
 Multi purpose space, no permanent stage just temporary risers

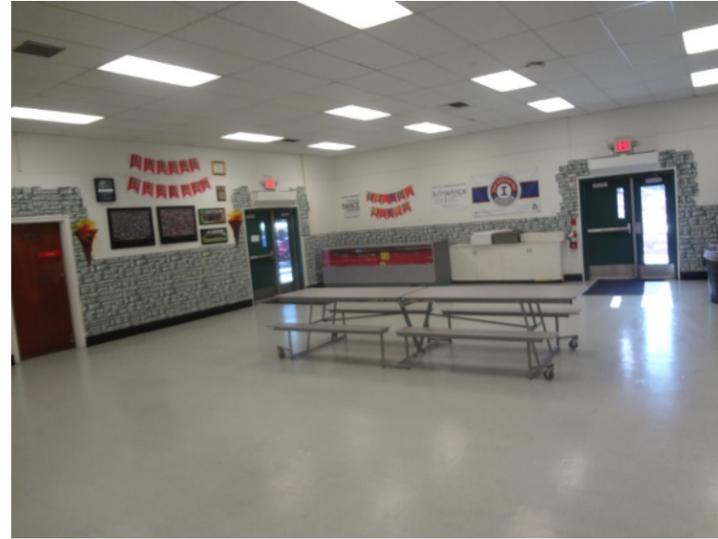
Photo -18
Building 12
 Multi purpose space used for some sheltered dining space along with other functions. Finishes in decent condition

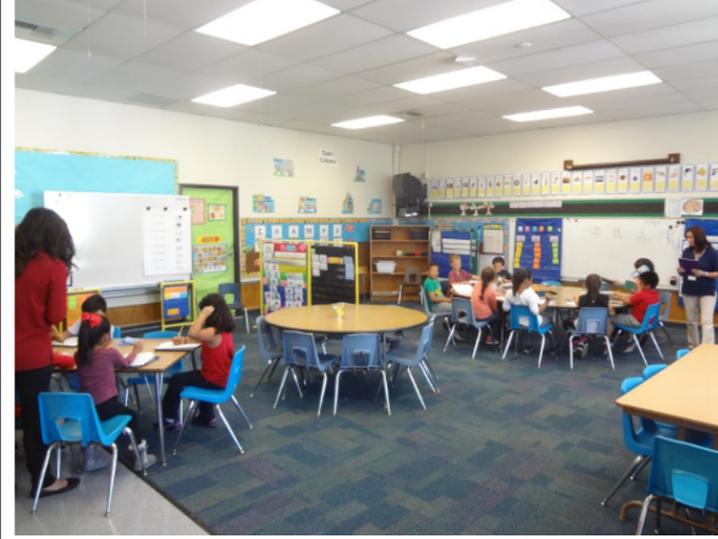
Photo -19
Building 11
 Typical classroom, with promethean boards. Carpets/flooring recently updated

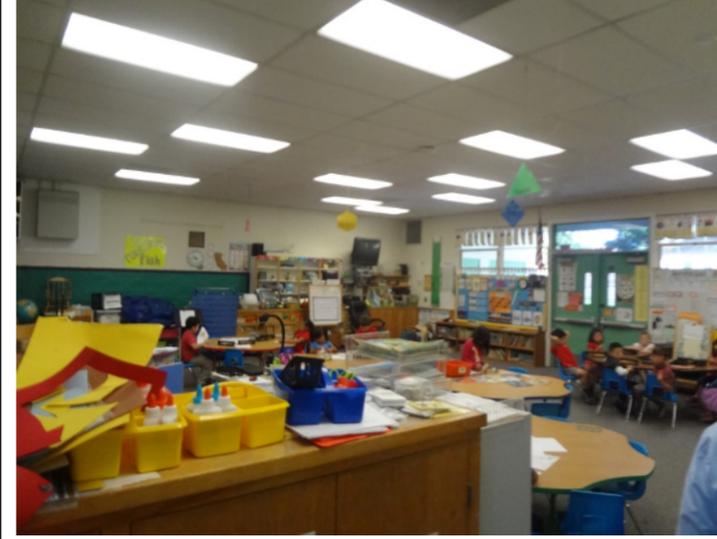
Photo -20
Building 2
 Typical kindergarten classroom

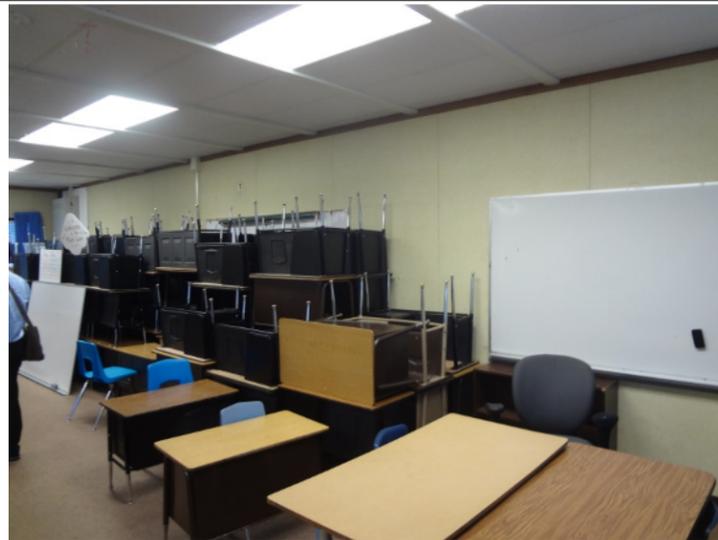
Photo -21
Building 5
 Typical modular classroom building. Finishes have been updated, building used partially for storage.

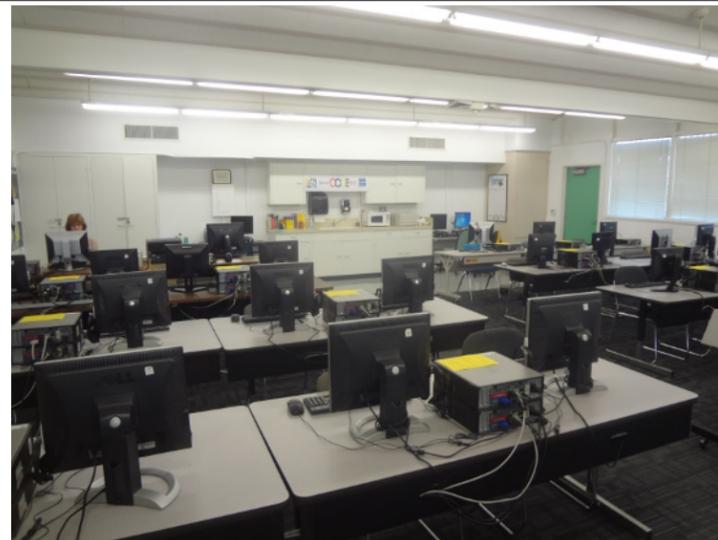
Photo -22
Building 12
 Computer lab has been recently upgraded with new computers and finishes. No accessibility upgrades have been made

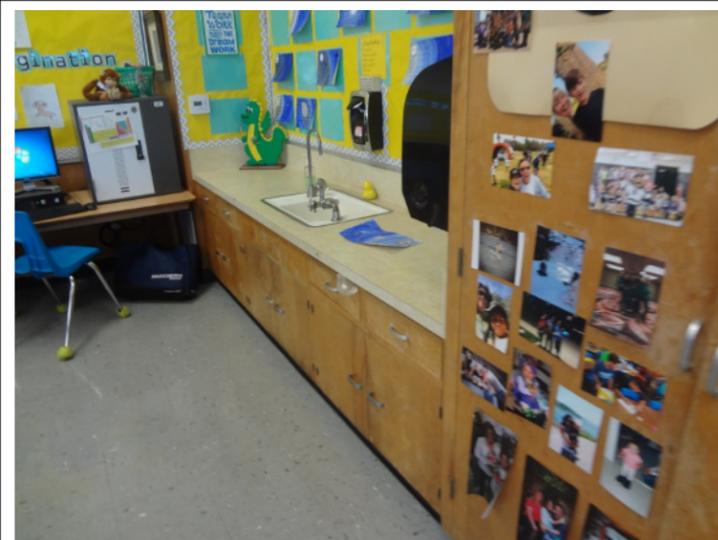
Photo -23
Building 11
 Typical sink in classrooms have not been upgraded to current accessibility standards

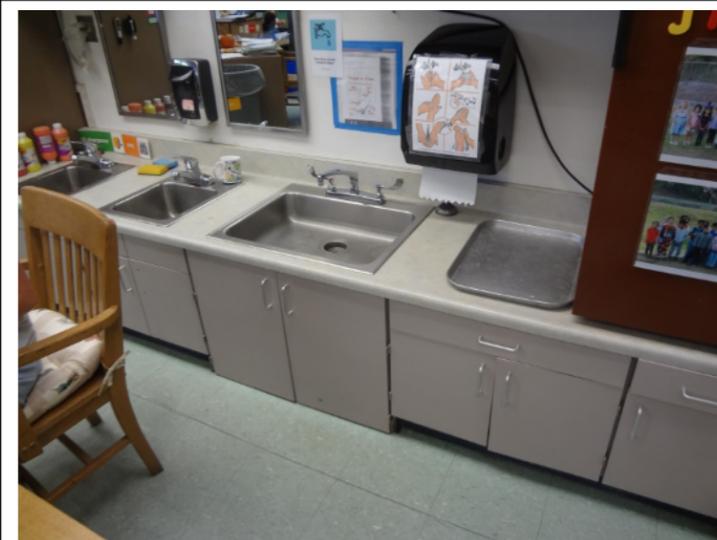
Photo -24
Building 2
 Typical sink in kindergarten classrooms have been upgraded to comply with currently accessibility standards

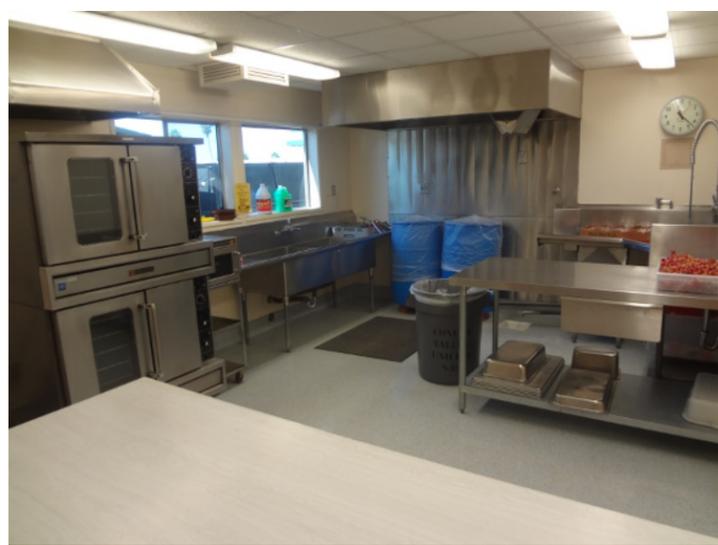
Photo -17
Building 12
Warming kitchen area in multi purpose building

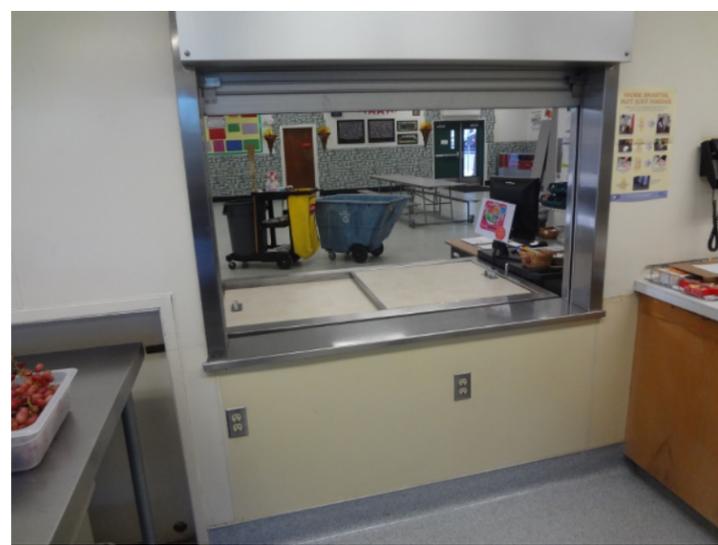
Photo -18
Building 12
Lunch/food service area

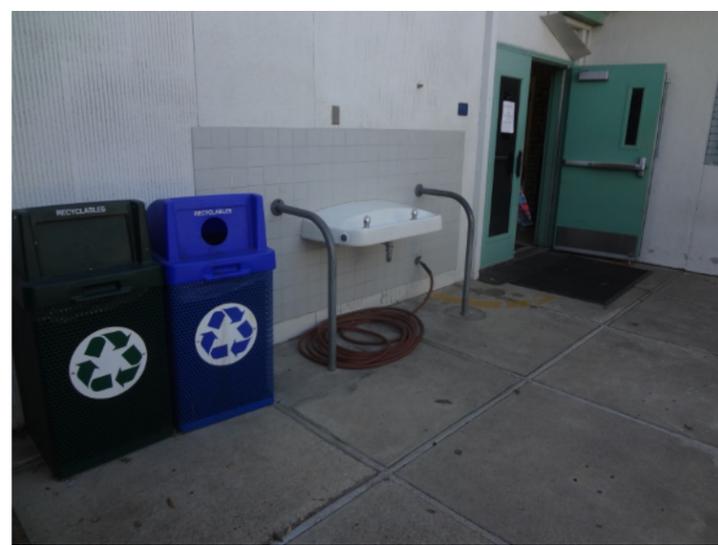
Photo -19
Building 12
Typical drinking fountains on campus have not been upgraded to meet current accessibility standards

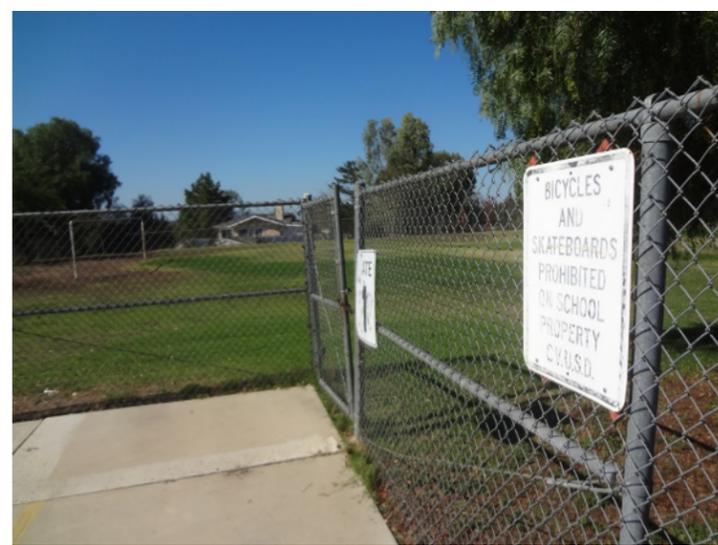
Photo -20
Exterior Chain-Link Fencing
Current fencing is very old and is showing some rusting

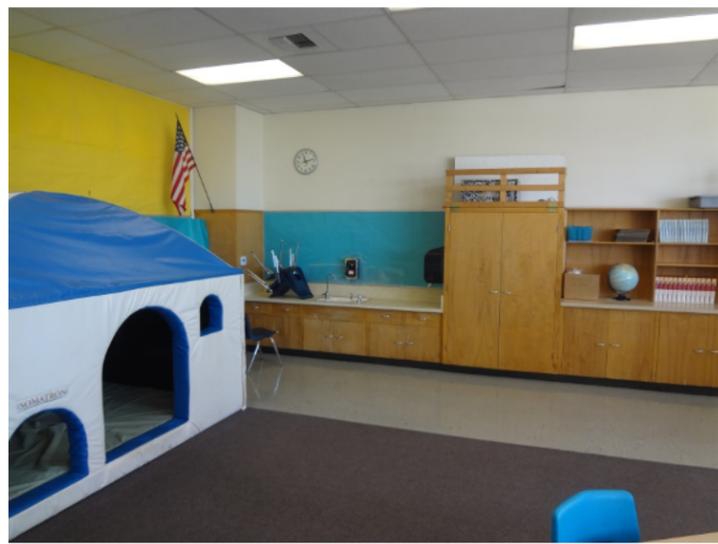
Photo -21
Building 11
Unused/underused classroom, is used as more of a flex space because it has no designated class

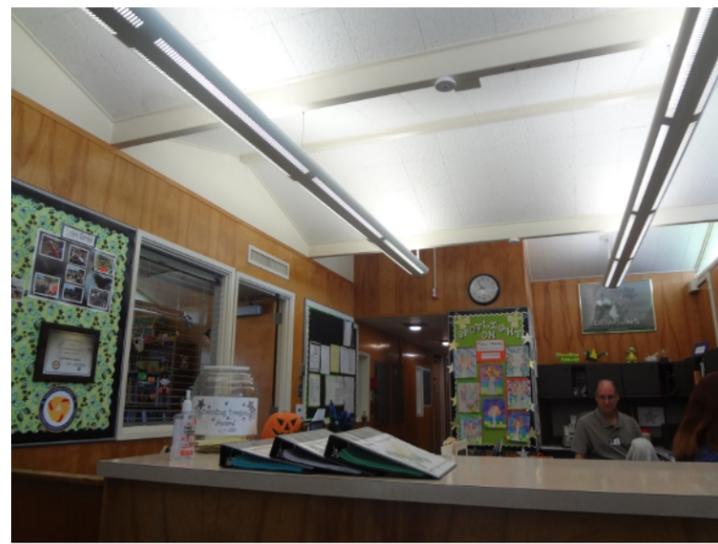
Photo -22
Building 1
Reception area of administration building

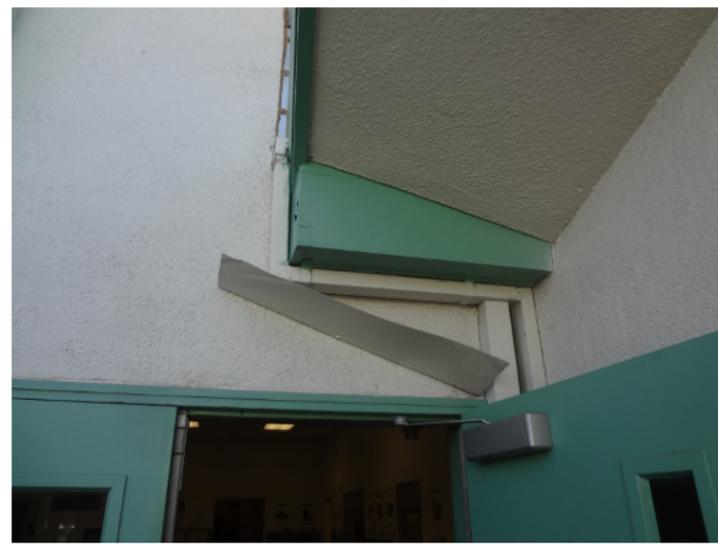
Photo -23
Building 12
Multi purpose building is having water intrusion issues over its rear door. Needs to be reworked.

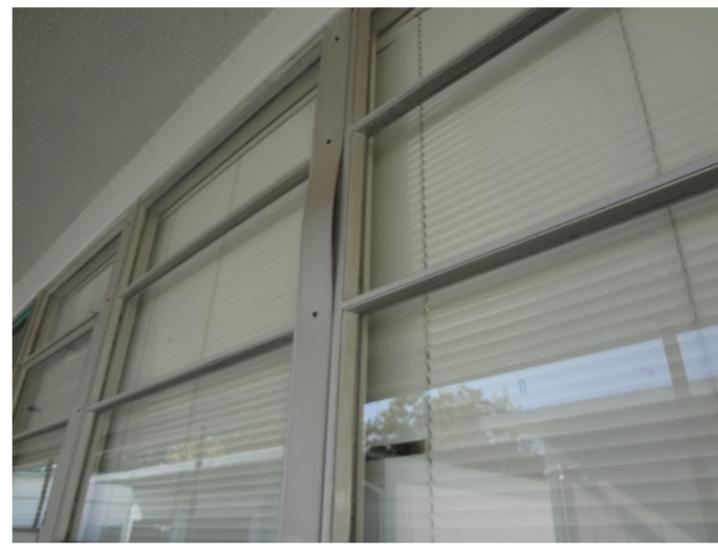
Photo -24
Building 11
Current windows are buckling in the vertical mullions

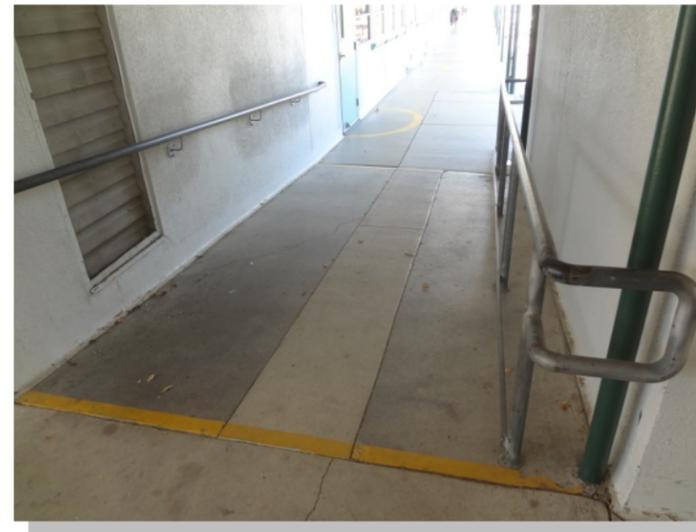
Photo -1
There has been some accessibility upgrades around the campus, including the added handrails shown in this photo.

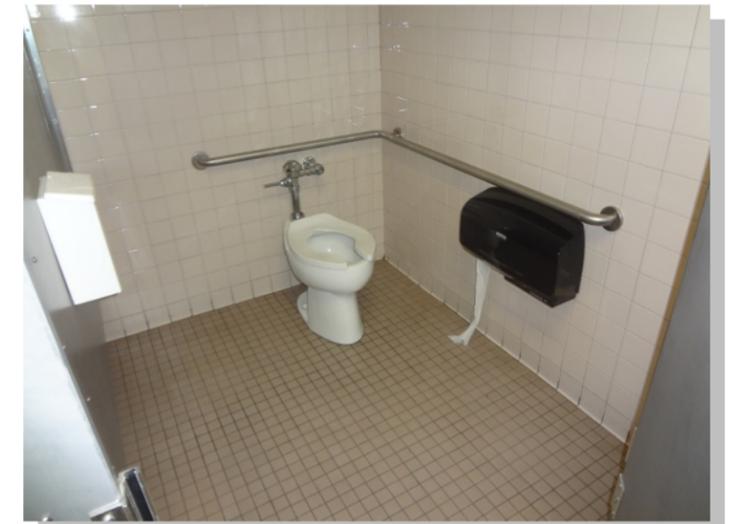
Photo -2
Many of the bathrooms have been upgraded to meet current accessibility standards.

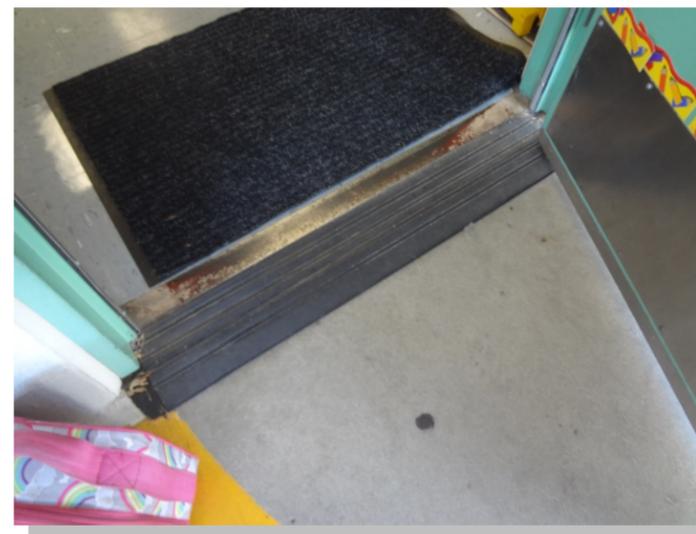
Photo -3
Current thresholds do not meet current accessibility standards

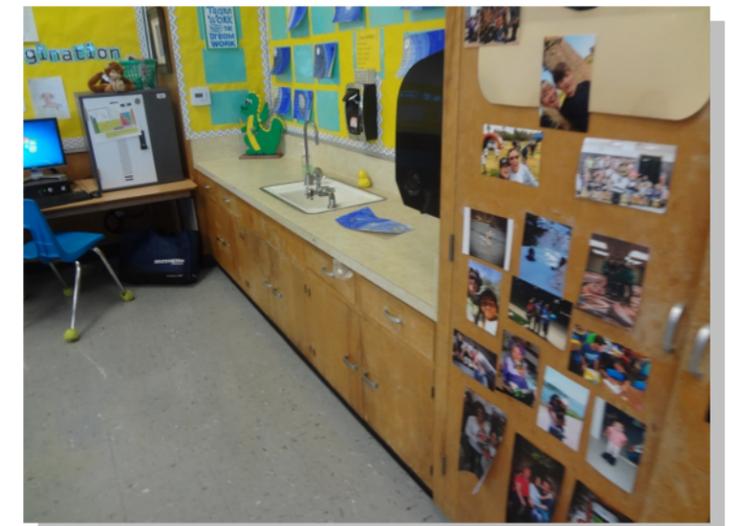
Photo -4
Many of the sinks on campus will need to be upgraded
