CVUSD – THOUSAND OAKS CLUSTER SURVEY

Madrona Elementary School | *Survey*

December 9th, 2016 – DRAFT v1

Dougherty + Dougherty
Architects

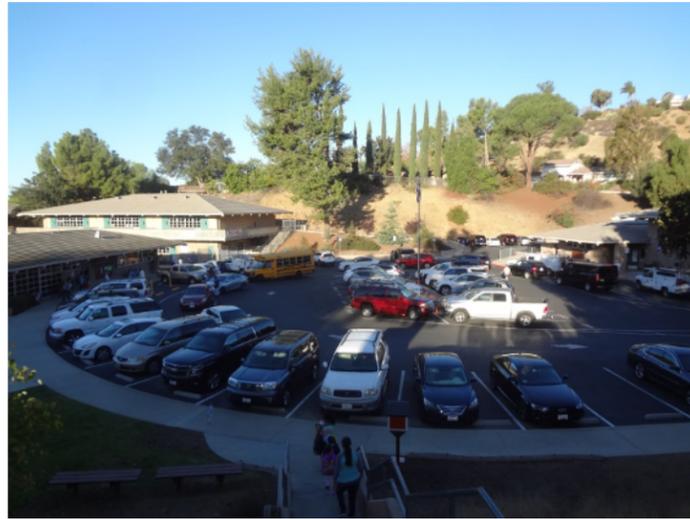
Photo -1
Parking Lot and Drop Off
Current parking lot configuration is very congested

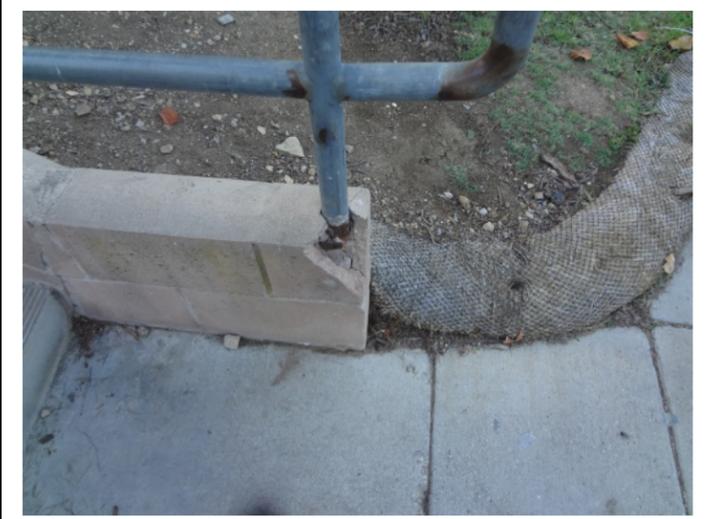
Photo -4
Stair Railing Spalling
Base railing for church parking stair case is spalling

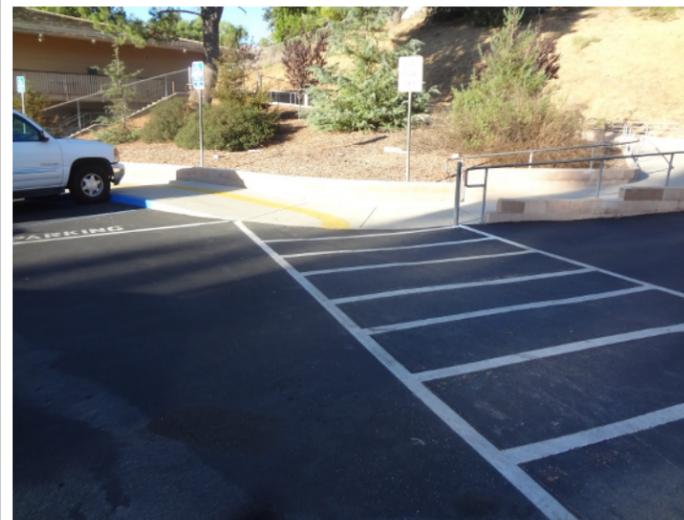
Photo -6
Building 2
Crosswalk from main campus to Multi Purpose building requires kids to cross parking lot

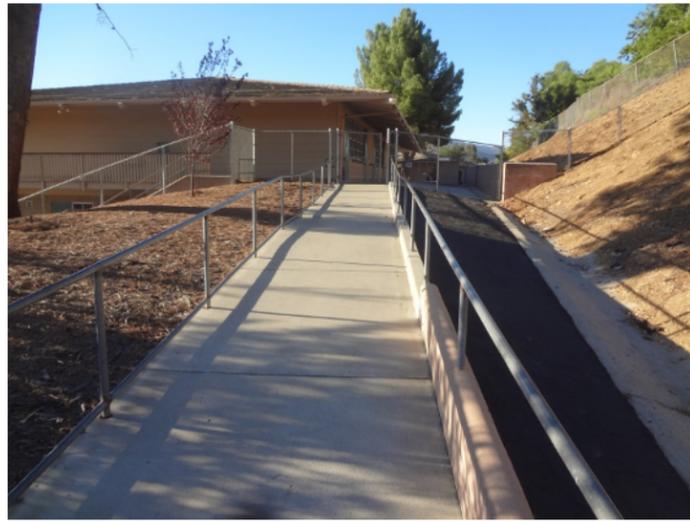
Photo -9
Building 3
Backside ramp to upper portion of building 3 from exterior of campus. Ramp is not current with accessibility standards

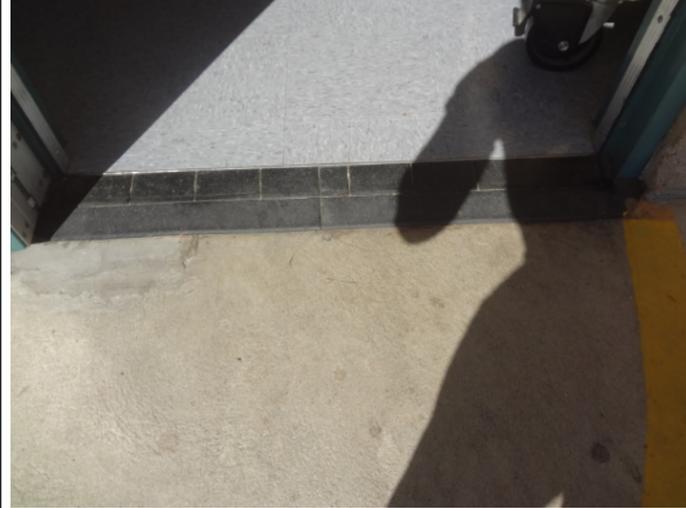
Photo -23
Building 3
 Typical thresholds around campus have not been updated to current accessibility standards.

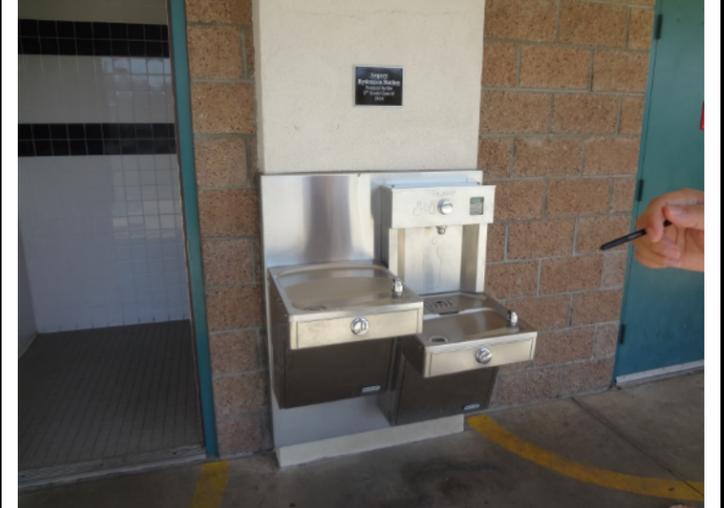
Photo -24
Building 6
 New hydration station, not built in compliance with accessibility guidelines.

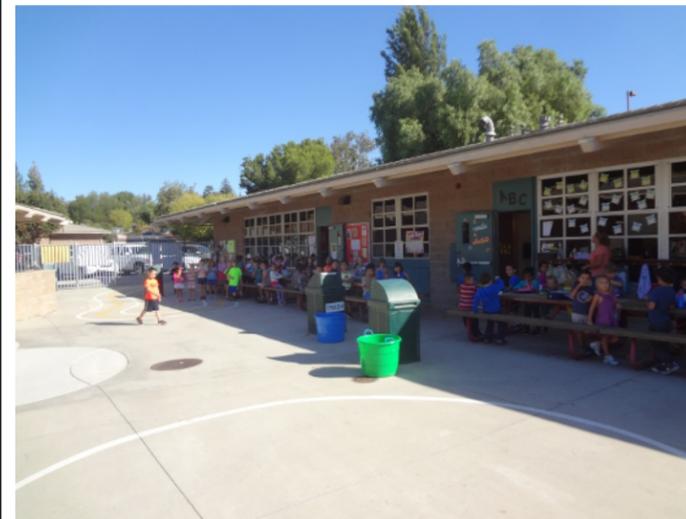
Photo -27
Building 7
Exterior kindergarten classroom space. Desire for shade structure for kids

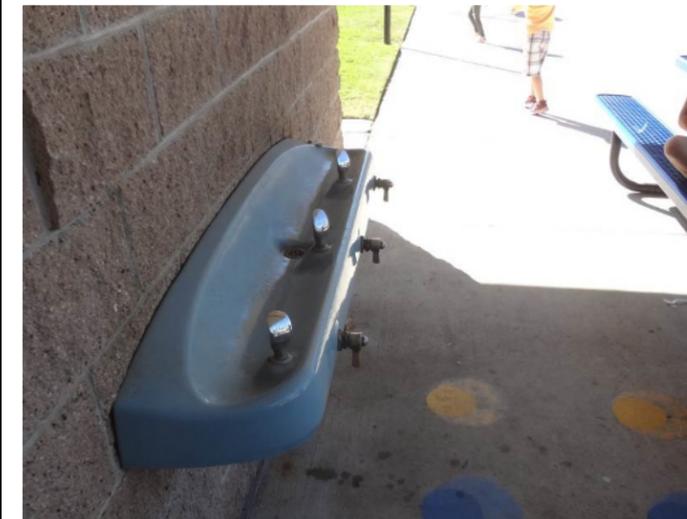
Photo -28
Building 6
Typical drinking fountain in original condition, not current with accessibility standards.

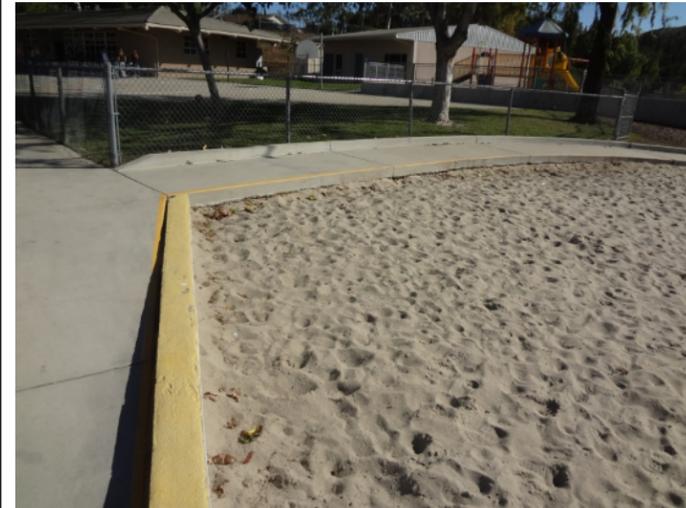
Photo -31
Sand Box
Current fall protection is sand, however there are accessibility issues all around the sand box.

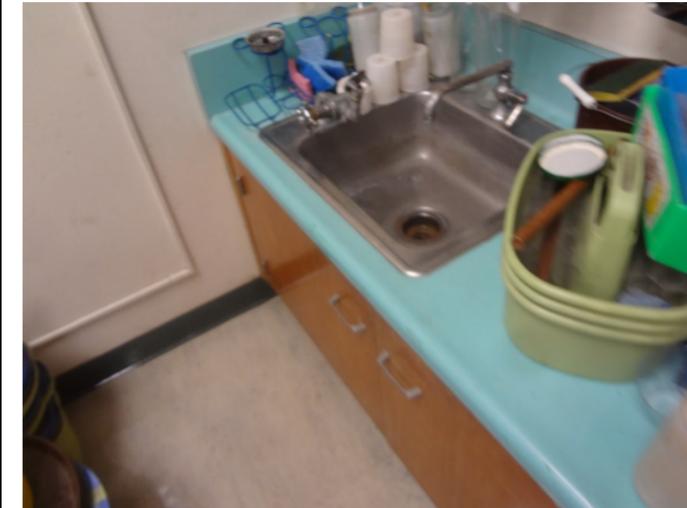
Photo -32
Building 7
Typical classroom sink, not current with accessibility standards.

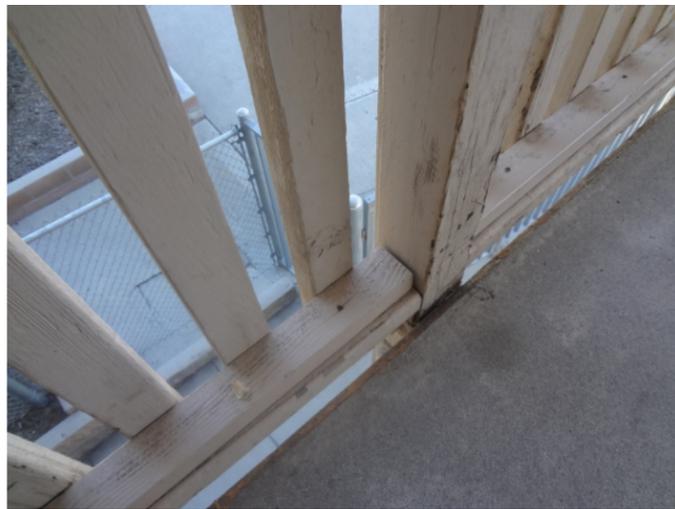
Madrona has 5 buildings that are over 40 years old, however these buildings are concrete brick masonry construction and overall have aged well. The older 2 story buildings have wood railing that are deteriorating and in need of replacement. Overall the HVAC systems are in need of replacement. The roofing system is tile and although very old is still working well.

Photo -33
Building 3
Railing on second floor of older 2 story building are made of wood and are deteriorating and need replacement.

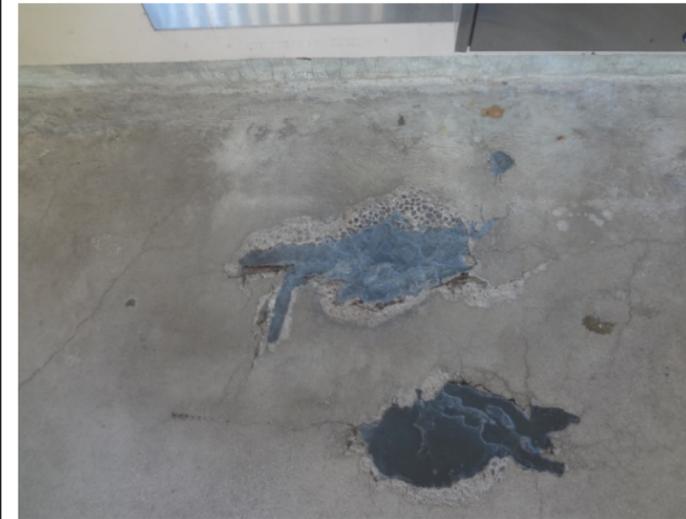
Photo -35
Building 3
Concrete spalling issues in the deck of the second floor, should be repaired.

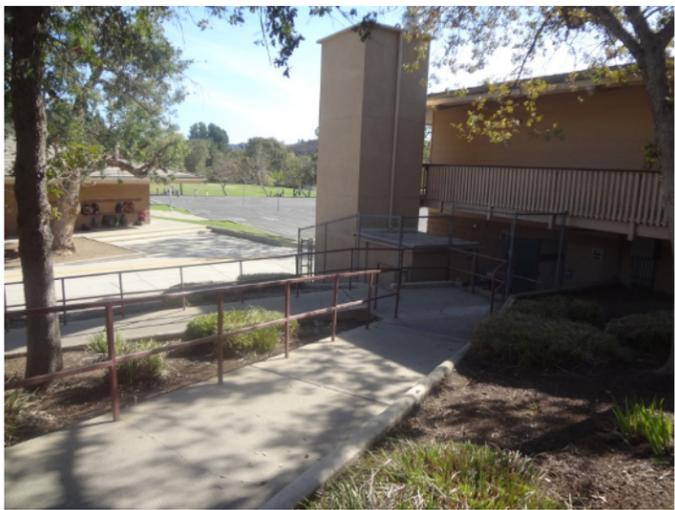
Photo -37
Building 3-4
Exterior ramp between building 3 and 4 is not current with accessibility standards

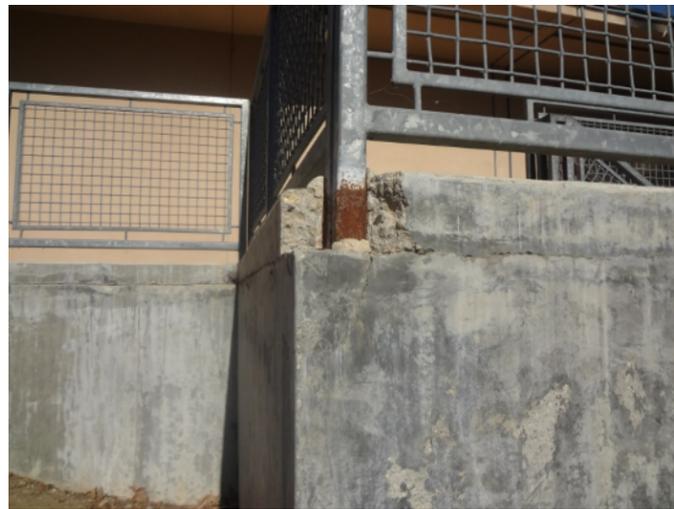
Photo -41
Building 5
Concrete is spalling at the railing connections for some of the railings in building 5

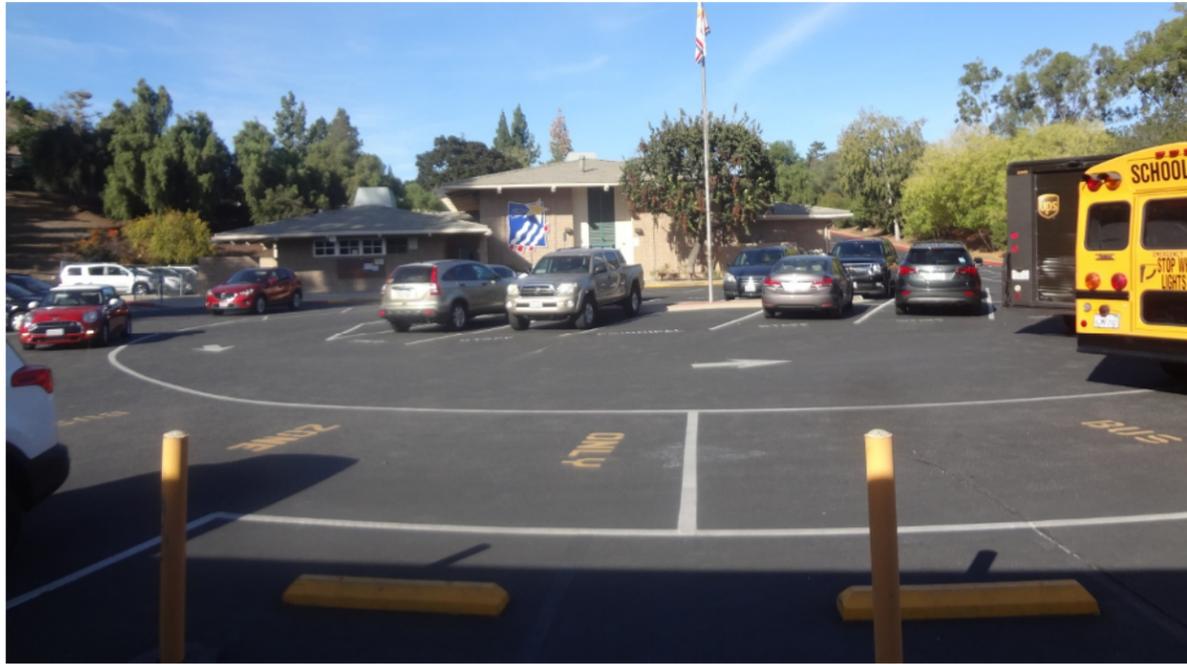
Image 1: The main drop off area is very limited and the curvature makes maneuvering vehicles difficult in the loading zone.

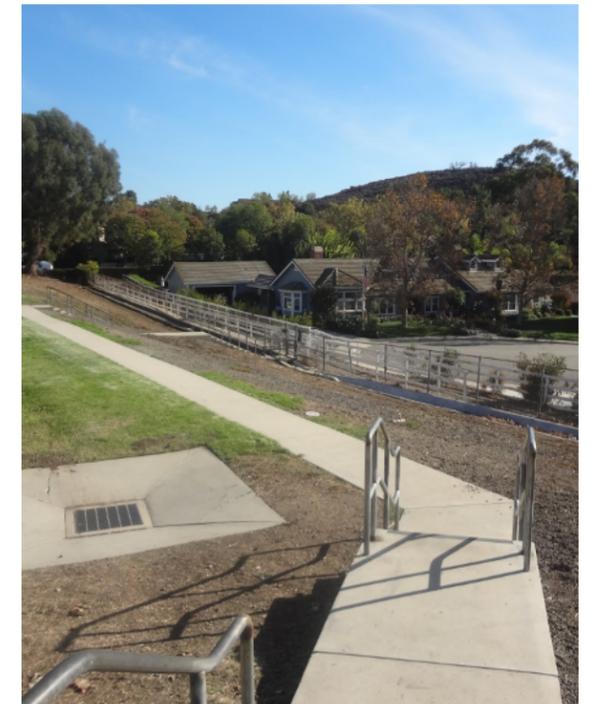
Image 3: Secondary drop-off is not wheel chair accessible due to steps

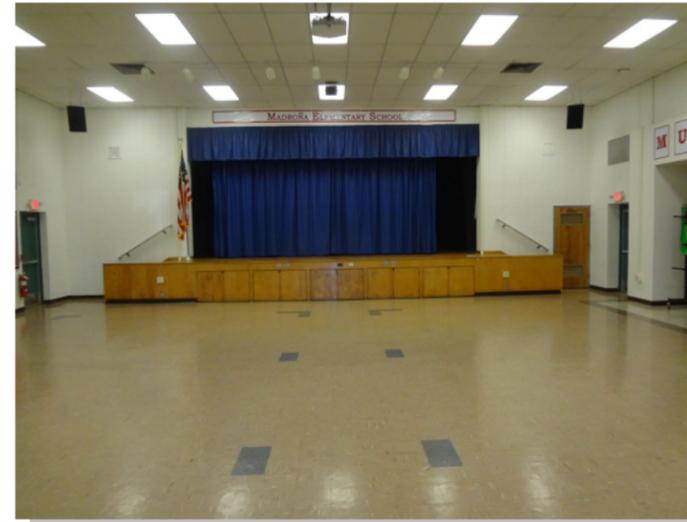
Photo -1
The platform in MPR does not have wheelchair lift or ramp to provide wheelchair access.

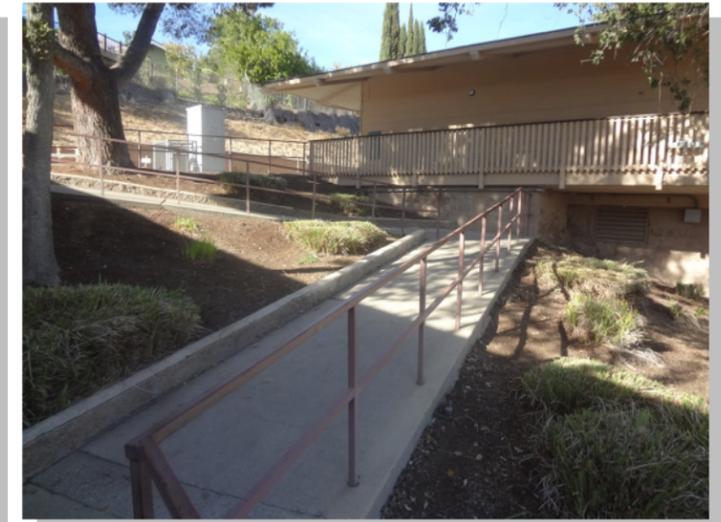
Photo -2
The long concrete ramps between building 4 and 3 have slope that exceeds maximum slope allowed for wheel chair at certain sections

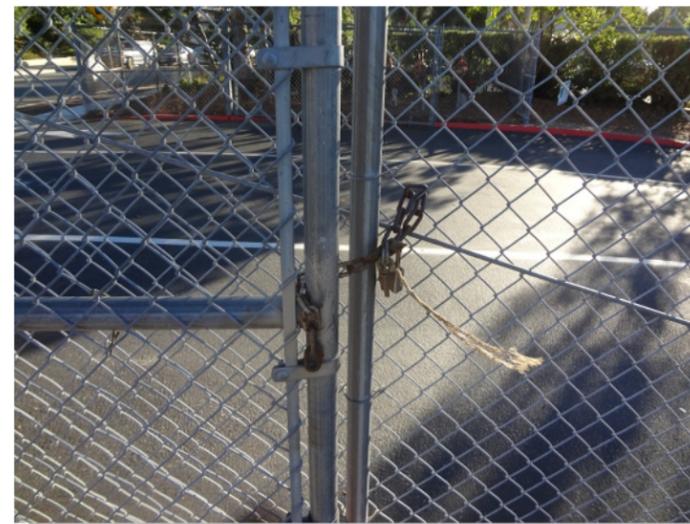
Photo -3
Chain link gate has padlock that do not meet accessibility requirement.

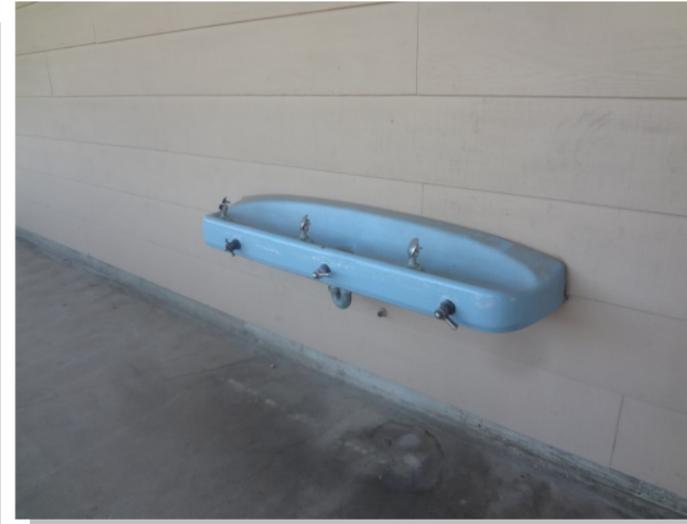
Photo -4
Most trough style drinking fountain on sites do not comply with accessibility standard

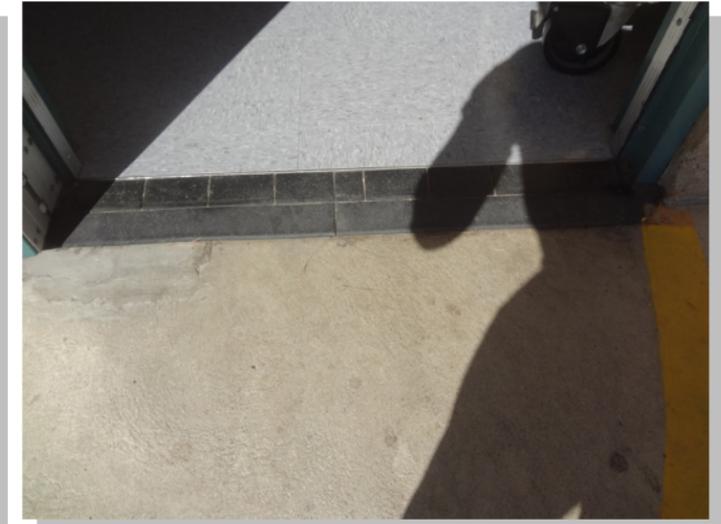
Photo -5
Existing door thresholds, with exceptions of those in Building 5, do not comply with accessibility requirement .
