CVUSD – THOUSAND OAKS CLUSTER SITE ANALYSIS

Ladera Elementary School | *Site Analysis*

1211 Calle Almedro | Thousand Oak, CA 91360

January 10th, 2016

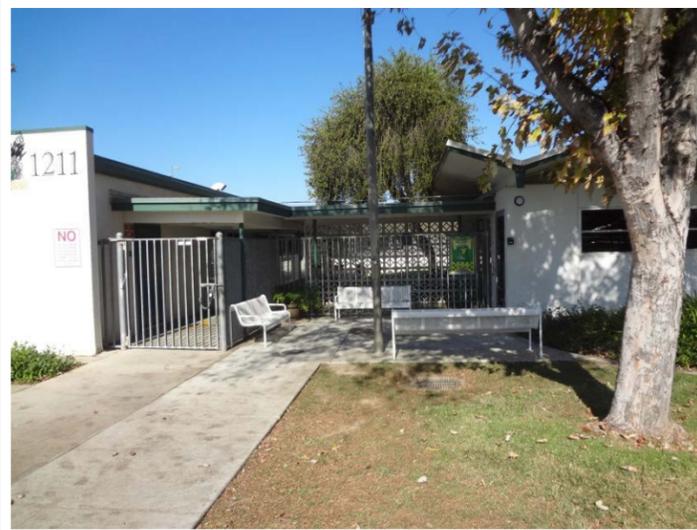
Photo -1
Curb Appeal – View of Entry
 Primary entry location has potential with its mature trees and clearly defined visual location.

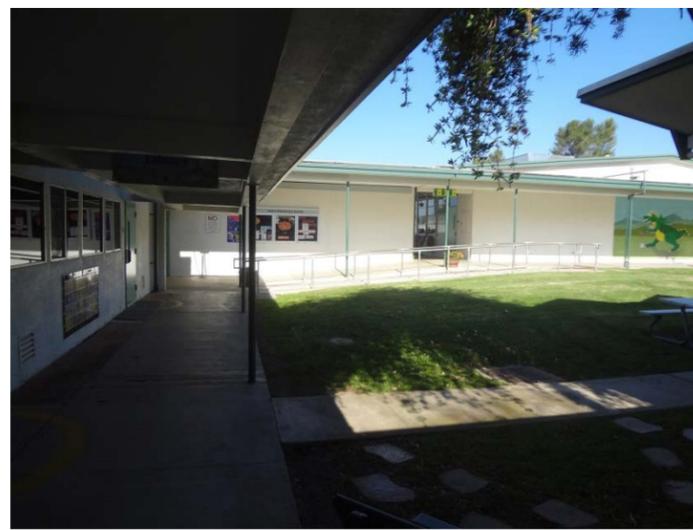
Photo -2
Curb Appeal – Covered Walkways
 All of the walkways on campus are covered with overhangs and this in conjunction with mature landscaping makes the classrooms well protected from the sun and elements.

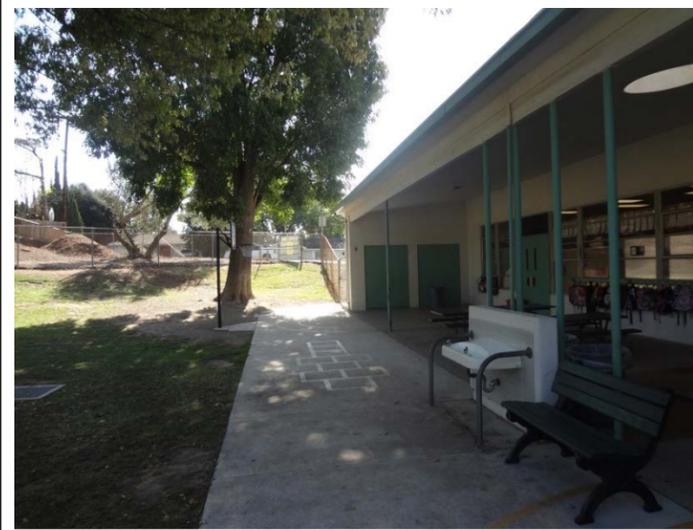
Photo -3
Curb Appeal – Kindergarten
 Kindergarten play area is well landscaped and has shading over the paved area to protect the students during the day.

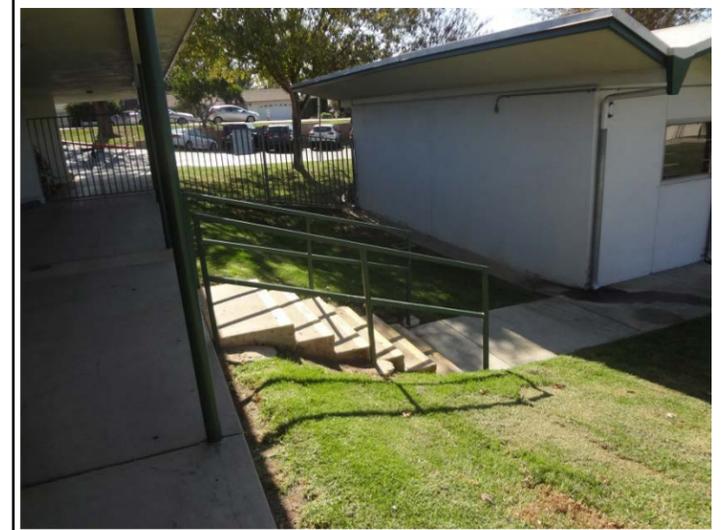
Photo -4
Curb Appeal – Kindergarten Entry
 The school entry location for the kindergarten area has a direct line of sight from the parking lot to the classrooms.

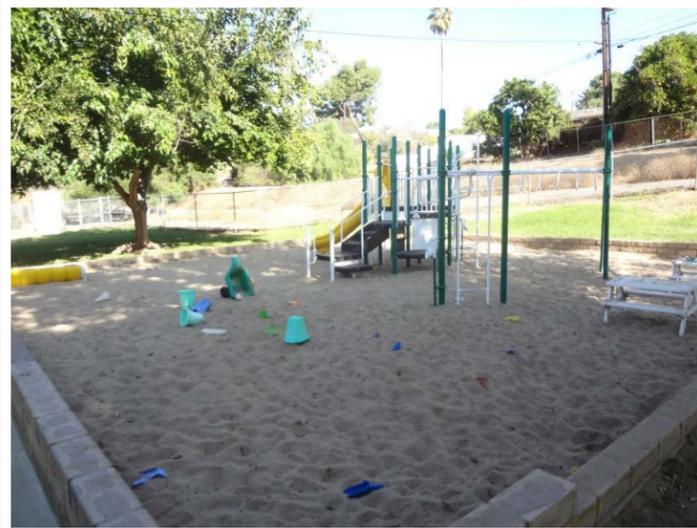
Photo -5
Curb Appeal – Kindergarten Play Area
 The kindergarten play equipment is well shaded to provide protection for the students in the morning.

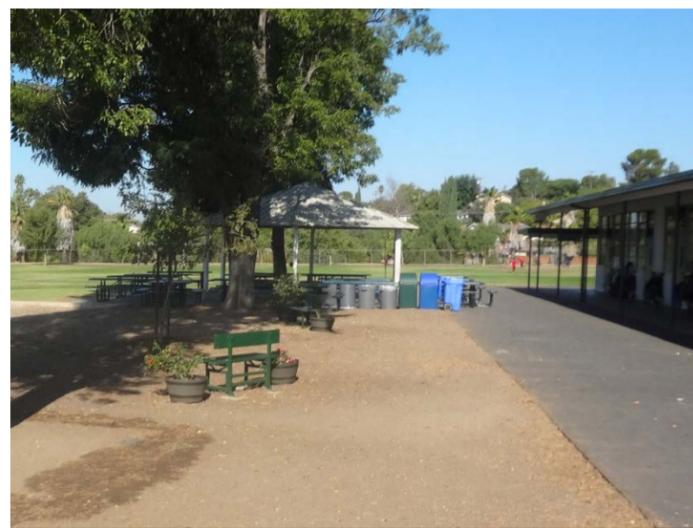
Photo -6
Curb Appeal – Lunch Shelter
 The lunch area has a relatively small lunch shelter and several mature trees that provide extensive shading for the students.

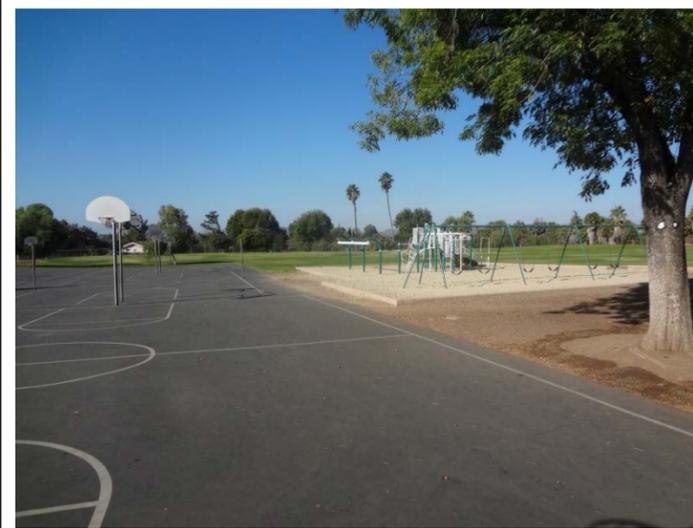
Photo -7
Curb Appeal – Play Area
 The playground area is large and well maintained with mature landscaping and scenery in the distance.

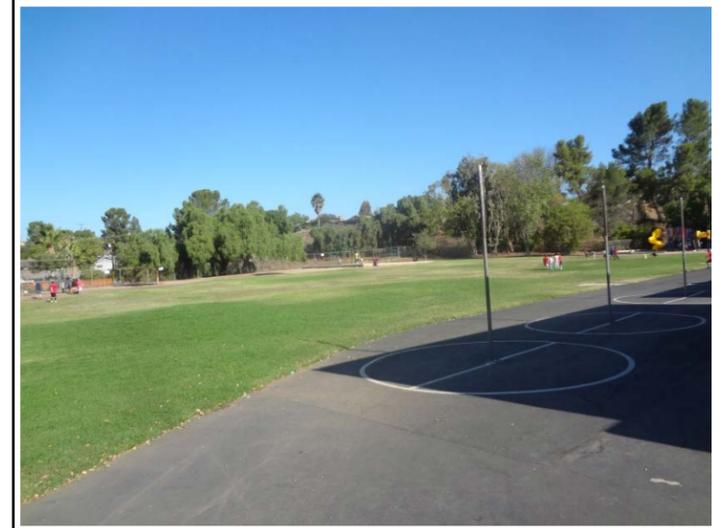
Photo -8
Curb Appeal – Play Area
 The school has a large turf area and a variety of play equipment locations.

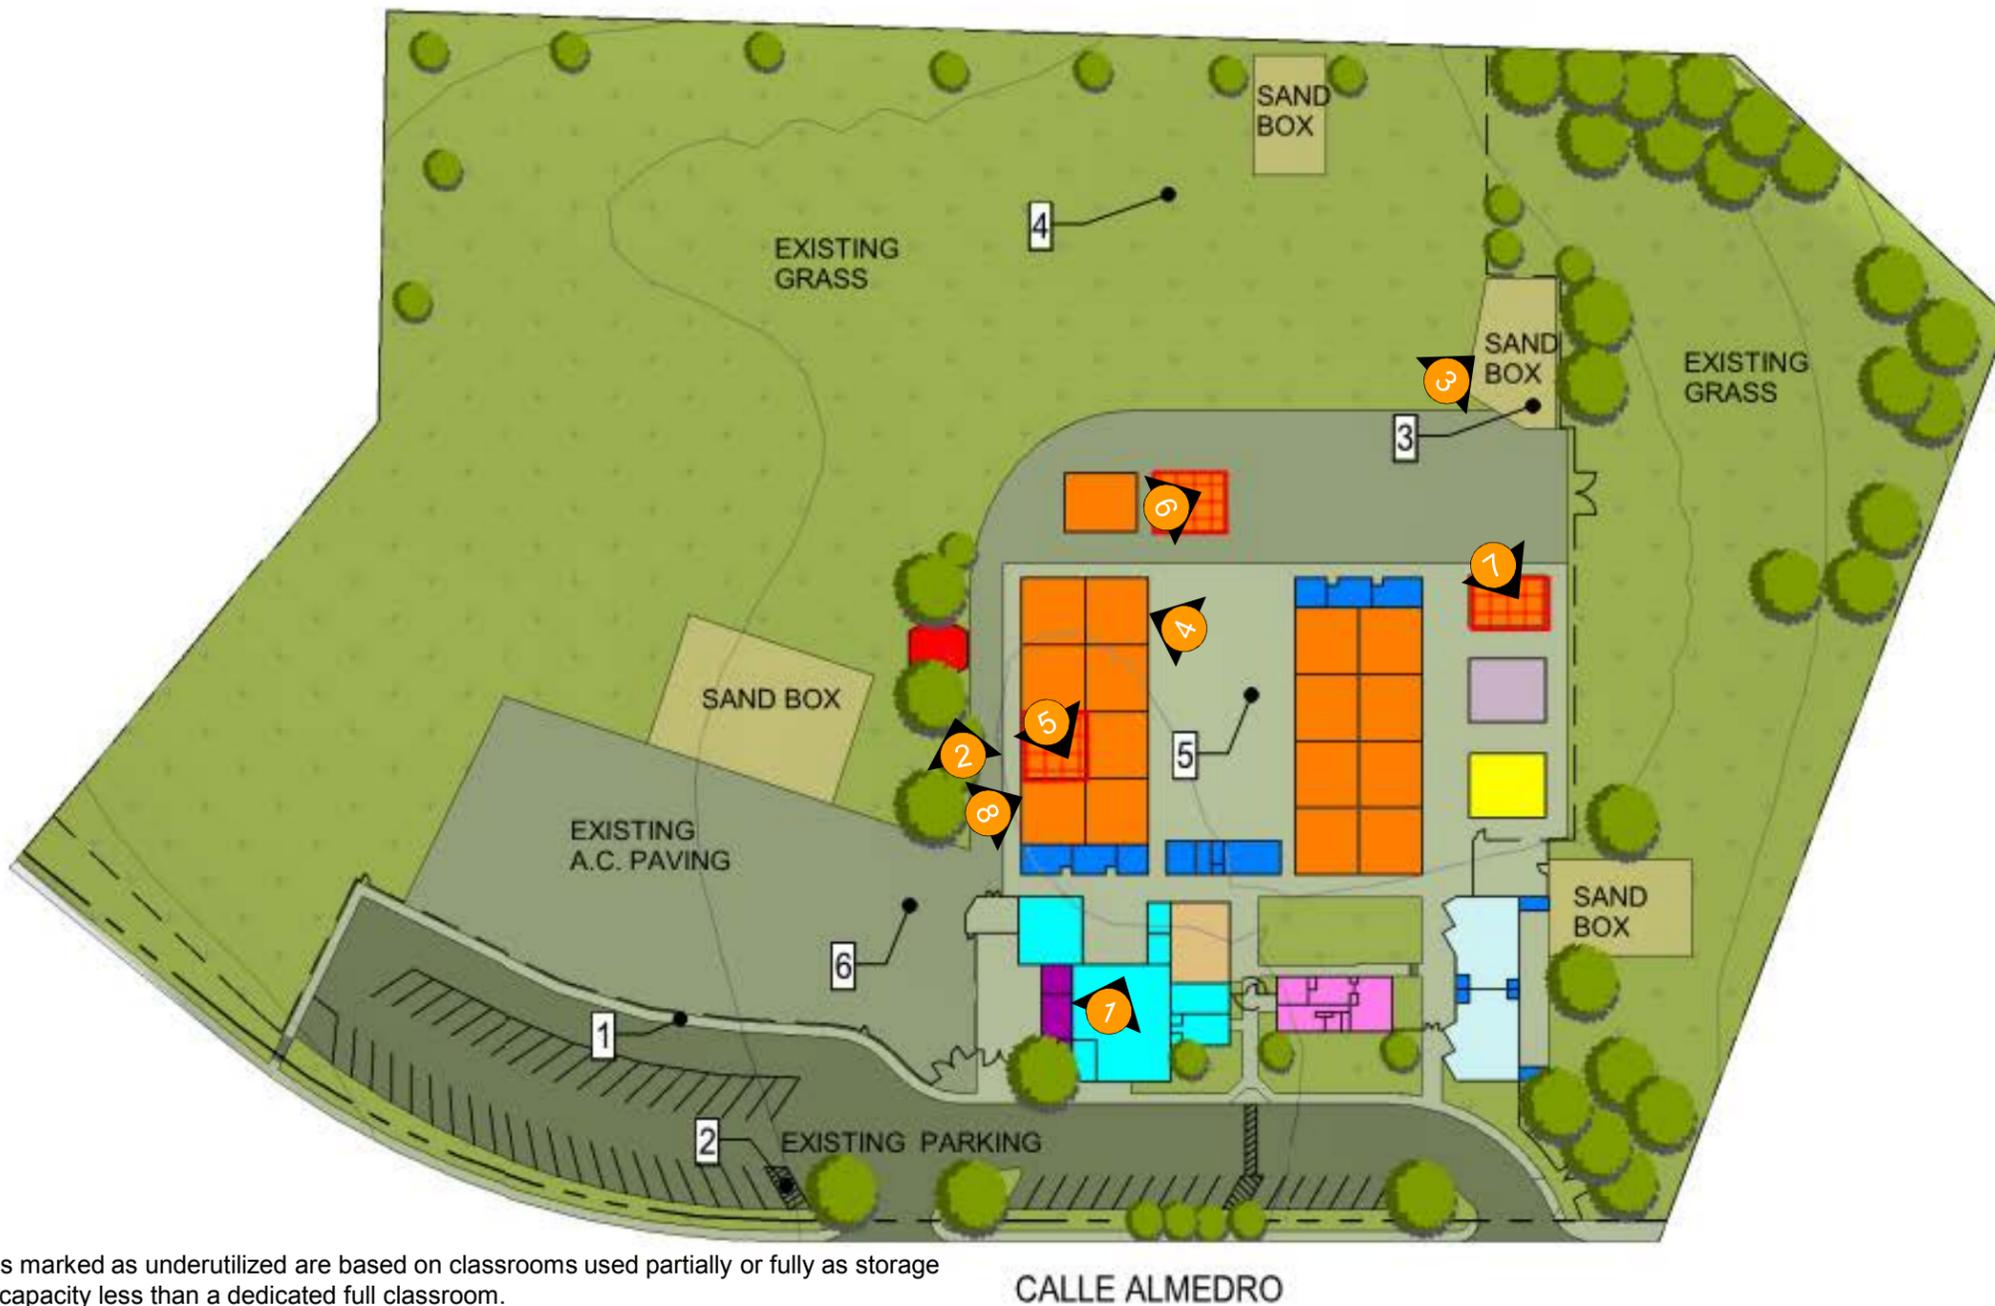
EXISTING SITE PLAN | LADERA ELEMENTARY SCHOOL BUILDING USE

- 1** CURRENT DROP OFF LOCATION IS NOT ADA ACCESSIBLE
- 2** ADA PARKING STALLS WITH NO ACCESSIBLE PATHWAY TO SCHOOL
- 3** REPLACEMENT OF PLAYGROUND EQUIPMENT MAY BE NEEDED
- 4** DESIRED LOCATION FOR JOGGING TRACK
- 5** POTENTIAL NEW SHADE STRUCTURE NEEDED
- 6** CURRENT LUNCH SHELTER SIZE INSUFFICIENT, NEW LUNCH SHELTER DESIRED IN THIS LOCATION

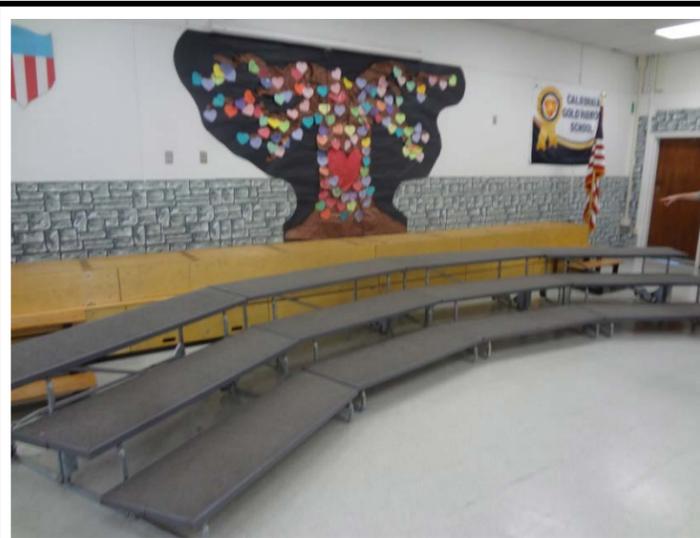
Photo -1
Multi Purpose Space
 Multi Purpose building does not have a permanent stage and may need to be reconfigured to add one.

Area 1: Beautification of the front entrance and the exterior of multi-purpose building may improve the curb appeal of the campus. A permanent stage and reconfiguration of the multi-purpose building, which may include works in the semi-enclosed courtyard area, may increase the spaces for music, performing art and other programs.

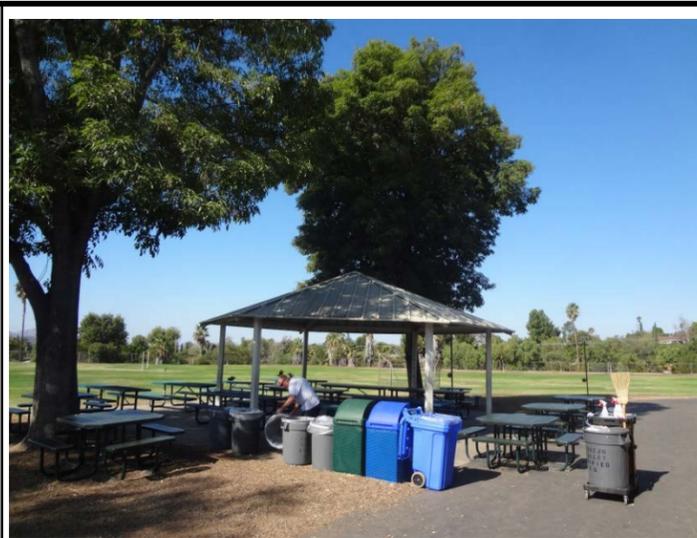
Photo -2
Lunch Shelter
 While there is ample shade for lunch, the lunch shelter itself is too small to protect students from rain.

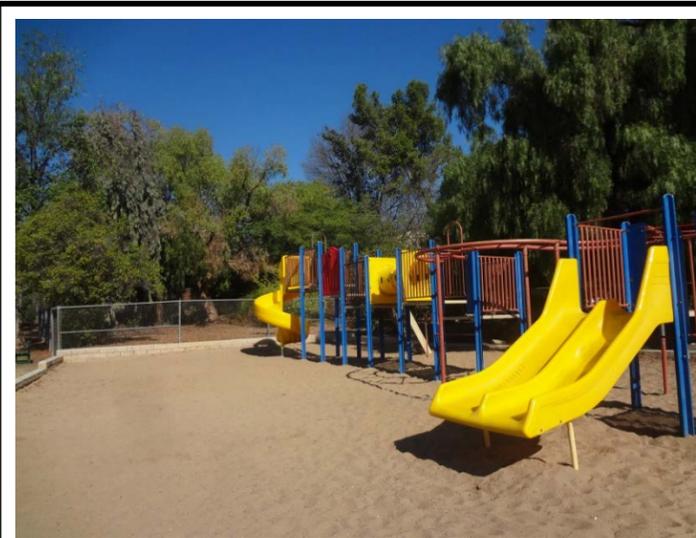
Photo -3
Playground Equipment
 The play equipment is over 20 years old and may need replacement.

Area 2: Additional shading and replacement of ground surface and equipment may improve the longevity and quality of the play area. Shading opportunities may be accomplished by either structure or landscaping.

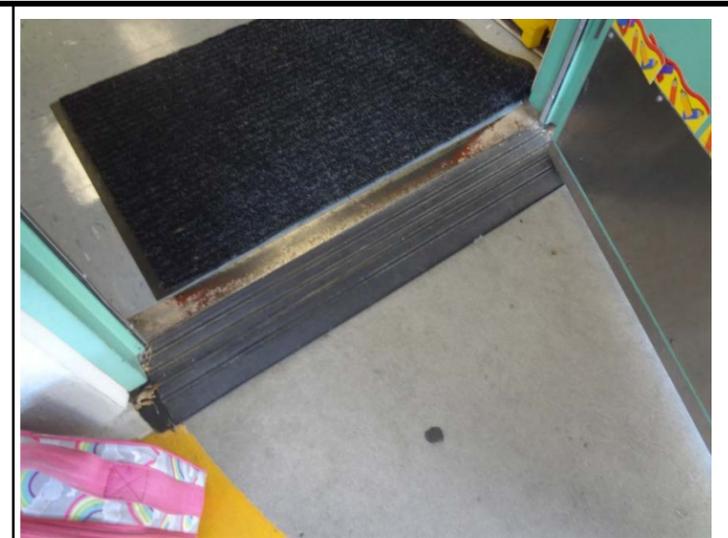
Photo -4
Accessibility
 There may be a need for campus wide accessibility upgrades. This door threshold condition no longer complies with ADA.

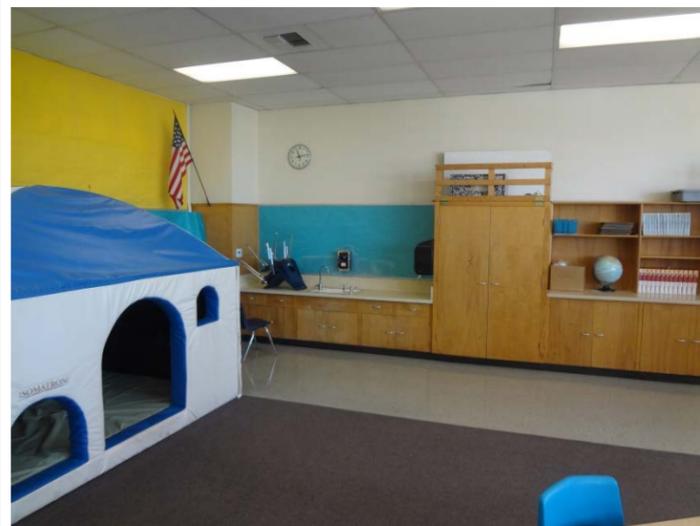
Photo -5
Under Utilized Permanent Classroom
 Classroom is in use but it may be inefficient to the size of the space.

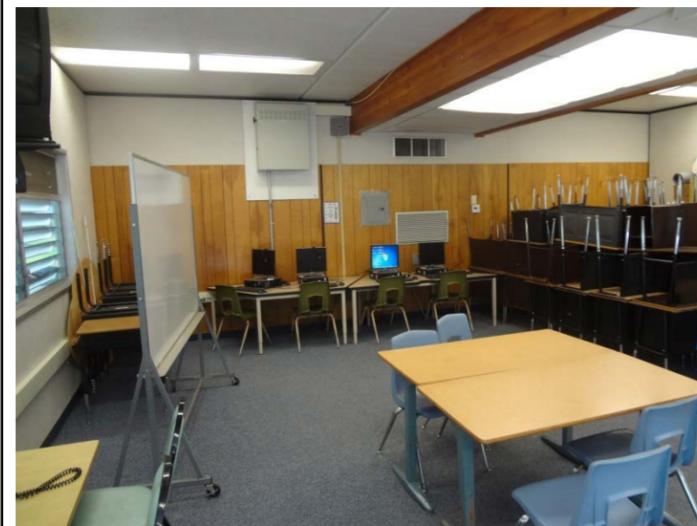
Photo -6
Under Utilized Portable Classroom
 Classroom Space Used for Storage

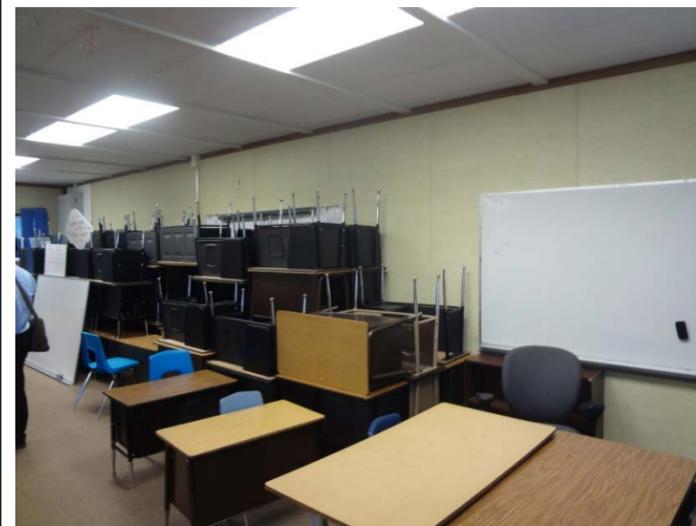
Photo -7
Under Utilize Portable Classroom
 Classroom Space Used for Storage

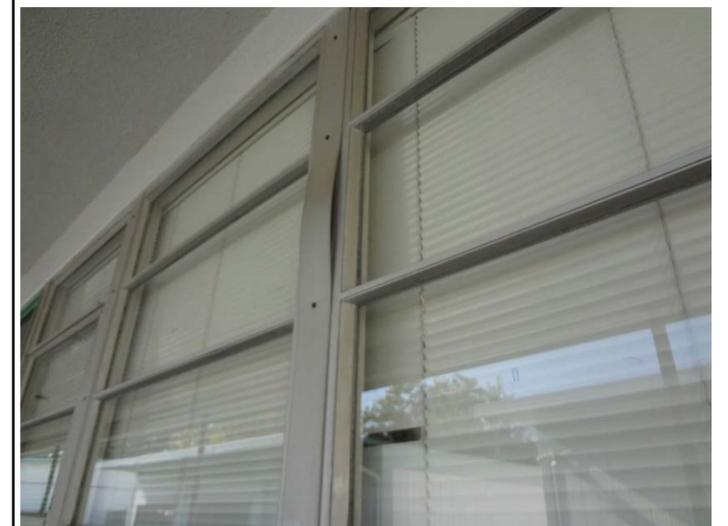
Photo -8
Window Buckling
 Some of the window frames are having buckling issues and may need to be replaced.
