# CVUSD | *Facilities Master Plan*

CVUSD - WESTLAKE CLUSTER

## Lang Ranch Elementary | *Site Analysis*

2450 Whitechapel Place | Westlake, CA 91362  
Conejo Valley Unified School District  
March 31, 2017

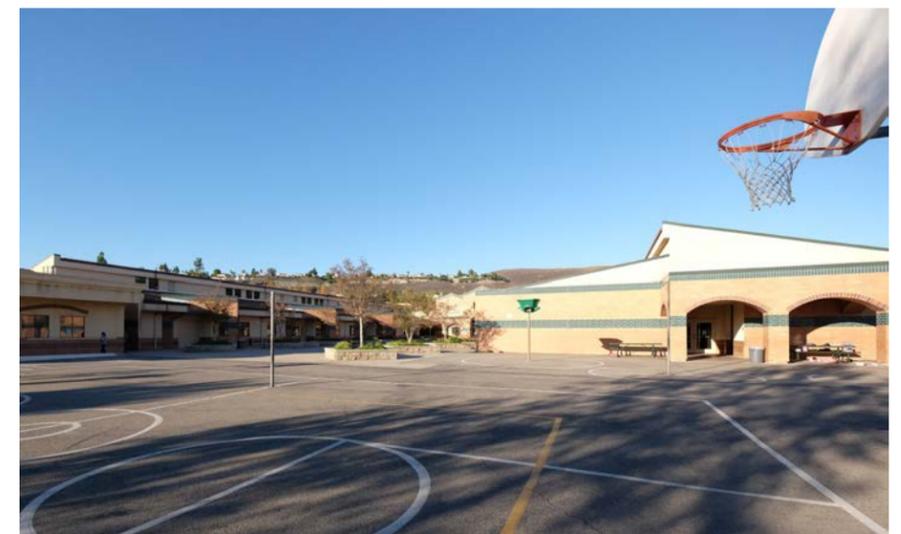
Image A

The addition of site lighting to illuminate the hardcourts adjacent to Knightsbridge Avenue and the courtyard at Building 1 would improve safety and security. Proper pedestrian gate hardware at perimeter fencing would improve access control.

Site lighting would improve safety and security

Proper pedestrian gate hardware at perimeter fencing would improve access control.

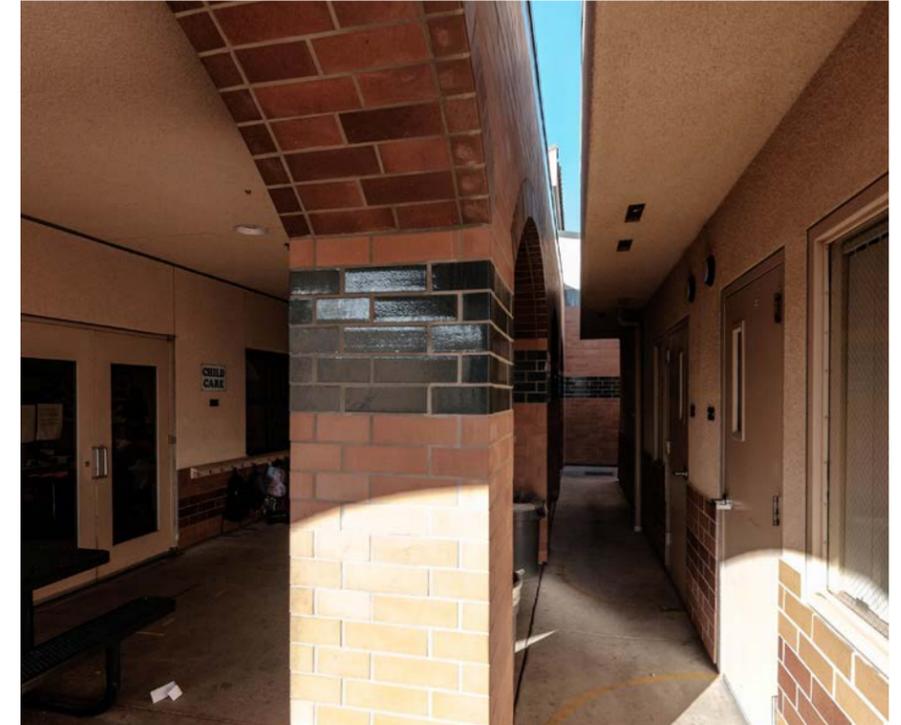
Image B

Pedestrian access from Knightsbridge Avenue requires the use of stairs. Accessibility here may be improved.

The close placement of Building 3 to Building 1 causes supervision concerns. Relocating Building 3 computer classrooms and removal of the structure may improve general safety and security.

Provide accessible pedestrian access from Knightsbridge

Relocating/removing Building 3 would relieve supervision concerns and improve safety and security

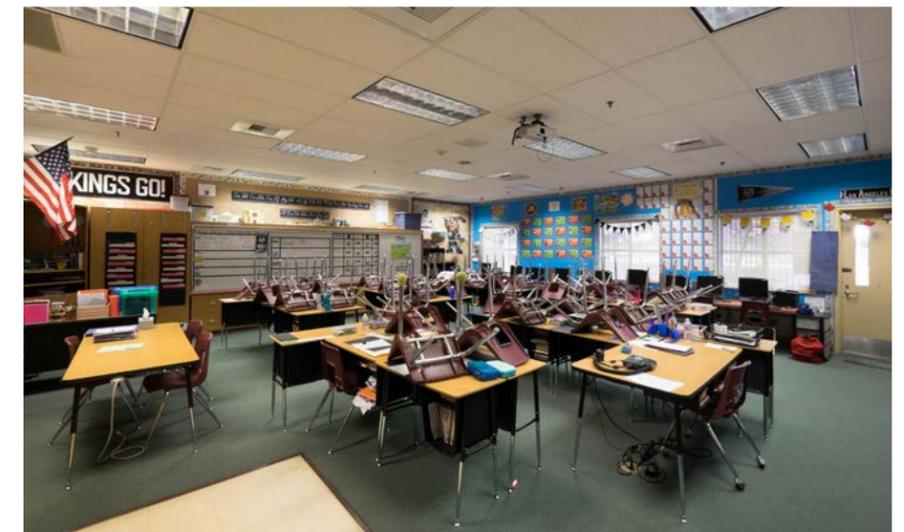
Image A

Water intrusion was noted to occur behind the campus buildings' exterior insulation and finish system (EIFS). Chipped exterior tile requires replacement. General maintenance of exterior finishes would benefit the school greatly.

- Repair water intrusion behind exterior building finish & chipped exterior tile
- Improve classroom environment with better electrical distribution & HVAC controls
