**WEATHERSFIELD
ELEMENTARY**

CVUSD – THOUSAND OAKS CLUSTER SITE ANALYSIS

Weathersfield Elementary School | *Site Analysis*

January 10th, 2017

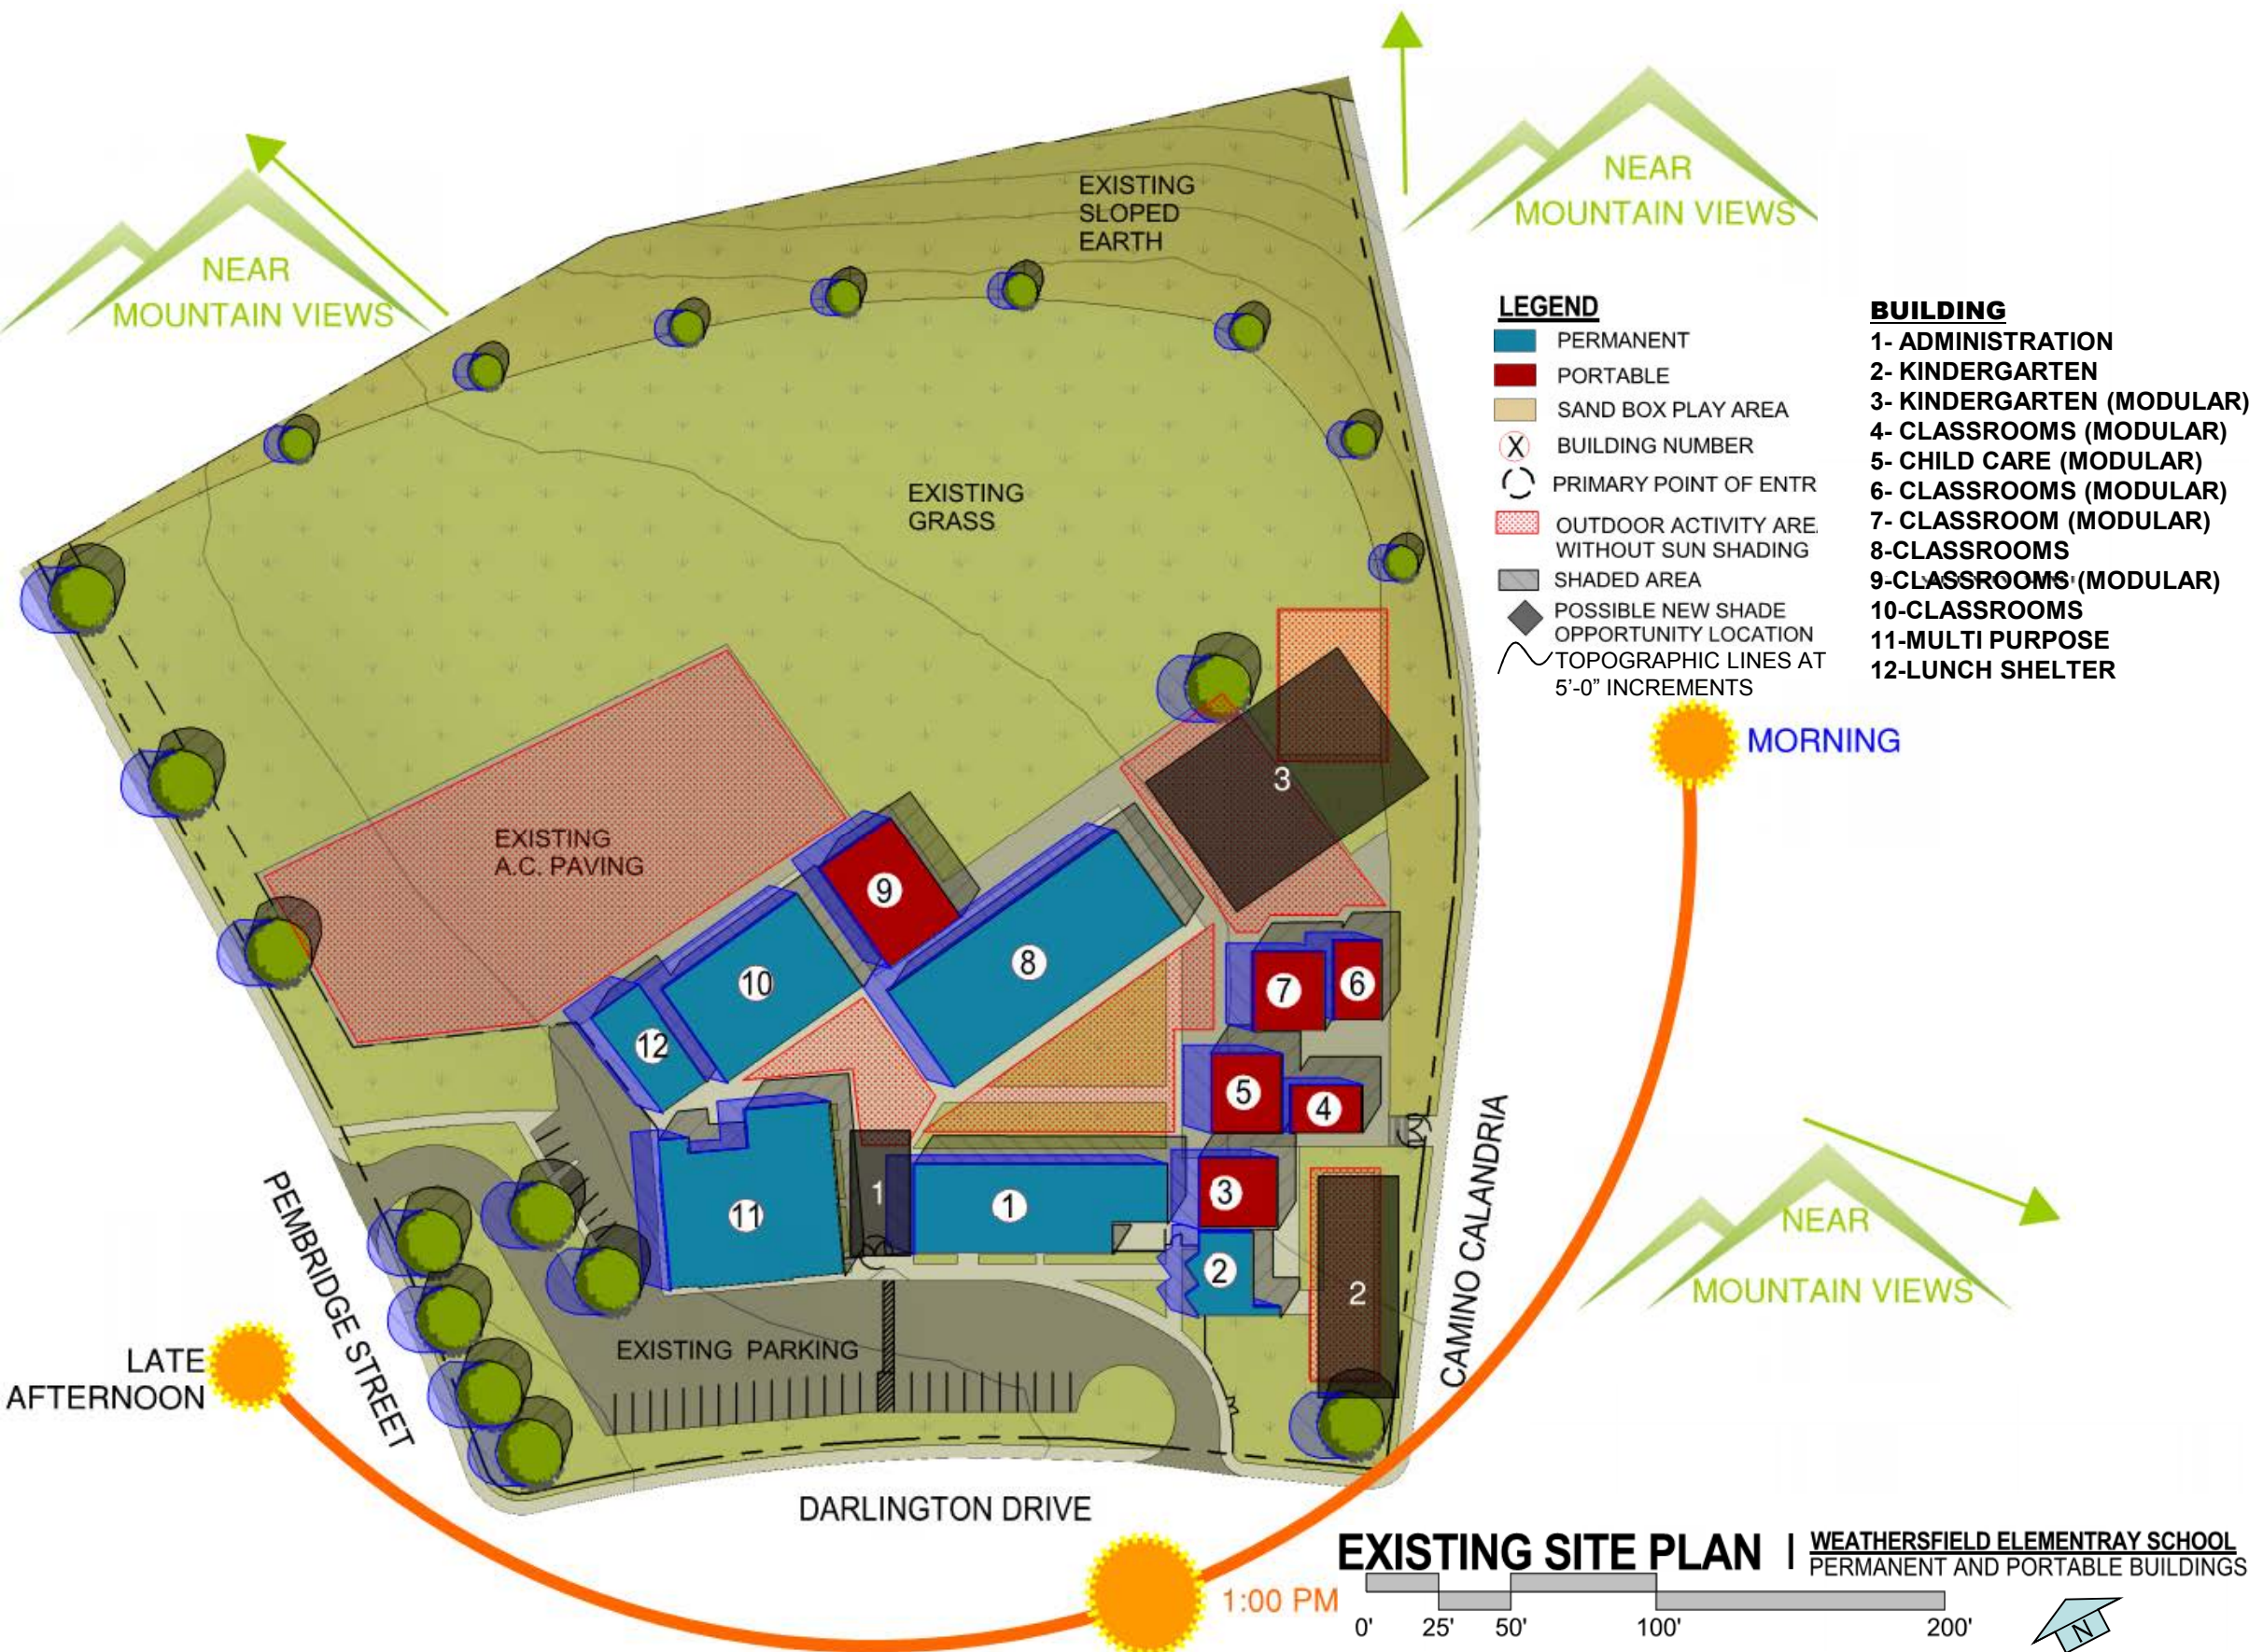
Weathersfield Elementary School's building alignment on the site provides little morning or afternoon shading of the playground areas. The staff of the school also noted that the entrance walkway north of the main entry gate lacks sufficient shading.

The overall topography of the site slopes down toward the south west corner. The north east corner of the site features a steep upslope that presents an opportunity for possible future development of an outdoor seating area.

The presence of ground water is noted north of Building 7 and 6 and east of Building 8. The source of this ground water should be investigated. The soil condition may be affected by the movement of ground water and further geotechnical investigation is recommended at Building 8 to determine if further ground settlement might occur.

Possible locations for shading opportunities have been indicated on the environmental analysis diagram. One of the possible ways to provide shading is to build shading structure. It should be noted that if free standing structure is to be built near the playground, the playground surface and equipment may be upgraded at the same time.

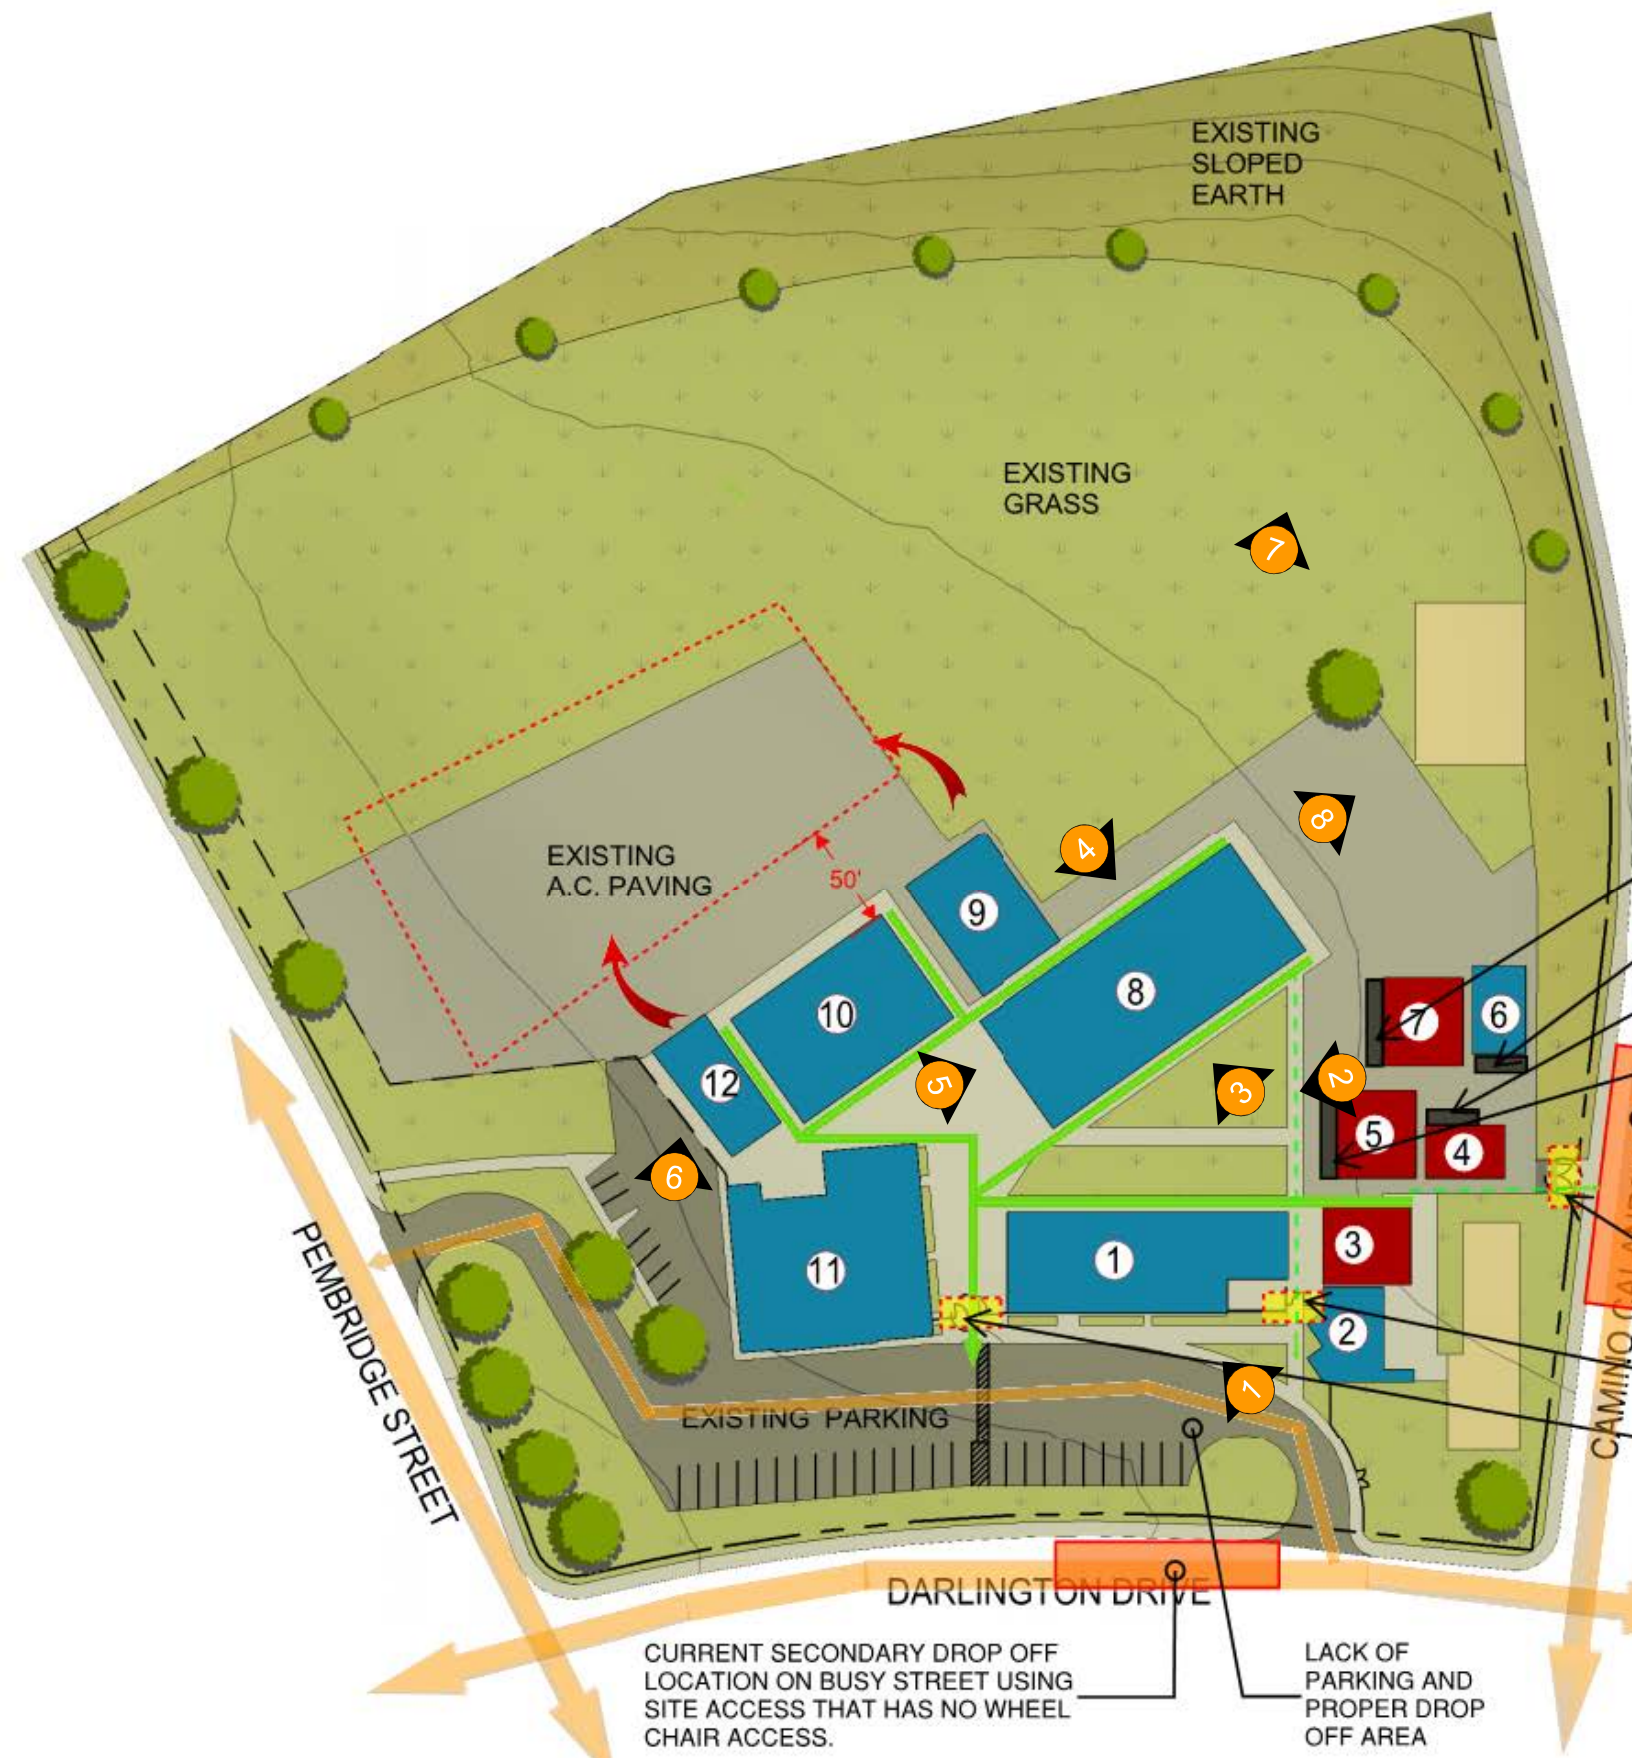
- PORTABLE RAMP WITH NON-COMPLIANT LANDINGS
- PORTABLE RAMP WITH NON-COMPLIANT LANDINGS
- PORTABLE RAMP WITH NON-COMPLIANT LANDINGS
- PORTABLE RAMP WITH NON-COMPLIANT LANDINGS
- CURRENT PRIMARY DROP OFF LOCATION ON BUSY STREET USING SITE ACCESS THAT HAS NO WHEEL CHAIR ACCESS.
- STEEP STAIRS
- GATE HARDWARE NON-COMPLIANT
- GATE HARDWARE NON-COMPLIANT

- CURRENT SECONDARY DROP OFF LOCATION ON BUSY STREET USING SITE ACCESS THAT HAS NO WHEEL CHAIR ACCESS.
- LACK OF PARKING AND PROPER DROP OFF AREA

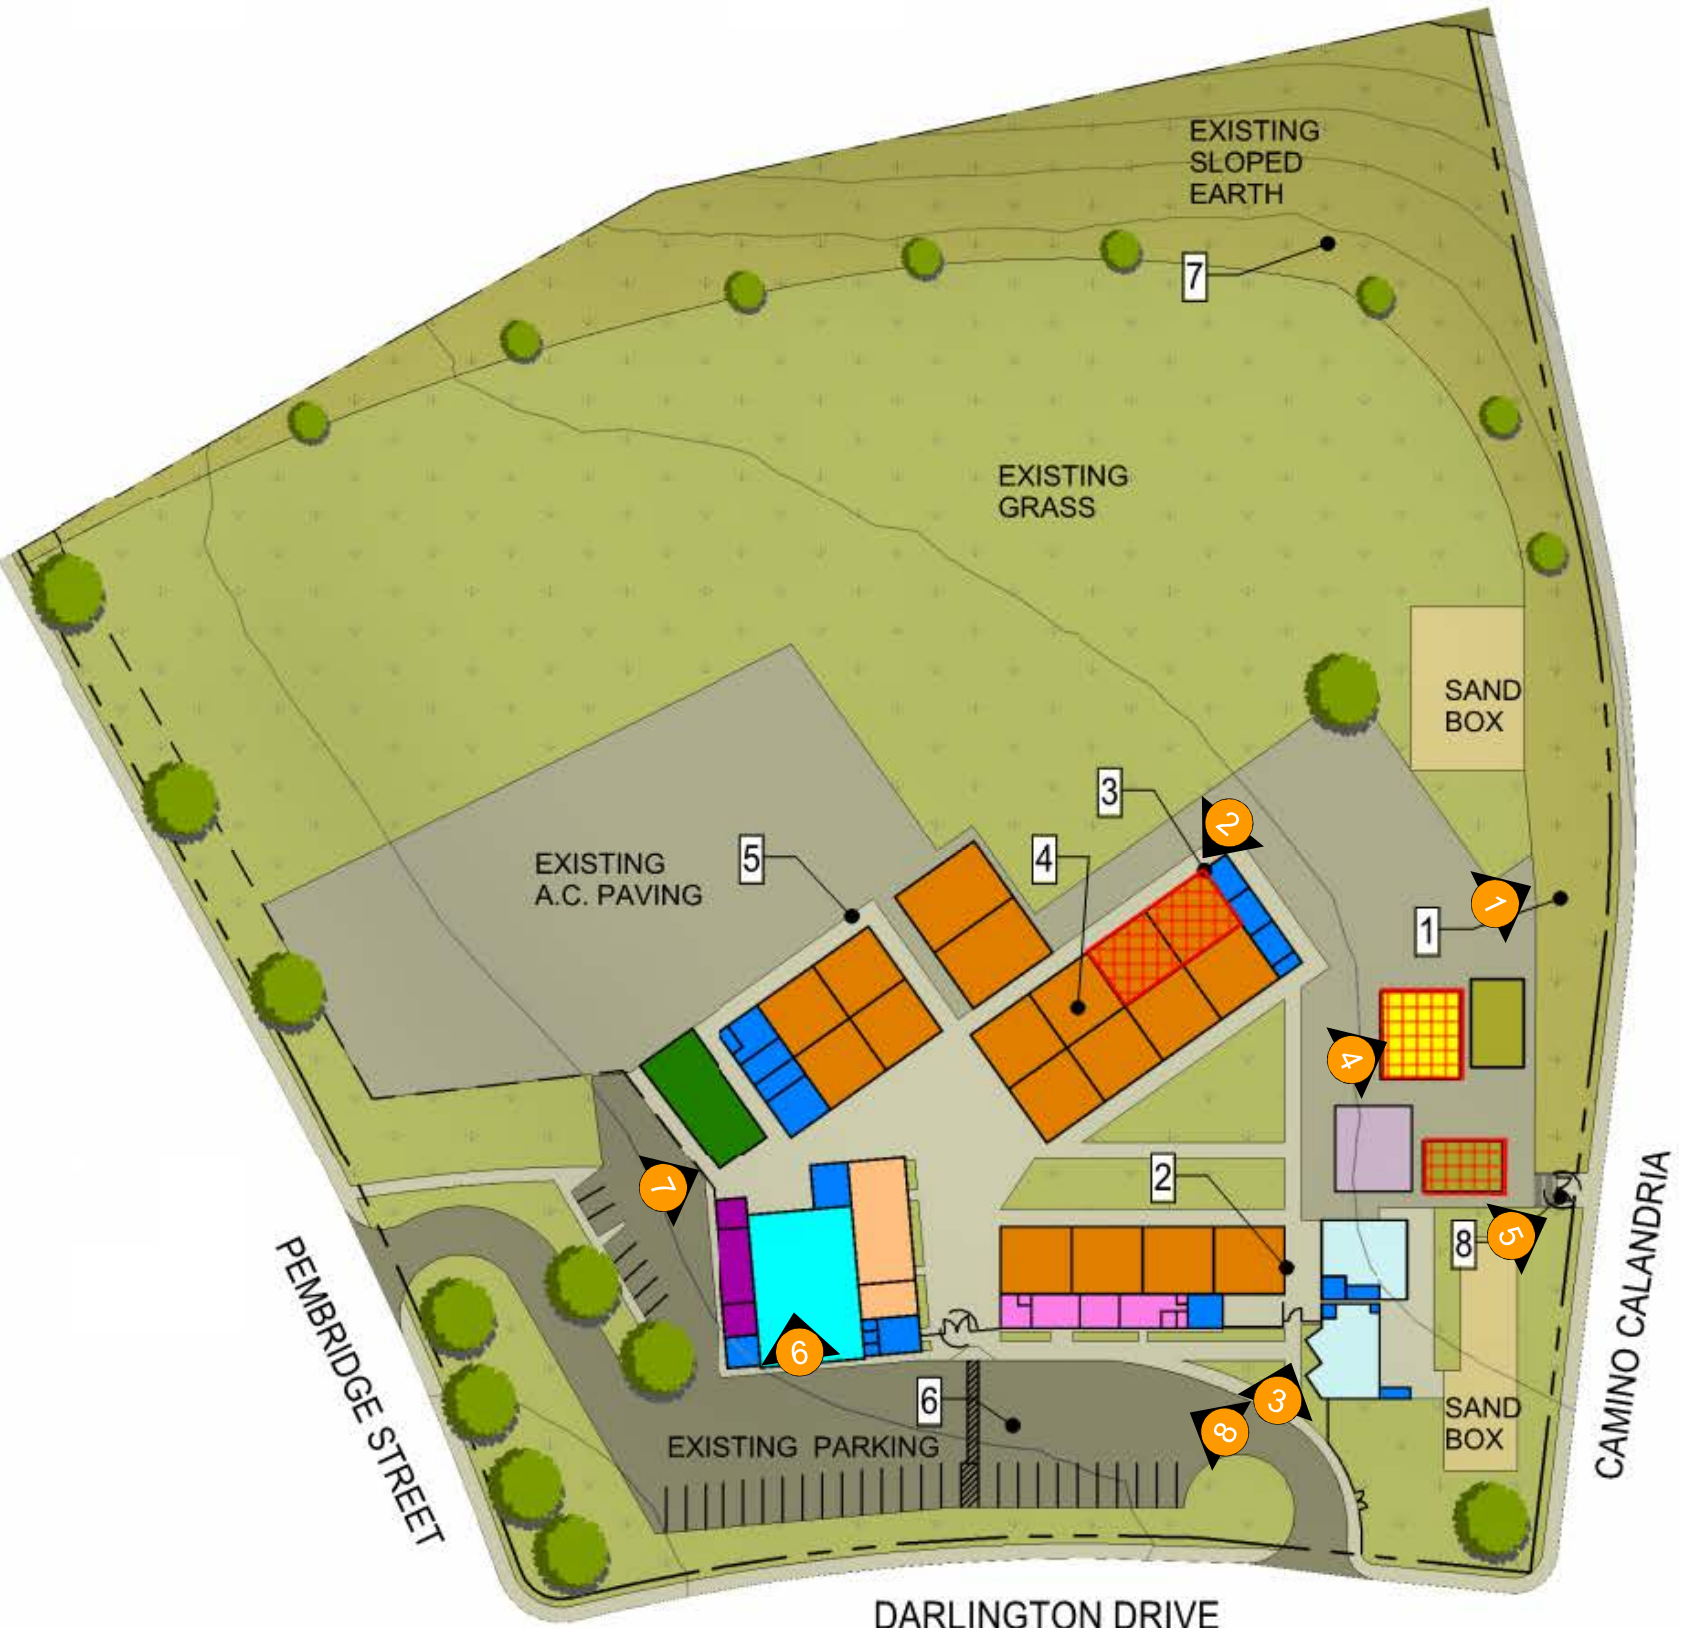
EXISTING SITE PLAN | WEATHERSFIELD ELEMENTARY SCHOOL BUILDING USE

- 1 SUMP PUMP AND CATCH BASIN LOCATION SHOWING CONSISTENT FLOW OF WATER. INVESTIGATION MAY BE NEEDED.
- 2 PLEXI GLASS WINDOWS MAY NEED REPLACEMENT.
- 3 GROUND SETTLEMENT ISSUES AND CRACKED WALL FINISH
- 4 CONCRETE SLAB SETTLEMENT ISSUES
- 5 NO WHEEL CHAIR ACCESSIBLE PATH TO PLAY AREA FROM ANY POINT.
- 6 INSUFFICIENT PARKING, CURRENT DROP-OFF IS DONE ALONG DARLINGTON DRIVE.
- 7 POTENTIAL LOCATION FOR OUTDOOR SEATING AND AMPHITHEATER.
- 8 NON-ACCESSIBLE GATE AND STEEP STAIRS.

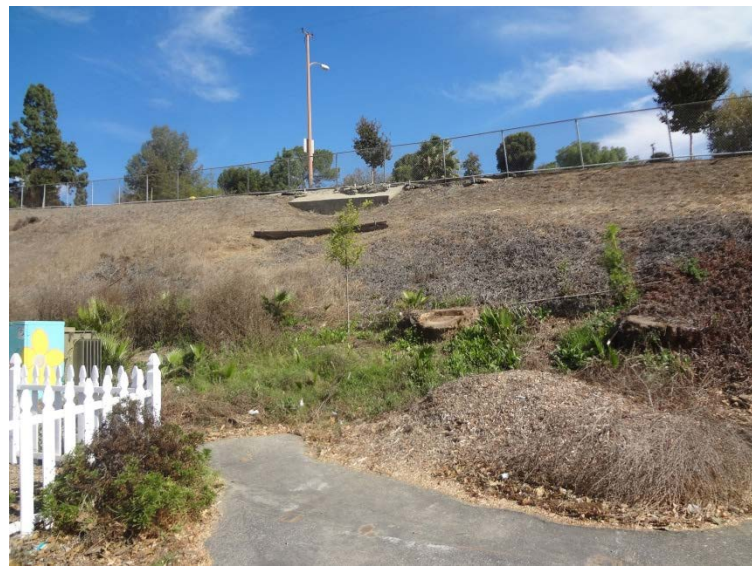
Photo -1
Sump Pump and Water issues
 Location of sump pump where continuous ground water is visible in the catch basin.

Area 1: Investigation into the source of ground settlement as well as ground water should be conducted as soon as possible. Pending the result of the investigation, the school may be entitled to additional funding to retrofit the building. Works occurring inside building 8 may include both structural improvement, refinishing and additional flexible learning spaces and music classroom.

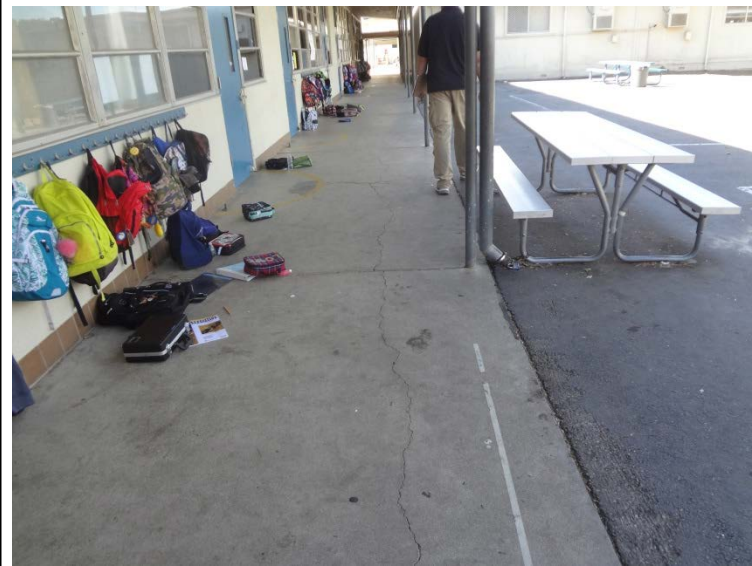
Photo -2
Concrete Slab Settlement
 Classroom building with potential differential settlement. Cracks are visible on wall finishes. Some door frames appear warped.

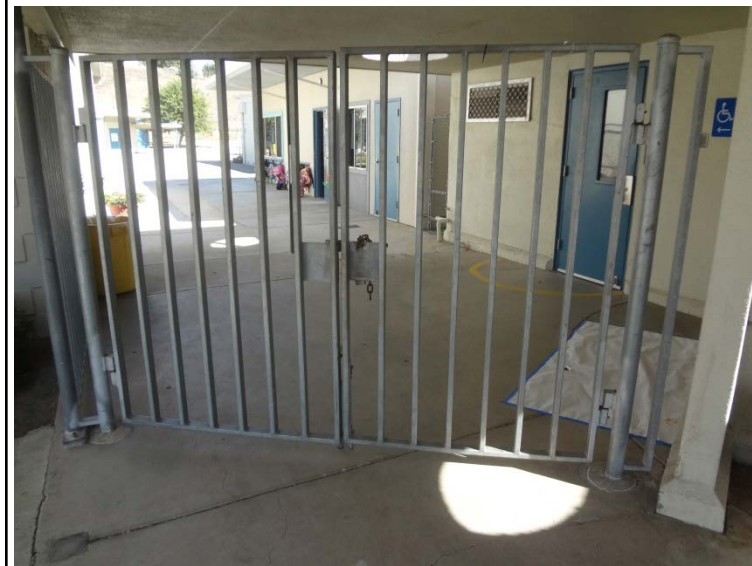
Photo -3
Gates to Campus
 Gates to campus do not have accessible hardware.

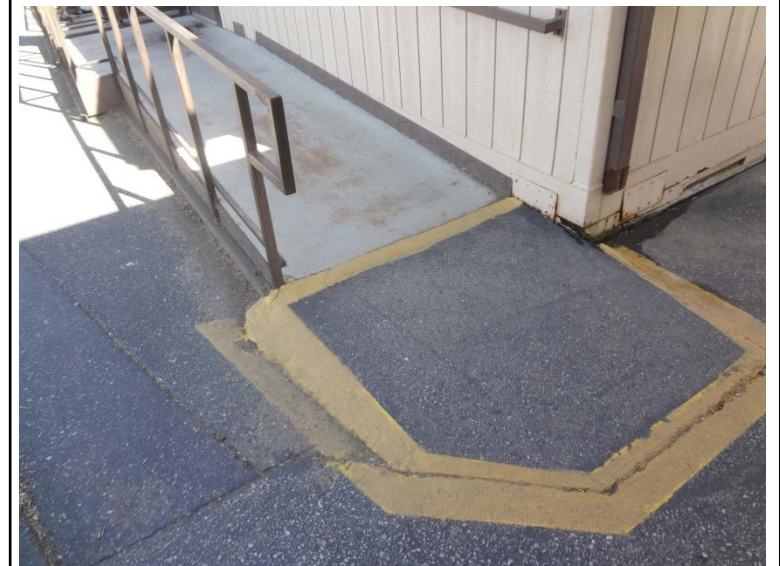
Photo -4
Portable Ramps
 Portable building ramps do not have compliant landings

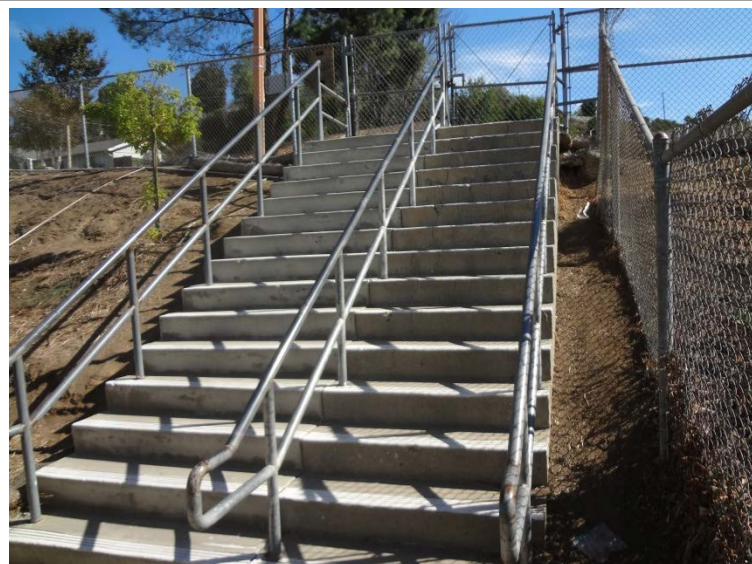
Photo -5
Stairs to Campus
 A large steep staircase has been used as a primary entry for students. Drop-off also occurs along the public street.

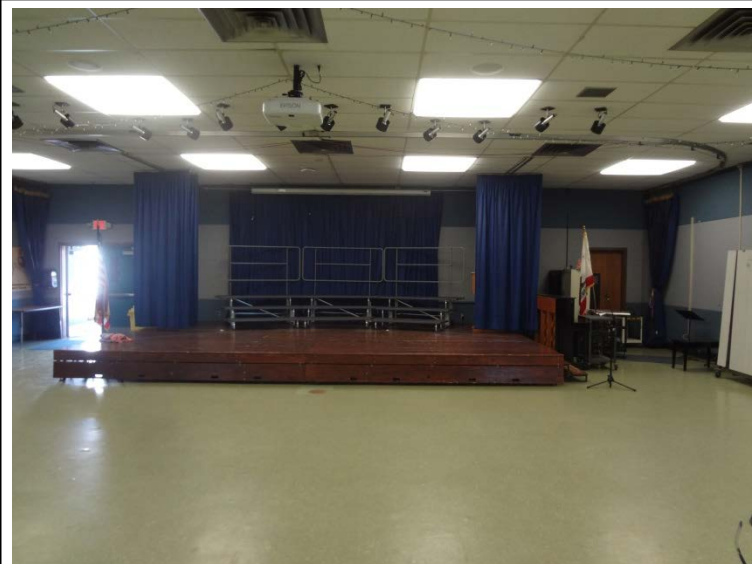
Photo -6
Multi Purpose Building
 Multi purpose space does not have a permanent stage.

Area 4: The multi-purpose building may receive a permanent stage and other improvements in the building.

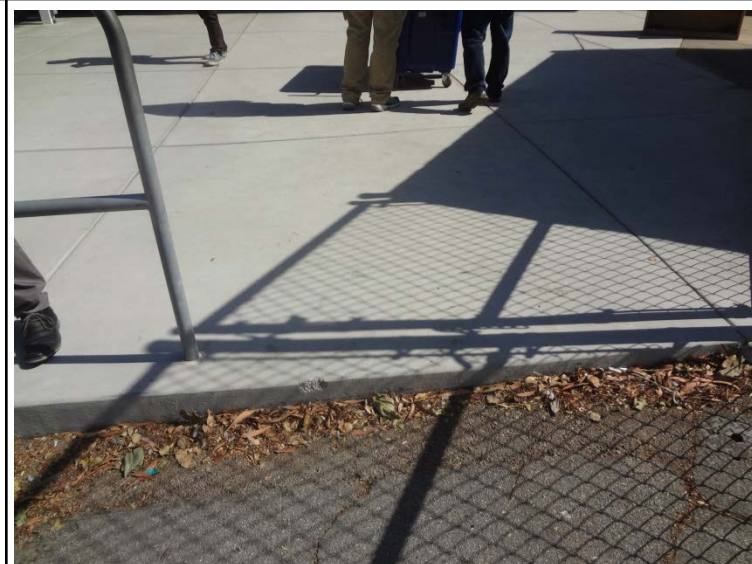
Photo -7
Lunch Shelter Access
 New lunch shelter has no wheel chair accessible path from playground area.

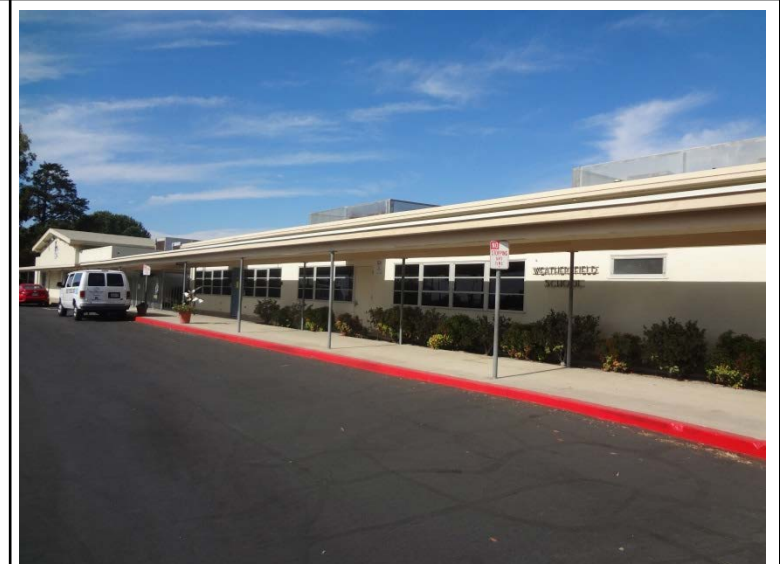
Photo -8
Drop Off Area
 Currently there is no designated drop-off area in the parking lot.

Area 2: A possible closure of gate and reconfiguration of area around the gate east of building 4 may improve the safety and traffic conditions along Camino Calandria during drop-off and pick-up hours. A potential reconfiguration of the main parking area may increase both parking and drop off capacity and bring the drop-off zone back to the school site from the street.
