# CVUSD | *Facilities Master Plan*

## Acacia Elementary School | *Site Analysis*

55 W Norman Ave | Thousand Oaks, CA 91360

January 10th, 2017

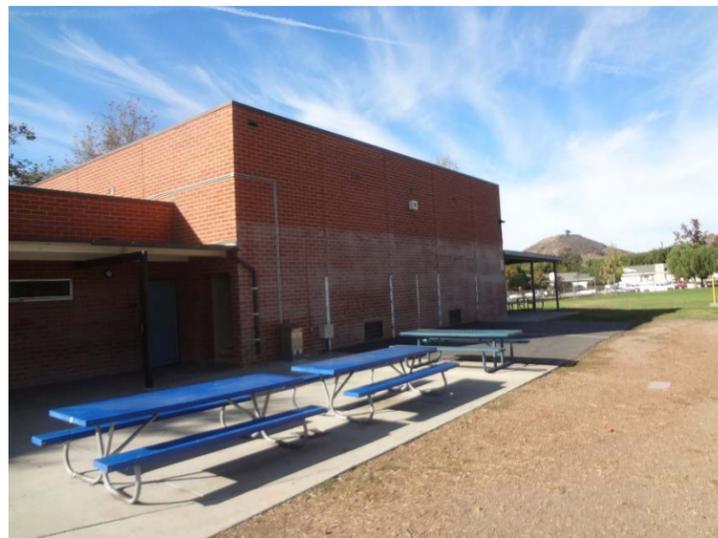
**Photo -5**  
**Curb Appeal – Multi Purpose**  
 Large Multi Purpose building has brick façade. The surface may need cleaning.

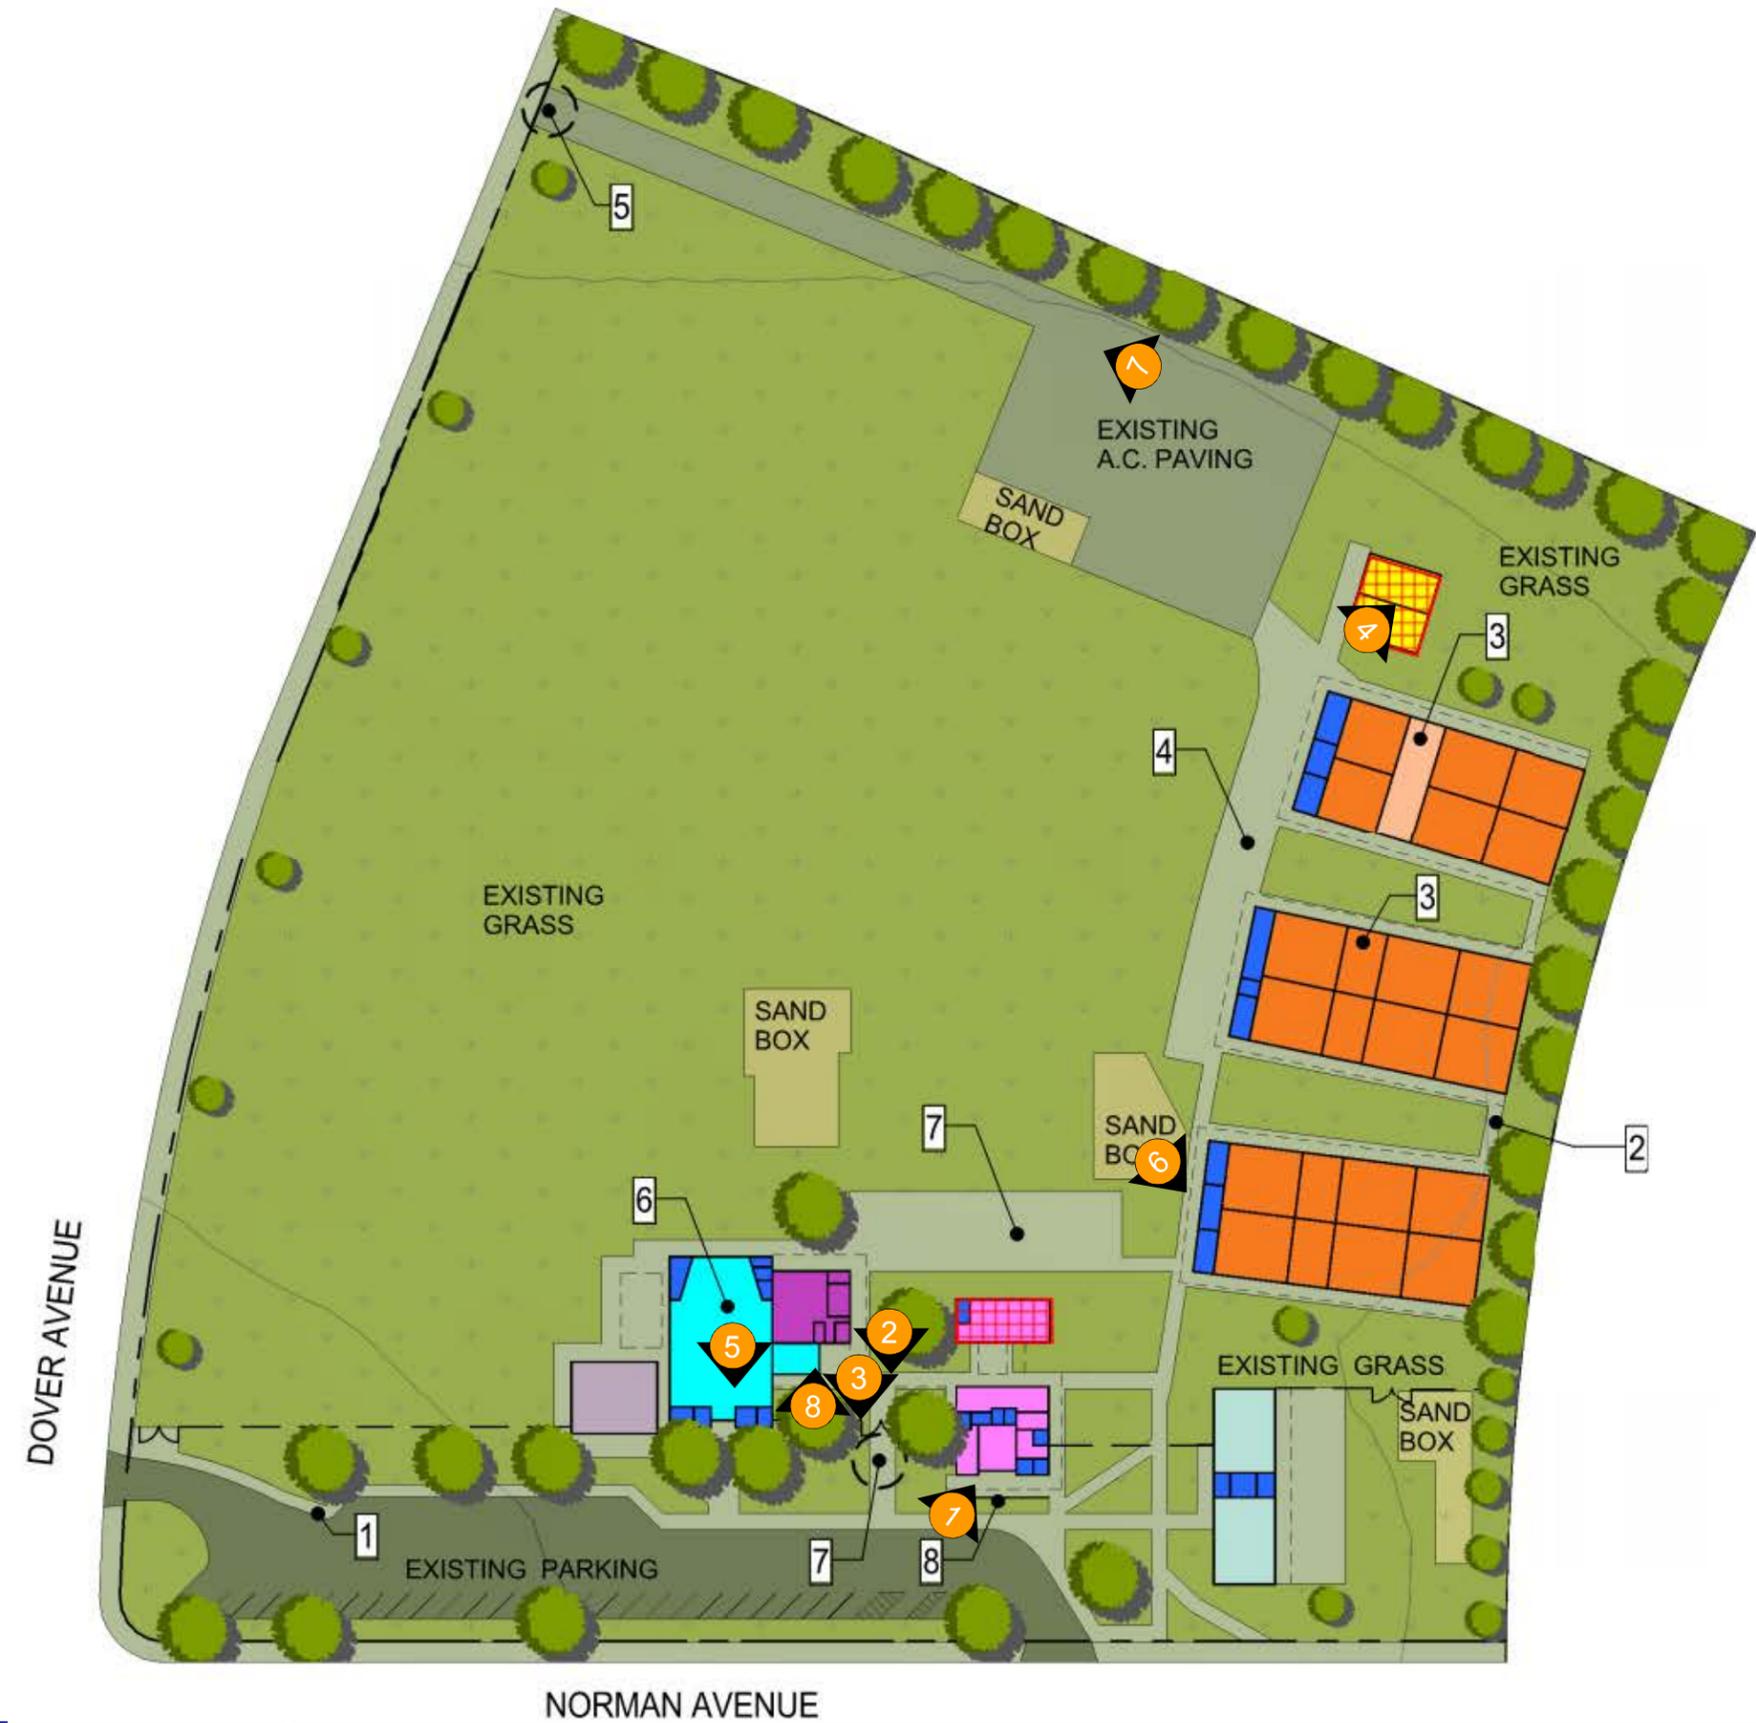
**EXISTING SITE PLAN | ACACIA ELEMENTARY SCHOOL BUILDING USE**

- 1 DRAINAGE AND CONCRETE SETTLEMENT ISSUES.
- 2 DRAINAGE ISSUES AND PONDING.
- 3 BREEZEWAY CONVERTED TO CLASSROOM
- 4 SLOPE OF GROUND TOO STEEP FOR WHEELCHAIR ACCESS TO PLAYGROUND
- 5 MAJOR ACCESS POINT TO SCHOOL IS NOT ACCESS COMPLIANT. GATE ORIENTATION MAY BE MODIFIED TO COMPLY.
- 6 CONCRETE SLAB SETTLEMENT AND VISIBLE CRACKS IN SLAB AND WALLS
- 7 CONCRETE WALKWAY SETTLEMENT ISSUES
- 8 BRICK WALL OBSTRUCTING VIEW FROM THE ADMINISTRATION BUILDING TO THE PARKING AREA

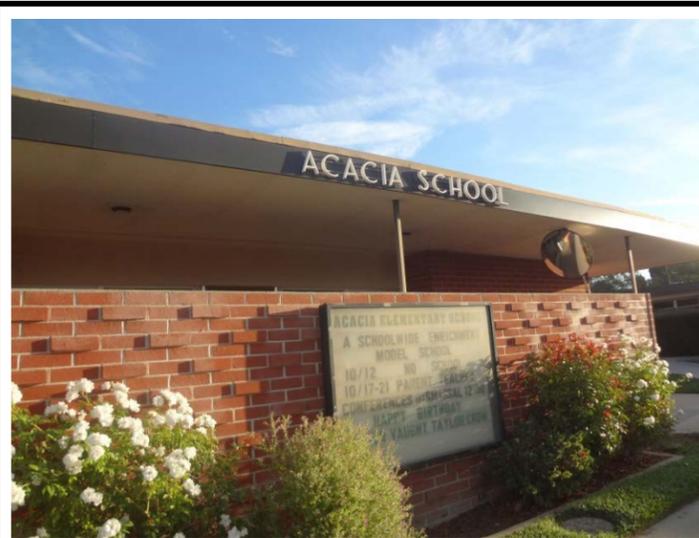
**Photo -1**  
**Large Wall in Front of Office**  
 Large wall in front of administration building obstructs view of the parking lot and drop off area.

Area 2: The area of improvement includes the possibility to improve line of sight from the administration office to the parking and drop-off area. In addition, site elements surrounding the main entry gate may be re-configured and refreshed to provide barrier free approach and aesthetically pleasing curb appeal. At north east entry point, possible improvement should reconfigure the gate and surrounding paving to comply with accessibility standard.

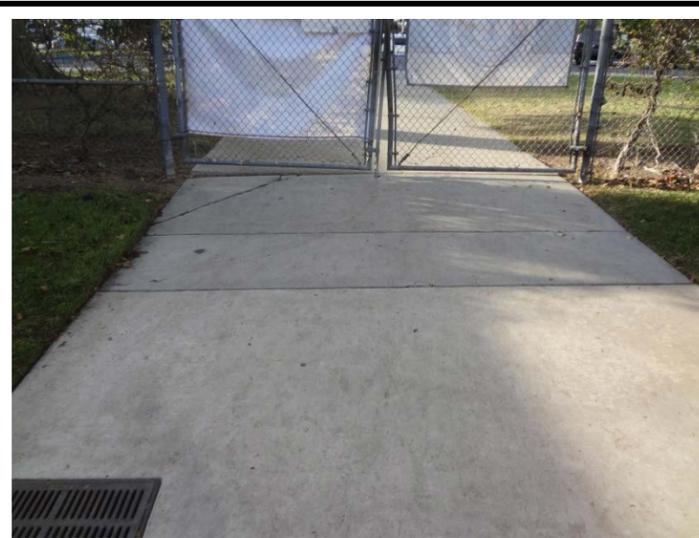
**Photo -2**  
**Concrete Slab Settlement**  
 Concrete pathways throughout campus appear to have settlement issues and show extensive cracks.

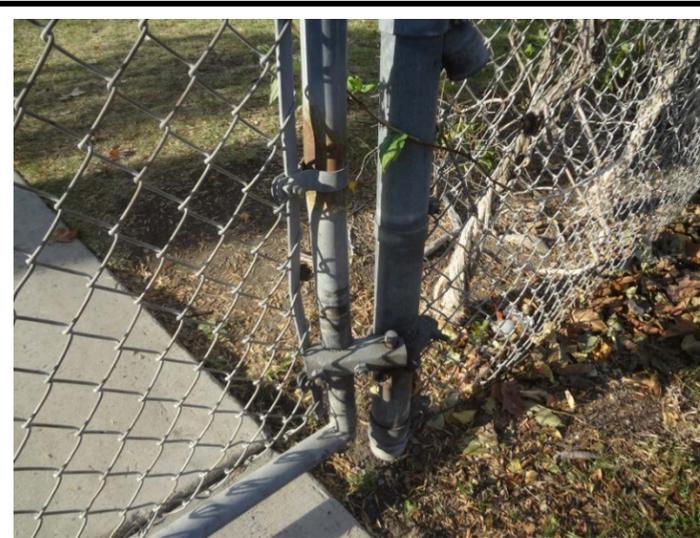
**Photo -3**  
**Fencing**  
 Fencing is particularly deteriorated at the entry points of the school.

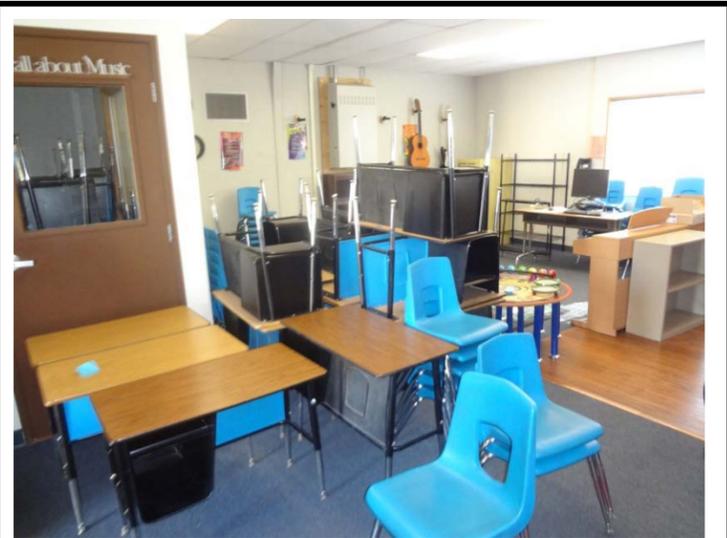
**Photo -4**  
**Under Utilized Portable Building**  
 The building is under utilized and being used for additional storage on campus.

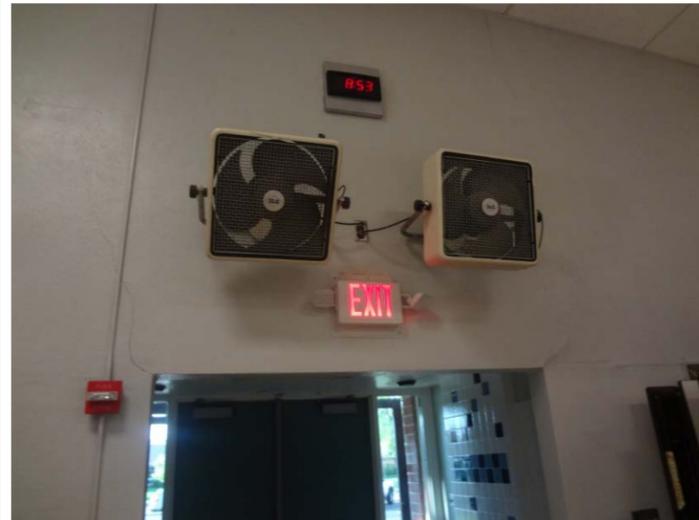
The overall topography of the site is rather gentle comparing to other schools in the district. However, the soil condition may be affected by the movement of ground water and further geotechnical investigation is recommended at Building 7 to determine if further ground settlement might occur.

**Photo -5**  
**Multi Purpose Building**  
 There are large amounts cracking in the walls and floors of the multi purpose building possibly caused by ground settlement.

Area 1: Investigation into the source of ground settlement should be conducted as soon as possible. Pending the result of the investigation, the school may be entitled to additional funding to retrofit the building. Works occurring inside building 7 may include both structural improvement, and refinishing of interior spaces.

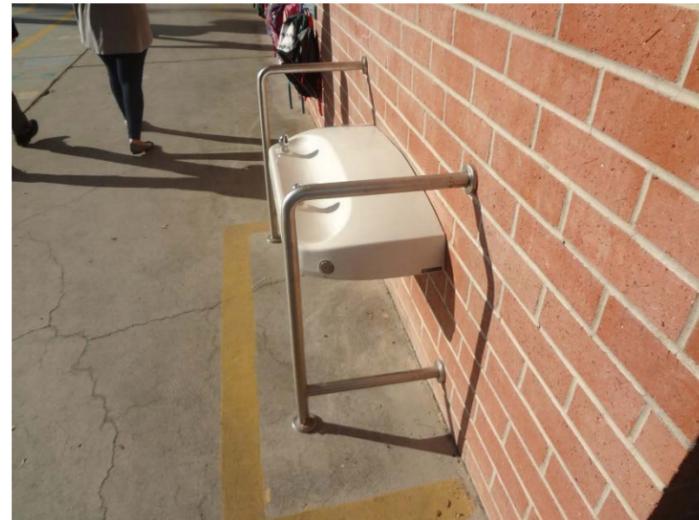
**Photo -6**  
**Accessibility Upgrades**  
 Accessibility upgrades are needed throughout the campus.

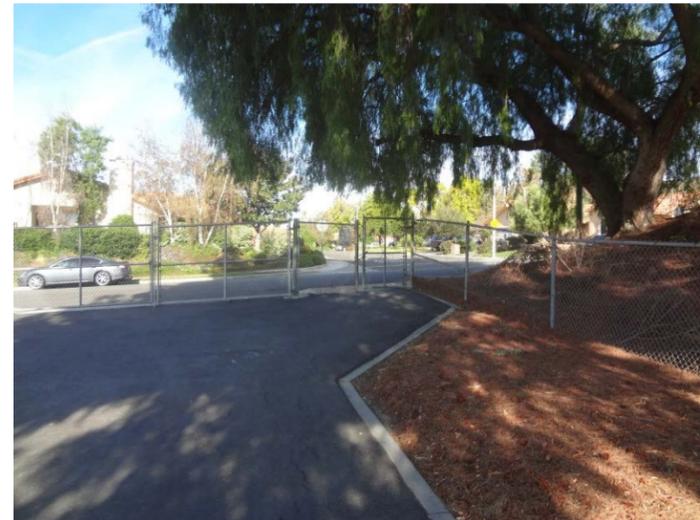
**Photo -7**  
**Secondary Entry Gate**  
 The secondary entry to the school may be reconfigured to be meet current accessibility standards.

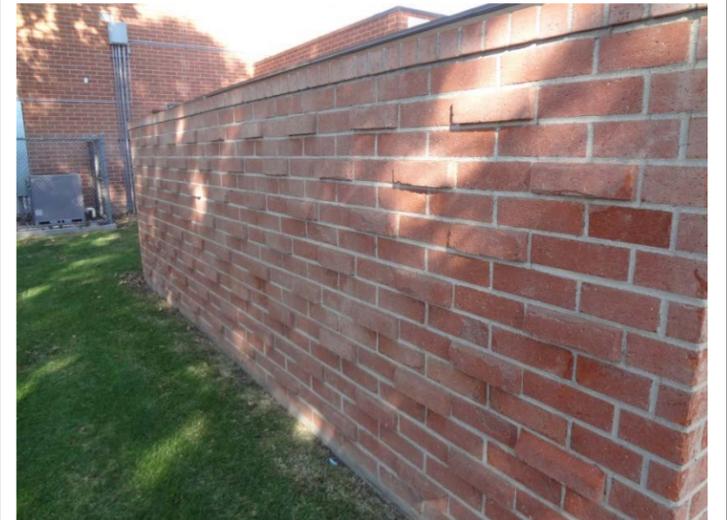
**Photo -8**  
**Brick Walls**  
 The decorative protruding bricks on the typical walls may present undesirable opportunity for students to climb the wall.
