# CVUSD | *Facilities Master Plan*

## Glenwood Elementary School | *Site Analysis*

Conejo Valley Unified School District

January 10th, 2017

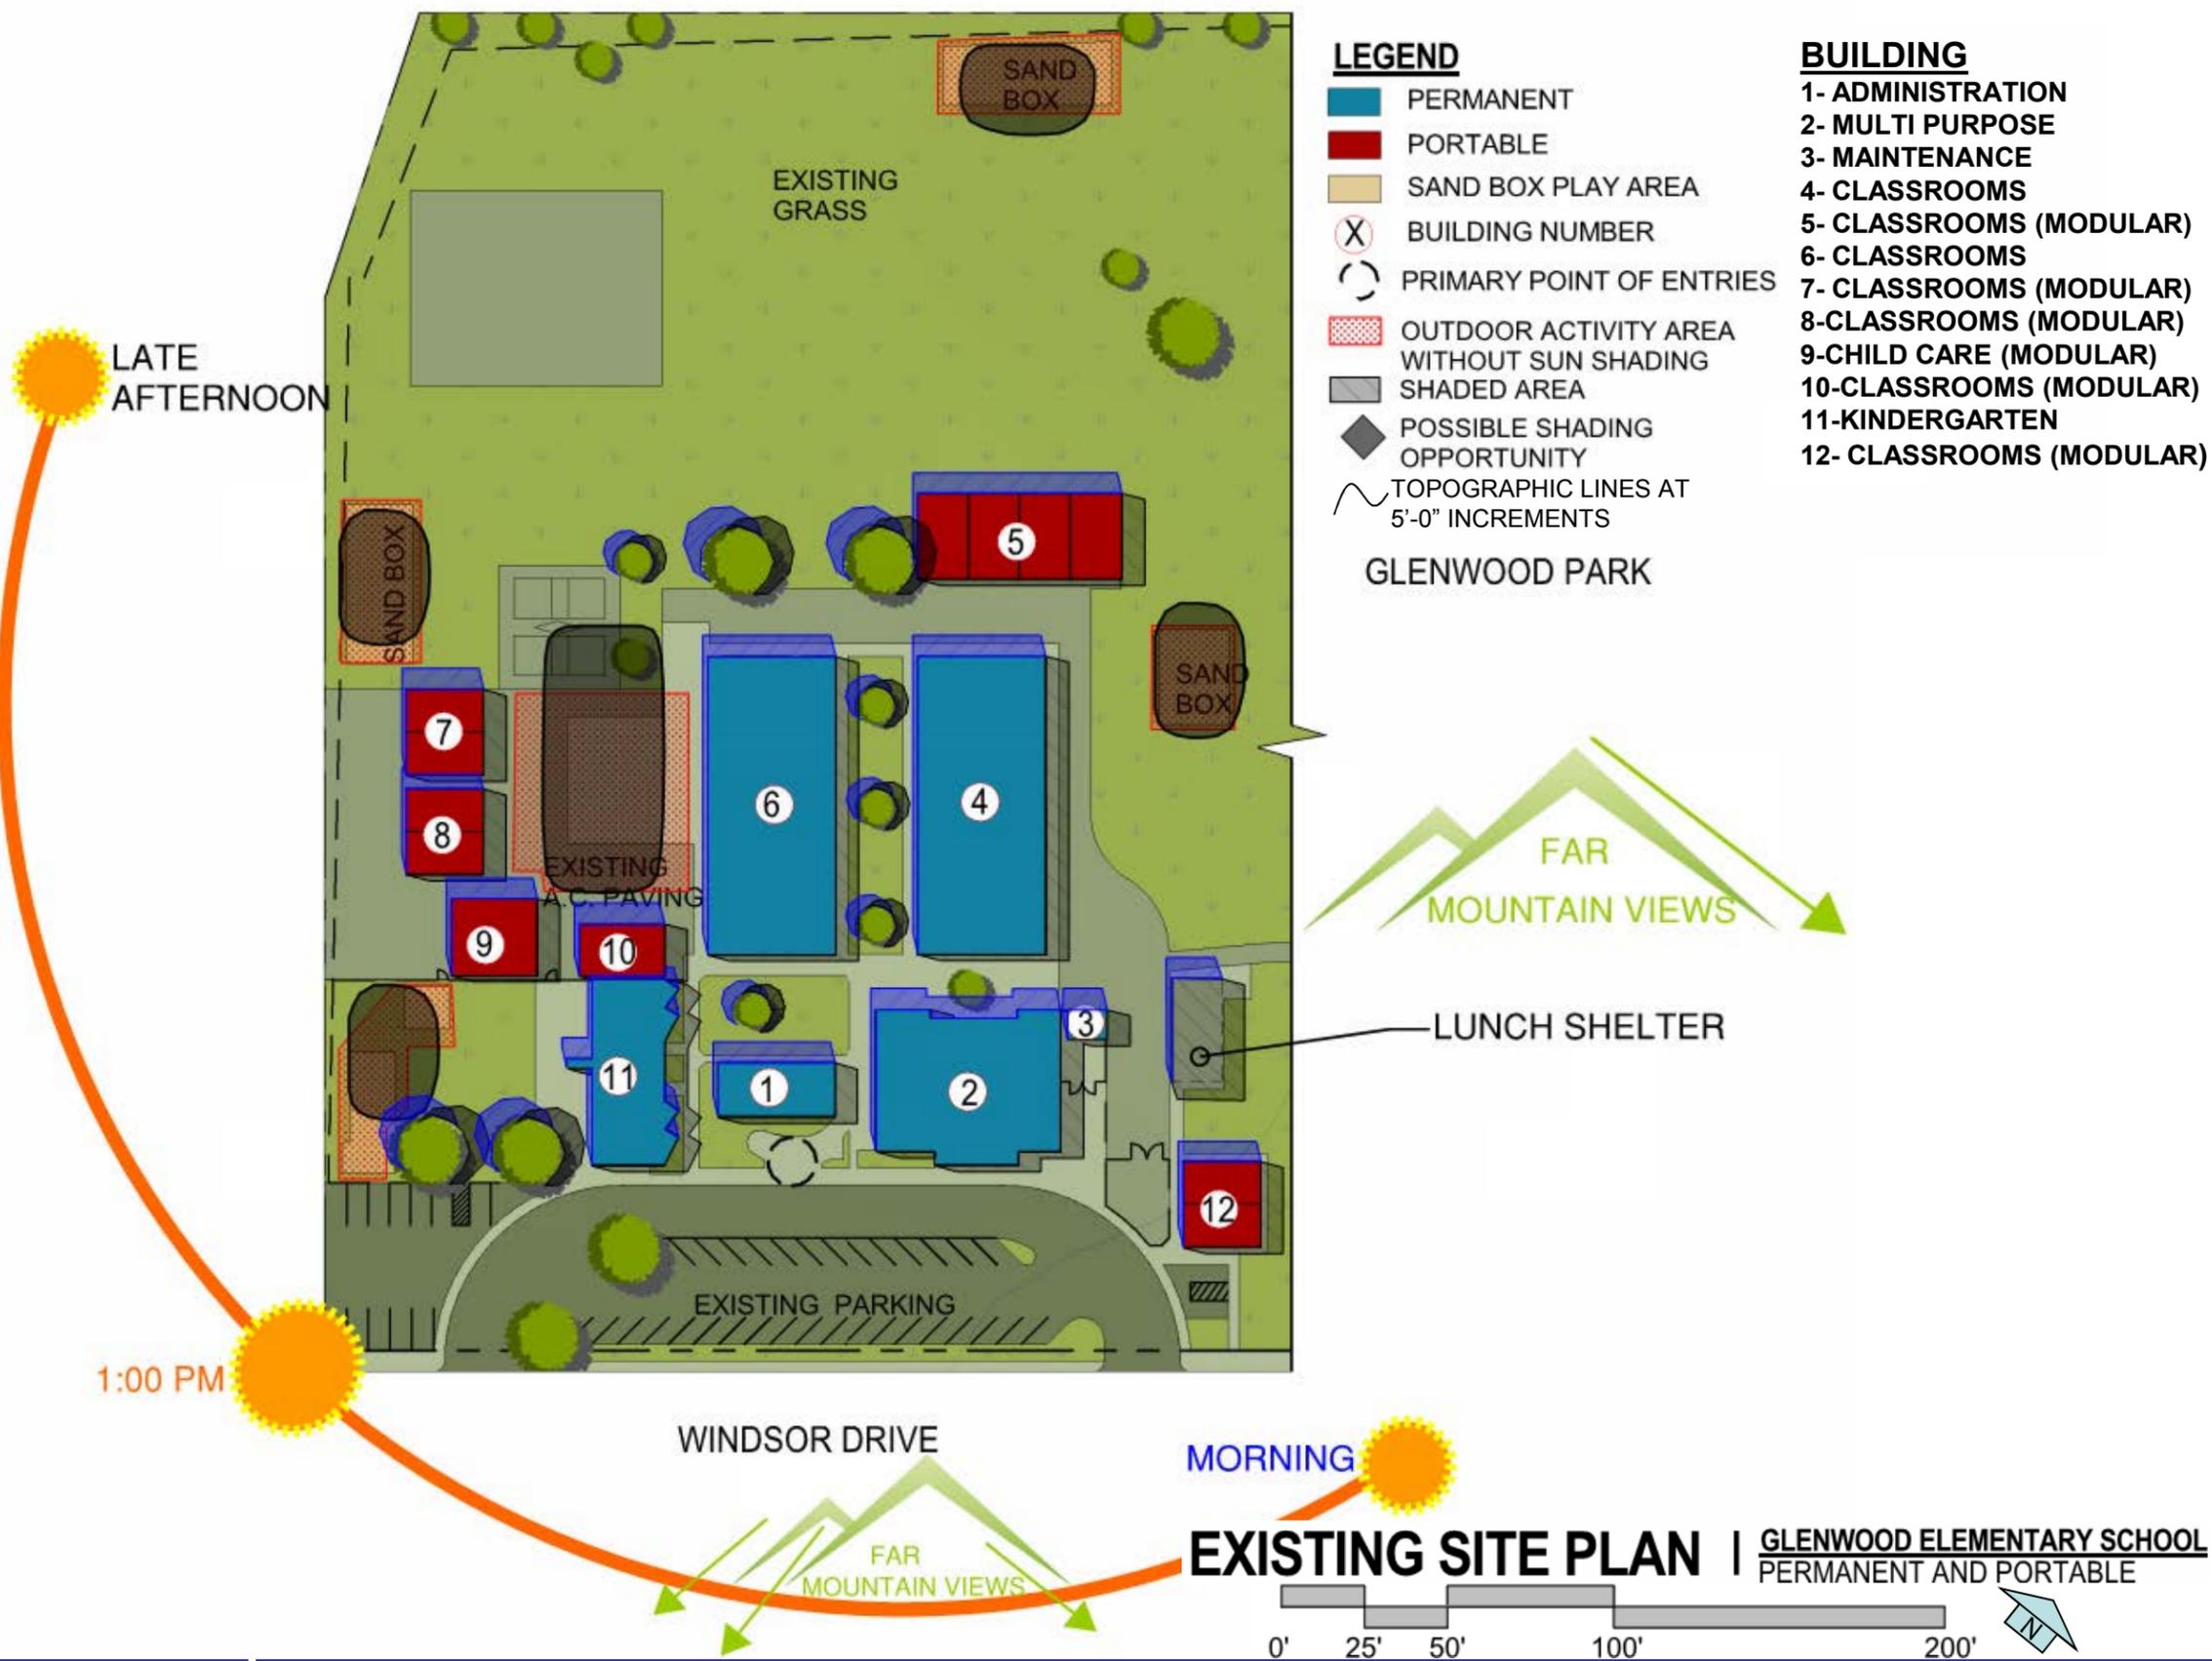
Glenwood Elementary School's building alignment on the site provides little morning or afternoon shading of the playground areas. There are two possible means of providing additional shading to those outdoor activity areas.

The current building orientation, which runs in the direction from northwest to southeast, may not provide the most efficient layout for solar panels on the existing roof. Opportunity for solar power generation may not be as viable as that in other school sites.

It should be noted that the topography on the site is relatively flat; however, the school still has several locations that require further improvement to be wheelchair accessible.

One opportunity is to build free-standing shading structure to shelter the playground from sun exposure. It should be noted that if free standing structure is to be built near the playground, the playground surface and equipment may be upgraded at the same time.

An alternative opportunity is to plant a row of trees at the western side of the playgrounds to provide shade in the afternoon.

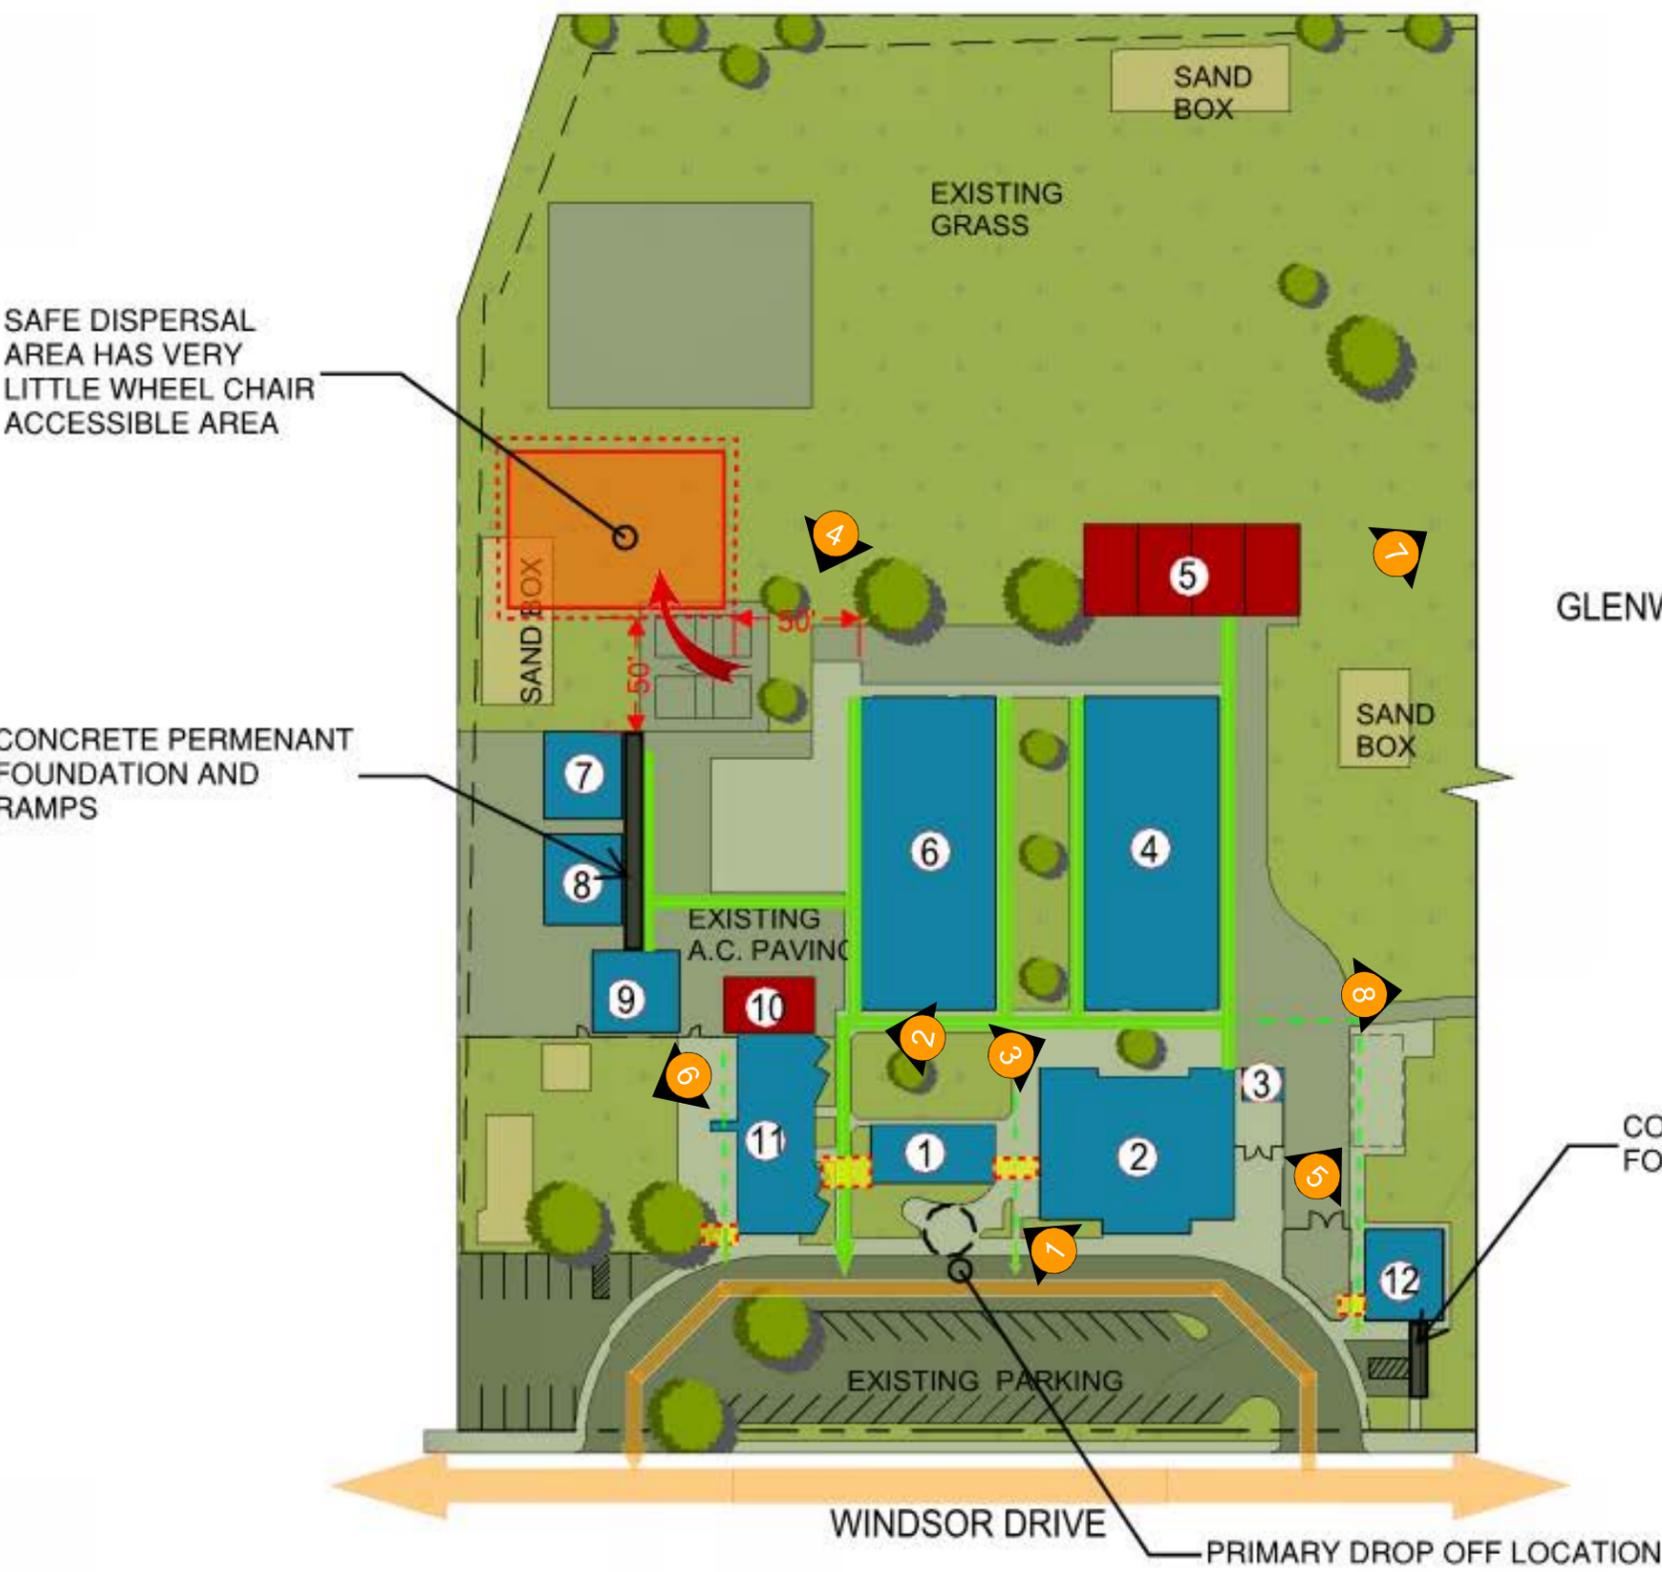
**EXISTING SITE PLAN | GLENWOOD ELEMENTARY SCHOOL  
DSA CERTIFICATION REQUIREMENTS**

**Safe Dispersal Area**

The current safe dispersal area for the school does not have adequate solid ground surface for wheelchair access. There is also no panic hardware or levered accessible hardware on the gates. Addressing those issues may improve the emergency egress of the campus.

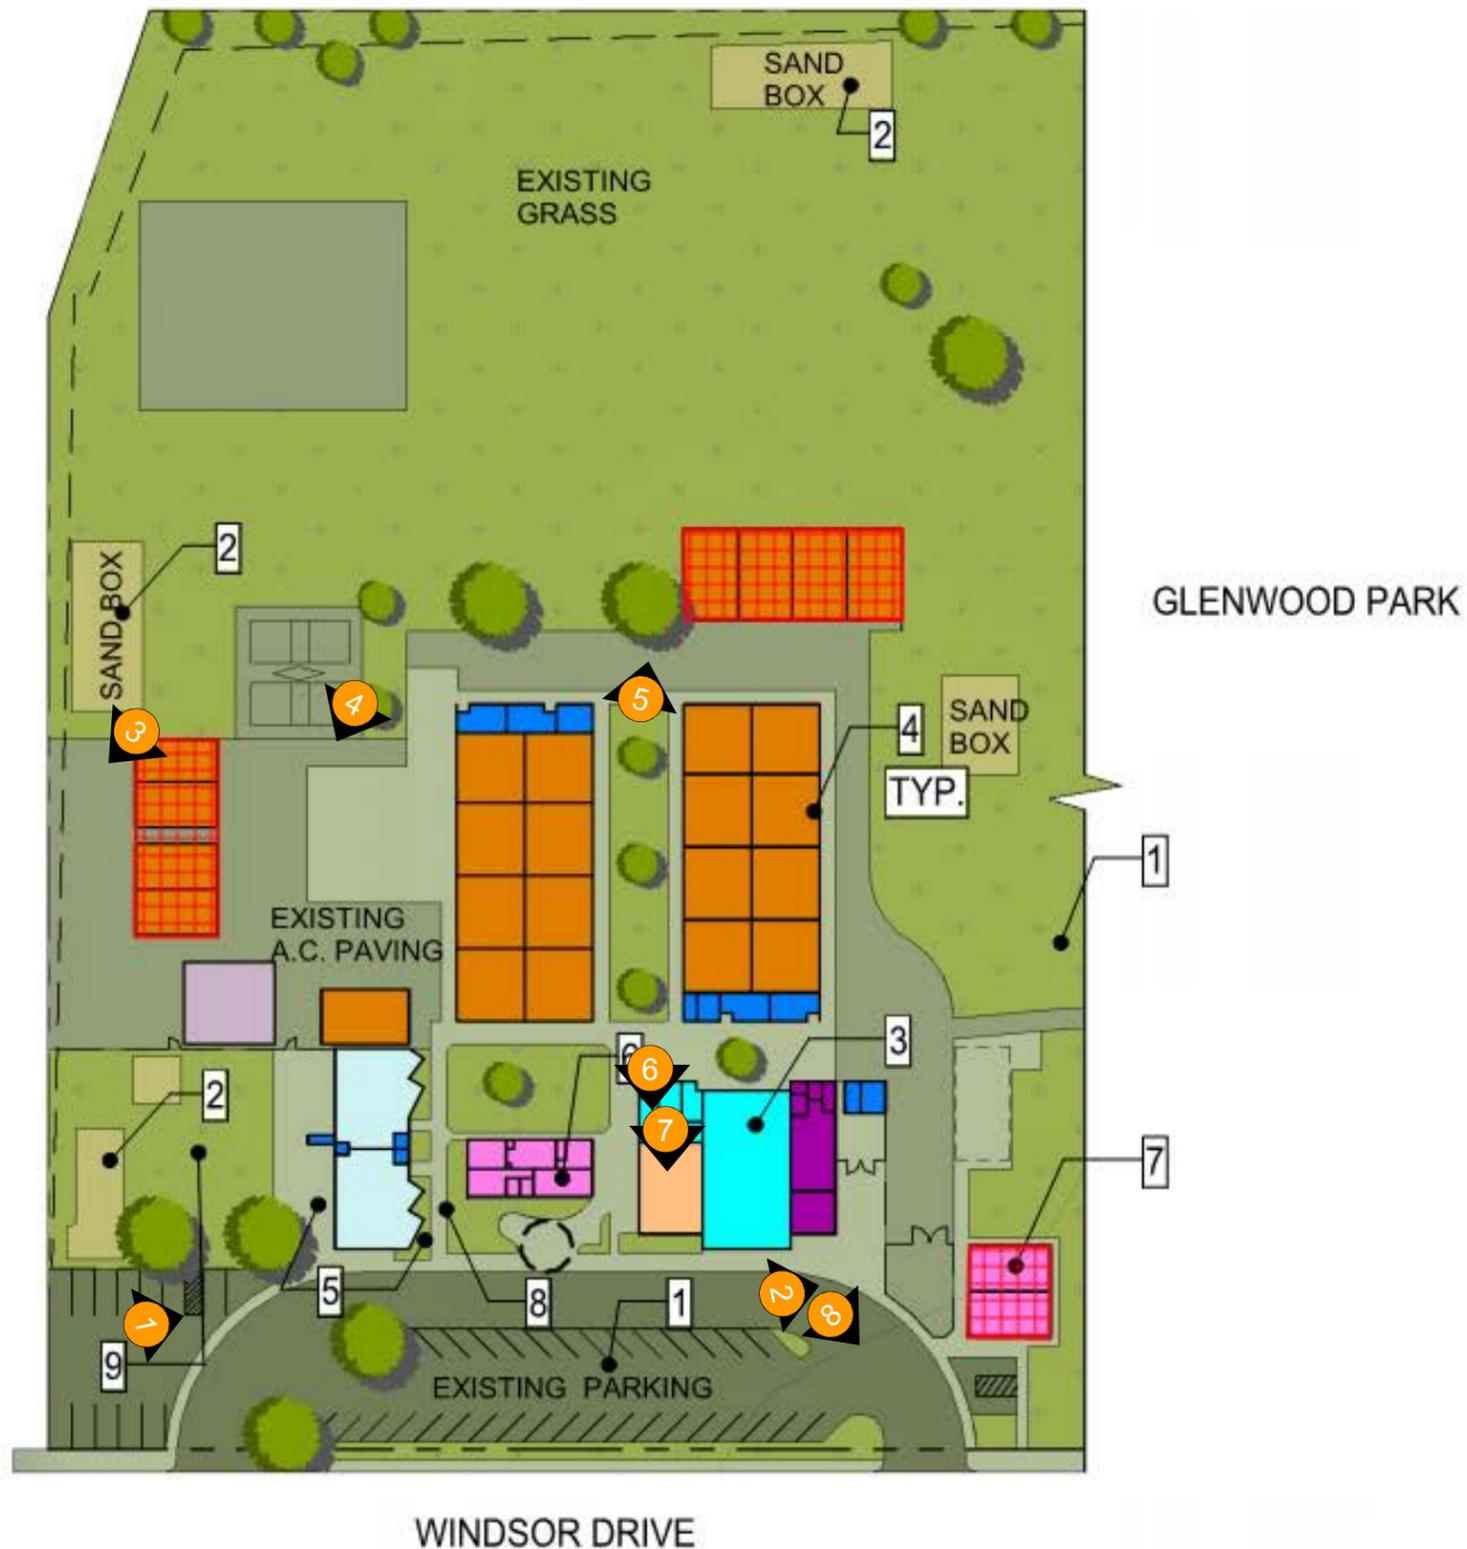
**EXISTING SITE PLAN | GLENWOOD ELEMENTARY SCHOOL BUILDING USE**

**SITE IMPROVEMENT KEY NOTES**

- 1 LACK OF LIGHTING TO ADDRESS SECURITY CONCERNS AT NIGHT.
- 2 LACK OF SHADING FOR PLAYGROUND AREA, TYP.
- 3 THE MPR DOES NOT HAVE A PERMANENT STAGE.
- 4 LACK OF WINDOW SHADING AND OPERABLE WINDOWS, TYP.
- 5 DRAINAGE ISSUE.
- 6 LACK OF WORK SPACE FOR TEACHERS' WORKROOM. STAFF RESTROOMS DO NOT HAVE THE PROPER CAPACITY.
- 7 6 YEARS OLD PORTABLE BUILDING MOSTLY USED AS STORAGE SPACE.
- 8 NO PANIC HARDWARE FOR MAIN ENTRY GATE.
- 9 KINDERGARTEN PLAYGROUND IS OVERCROWDED.

- CLASSROOMS WILL NEED ACCESSIBILITY UPGRADES ON HARDWARE THRESHOLDS AND SINKS.
- EXTERIOR DRINKING FOUNTAINS WILL NEED TO BE MADE ACCESSIBLE.
- ACCESSIBILITY UPGRADES NEEDED IN PARKING, GATE LOCATIONS, DOORS, AND SOME PATHWAYS.
- PAINT CONDITION AND MANY EXPOSED WOOD RAFTERS ARE DETERIORATING AND IN NEED OF REFINISHES THROUGHOUT CAMPUS.
- LACK OF INDOOR FLEXIBLE SPACES AND STORAGE SPACES.
- WINDOWS HAVE BUCKLING FRAMES, NON-MATCHING, SINGLE PANE CLASS.

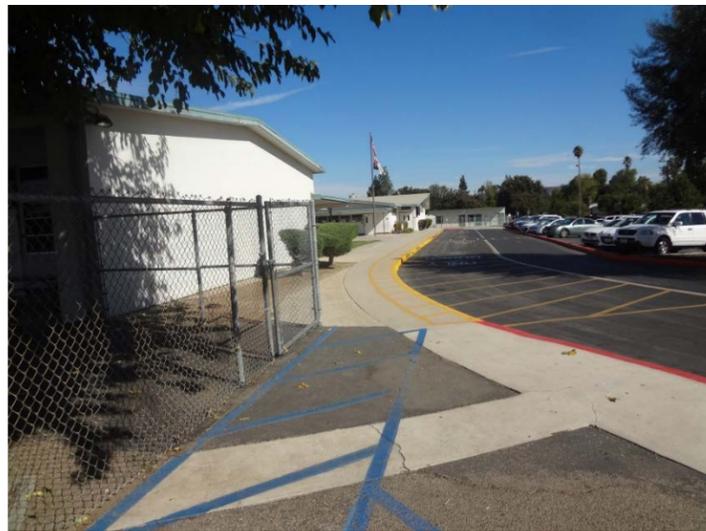
**Photo -1**  
**Parking Lot Accessibility**  
 Current parking lot layout has the accessible parking stalls not in the main parking area and there are accessibility issues with the stalls

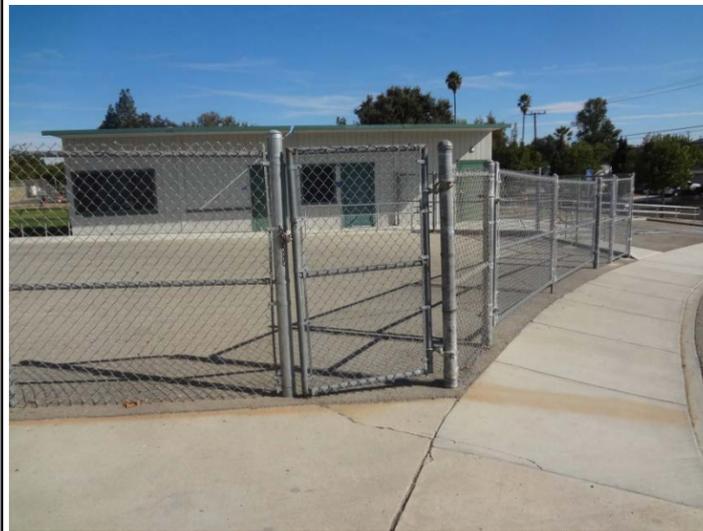
**Photo -2**  
**Under Utilized Classroom**  
 These buildings have been recently constructed, but are currently under utilized.

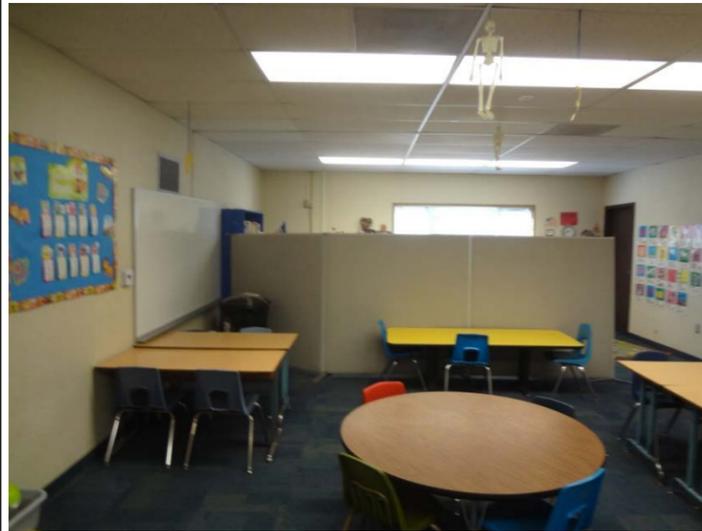
**Photo -3**  
**Under Utilized Classroom**  
 Several Portable buildings are being used as storage.

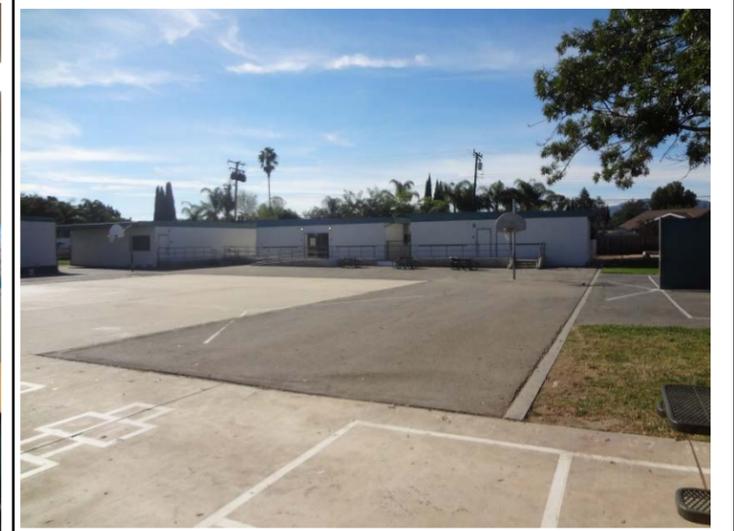
**Photo -4**  
**Safe Dispersal Area**  
 The black top area is too small and close to the existing buildings to qualify as a safe dispersal area.

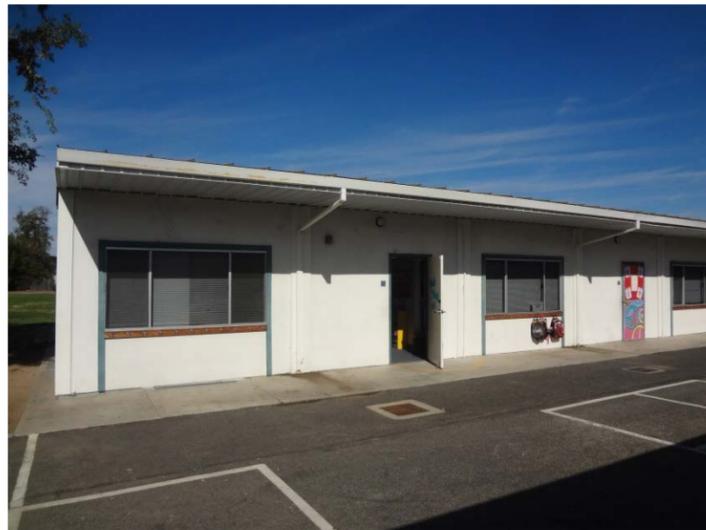
**Photo -5**  
**Uncertified Portable Buildings**  
 The portable buildings at the back of campus are not DSA certified.

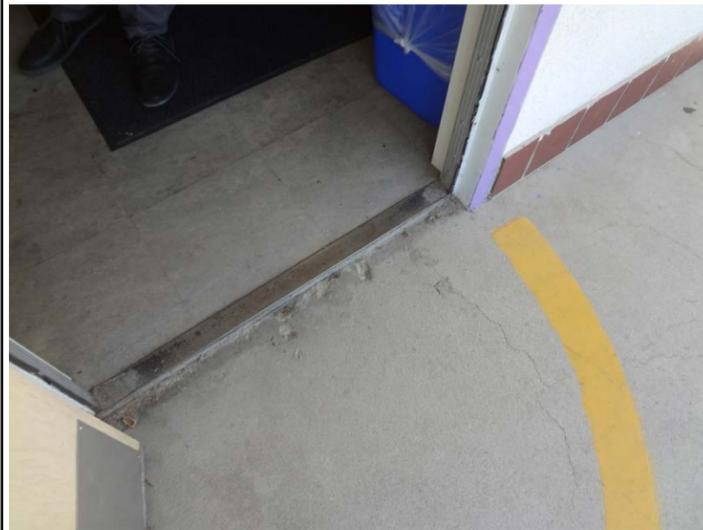
**Photo -6**  
**Accessibility Issues**  
 The campus may need of a full campus wide accessibility upgrade to meet current accessibility standards.

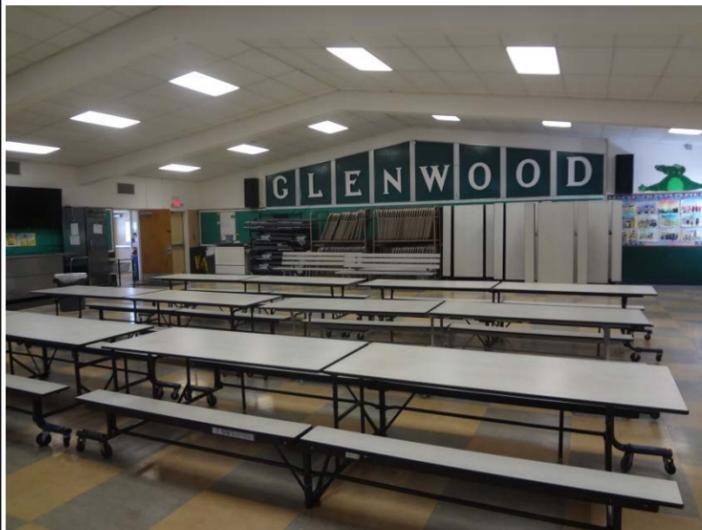
**Photo -7**  
**Multi Purpose Building**  
 The multi purpose building does not have a permanent stage.

**Area 1:** The multi-purpose Building 2 may receive a permanent stage while the remaining space, including the immediate outdoor area may be re-configured to accommodate activities such as additional sheltered lunch area. The temporary classroom building 12 may be re-purposed for music or other activities while allowing Building 6 and 4 to have capacity of adding flexible activity spaces.

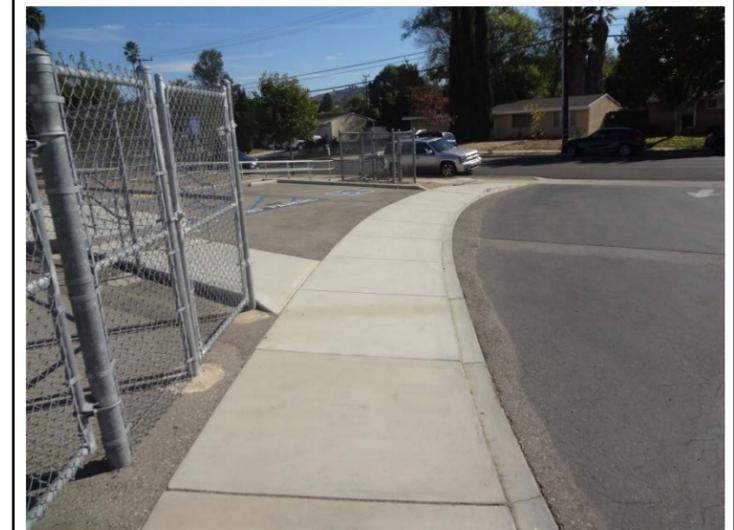
**Photo -8**  
**Accessibility Issues in Parking Area**  
 There is an issue with cross slope of the accessible path of travel in the parking lot.
