CVUSD | *Facilities Master Plan*

ASPEN
ELEMENTARY SCHOOL

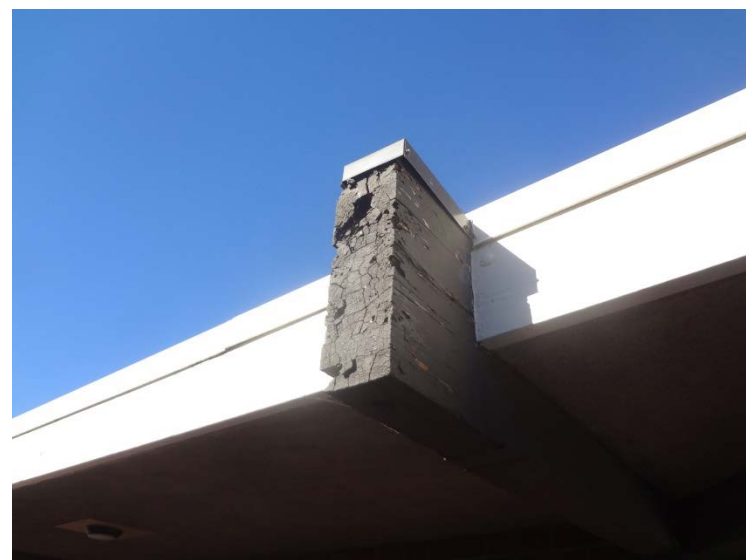
Photo -5
Building 1
Typical wood rafter, condition throughout campus varies some are in need of repair

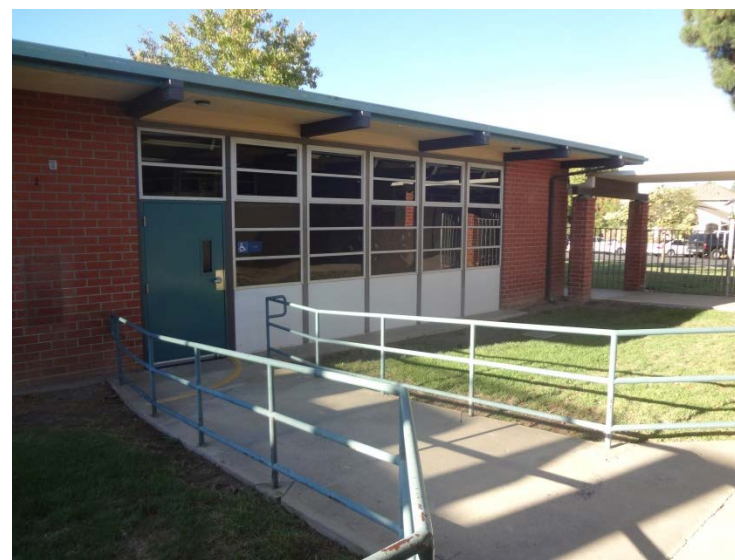
Photo -6
Building 8
Backside of learning center building with possible transite panels, and windows between primary brick structural systems and a sloping ramp between building 8 and 7

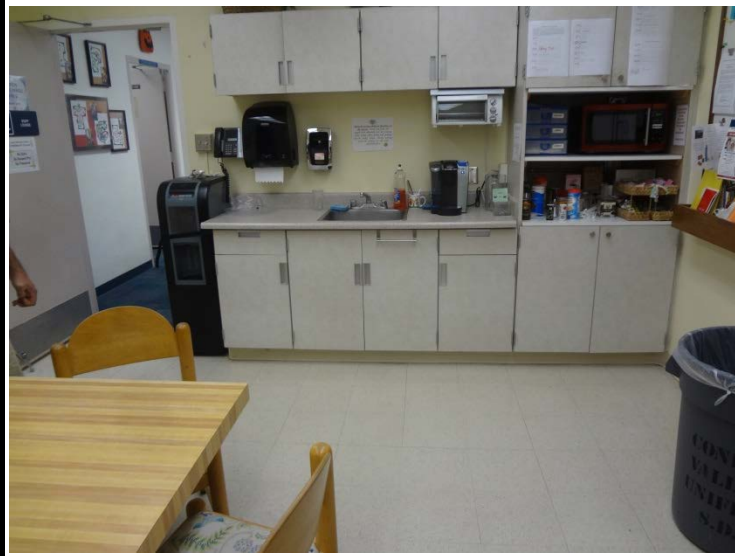
Photo -9
Building 1
 Faculty lounge and kitchen area in good condition with some minor accessibility issues

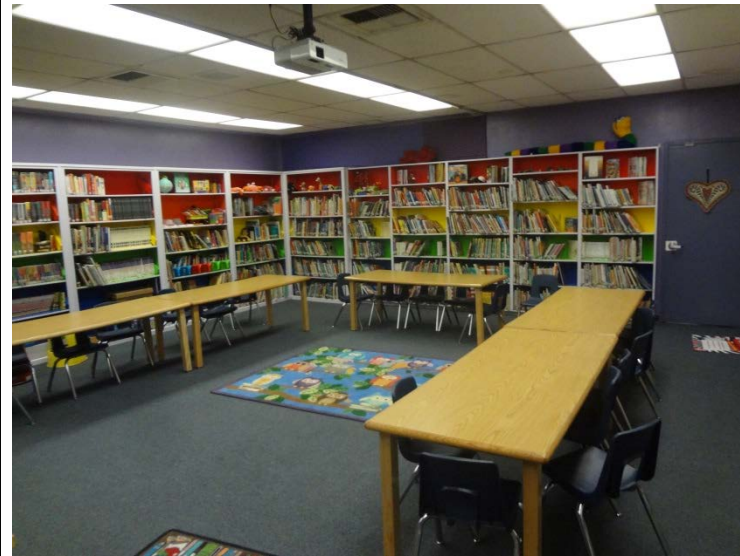
Photo -10
Building 1:
 Library for school has no windows but could have skylight or solar tube installed for daylight improvement

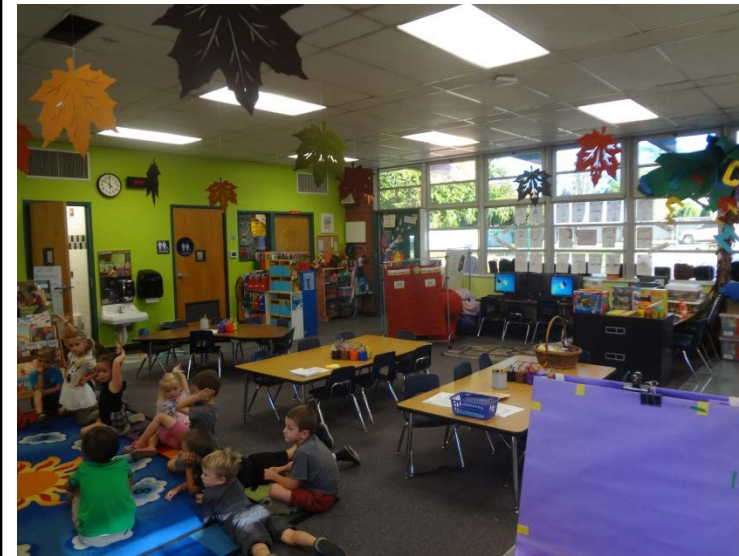
Photo -11
Building 7
 Typical kindergarten classroom in good condition fully accessible.

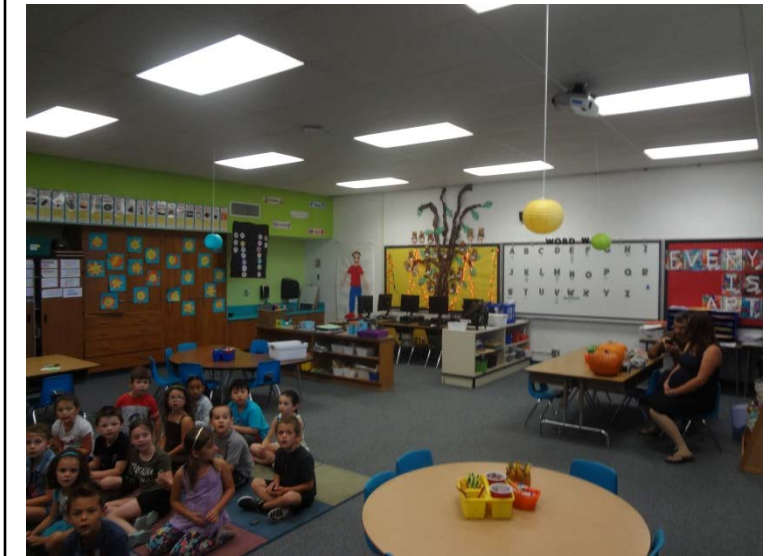
Photo -12
Building 4
 Typical classroom in good condition. Finishes are all in decent condition

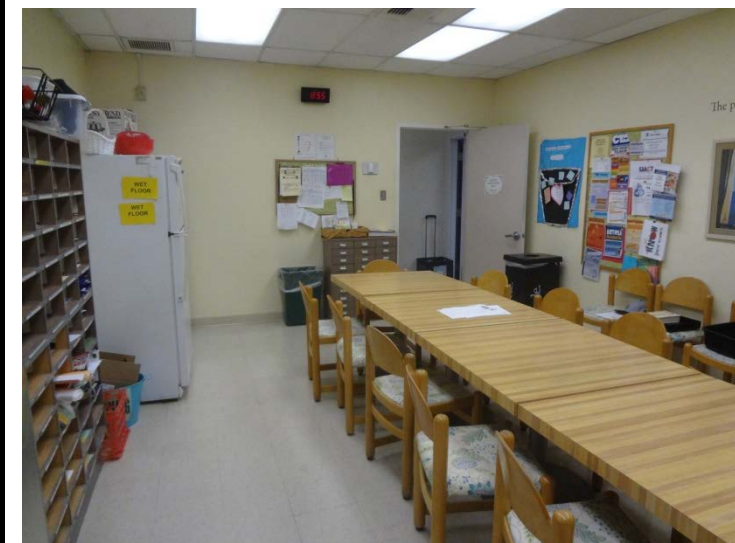
Photo -13
Building 1
 Faculty lounge and kitchen are with large table. Finishes in good condition

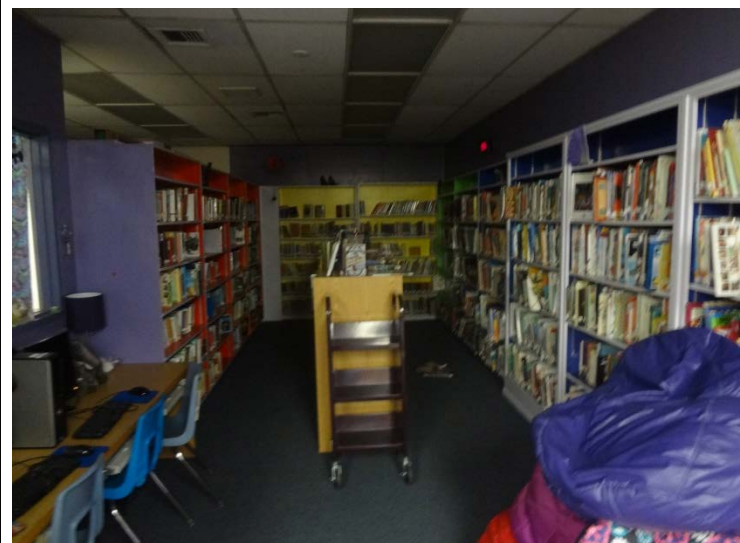
Photo -14
Building 2
 Library for school has no windows but could have skylight or solar tube installed for daylight improvement

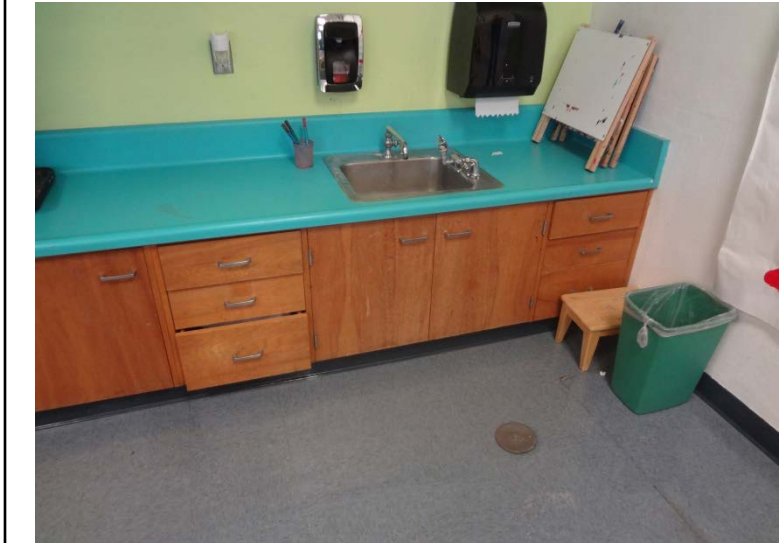
Photo -16
Building 4
 Typical classroom sink, finishes and casework in good condition. Not compliant with current accessibility codes.

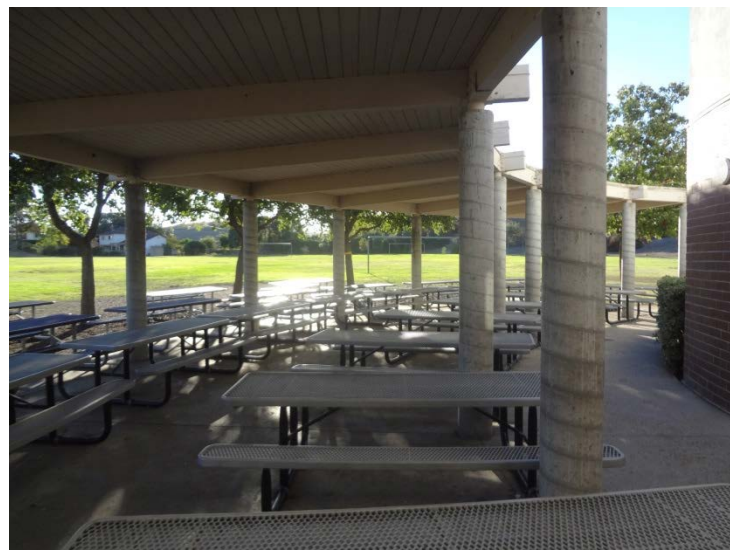
Photo -17
Building 2: Shade Structure
 Concrete columns with wood rafters. In good condition and sufficient to supply needs of campus

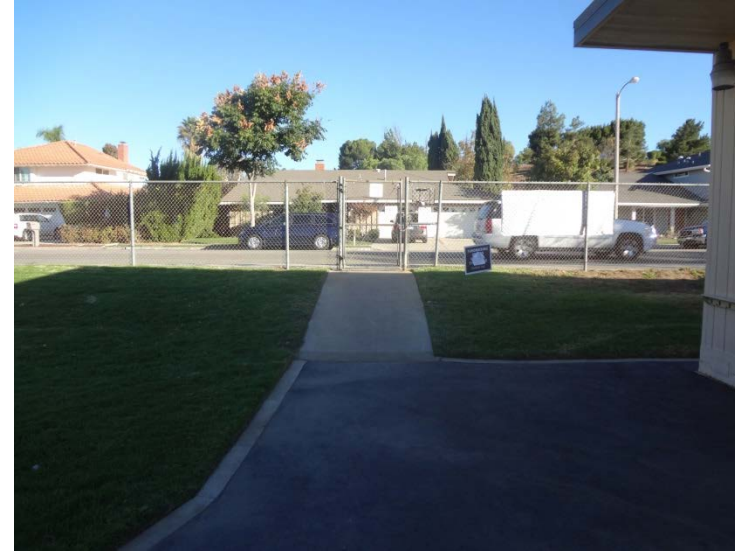
Photo -18
Building 6: Secondary Entrance
 Secondary entry location, gate is open before and after school for kids to enter campus. Currently not accessible path of entry.

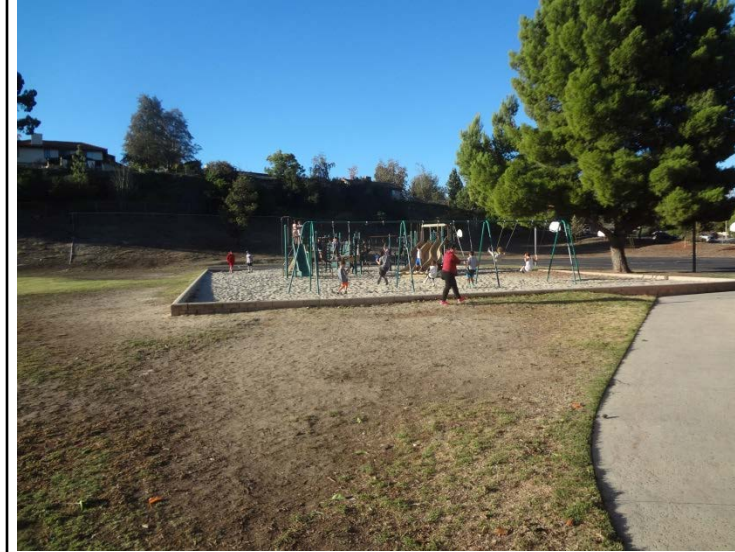
Photo -19
Playground Area
 Playground equipment is not shaded, but otherwise in decent condition. There is no accessible path to equipment.

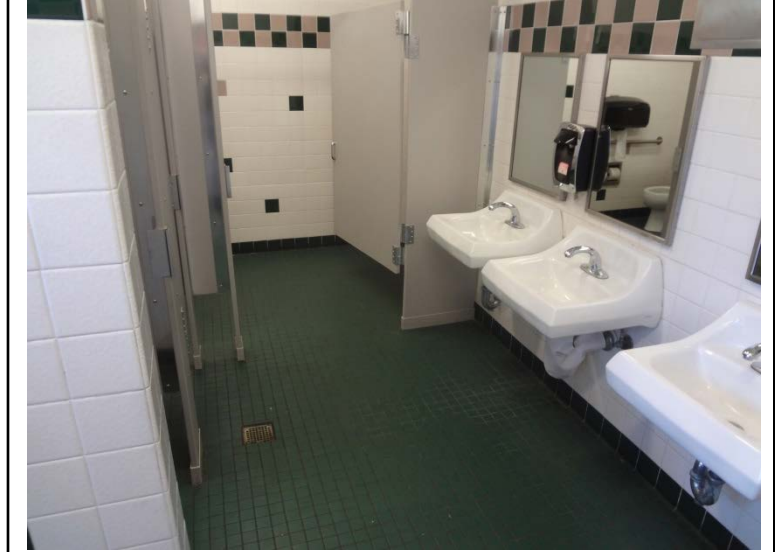
Photo -20
Building 4
 Typical public restrooms for students have received accessibility upgrades

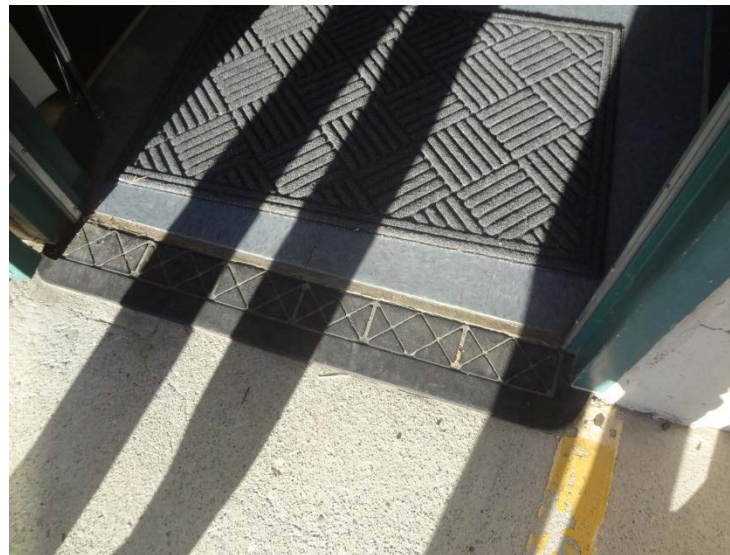
Photo -21
Building 1
 Typical threshold condition, not current with accessibility standards

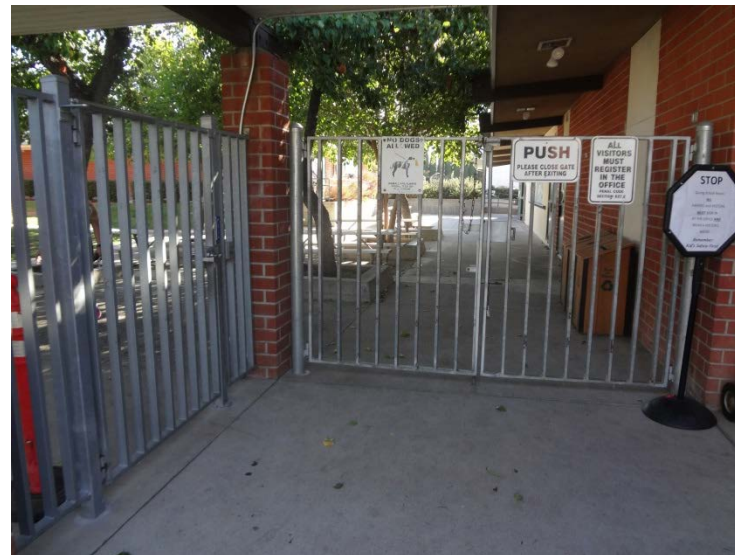
Photo -22
Building 1: Primary Entry to School
 Primary entry gate to campus is relatively new, but exiting configuration is not acceptable for current staff because of the inefficient layout for entering the campus during the day where people need to leave campus to enter office.

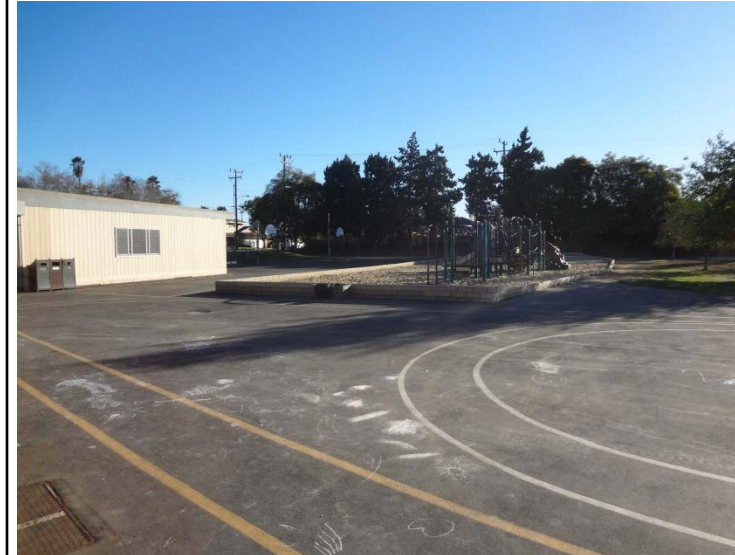
Photo -23
Playground Area
 Playground equipment is not shaded, but otherwise in decent condition. There is no accessible path to equipment.

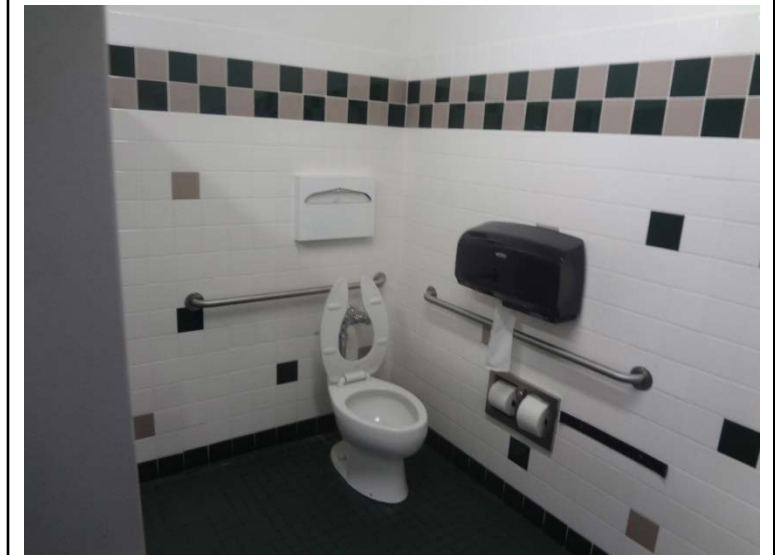
Photo -24
Building 4
 Typical public restrooms for students have received accessibility upgrades

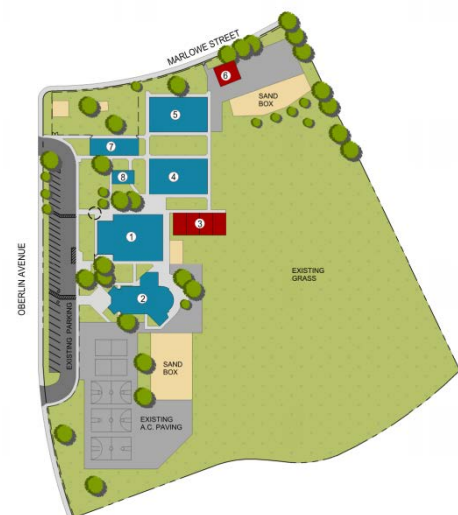
- LEGEND**
- PERMANENT
 - PORTABLE
 - SAND BOX PLAY AREA
 - X BUILDING NUMBER
 - PRIMARY POINT OF ENTRIES
