# CVUSD | *Facilities Master Plan*

## Madrona Elementary School | *Site Analysis*

Conejo Valley Unified School District

January 10th, 2017

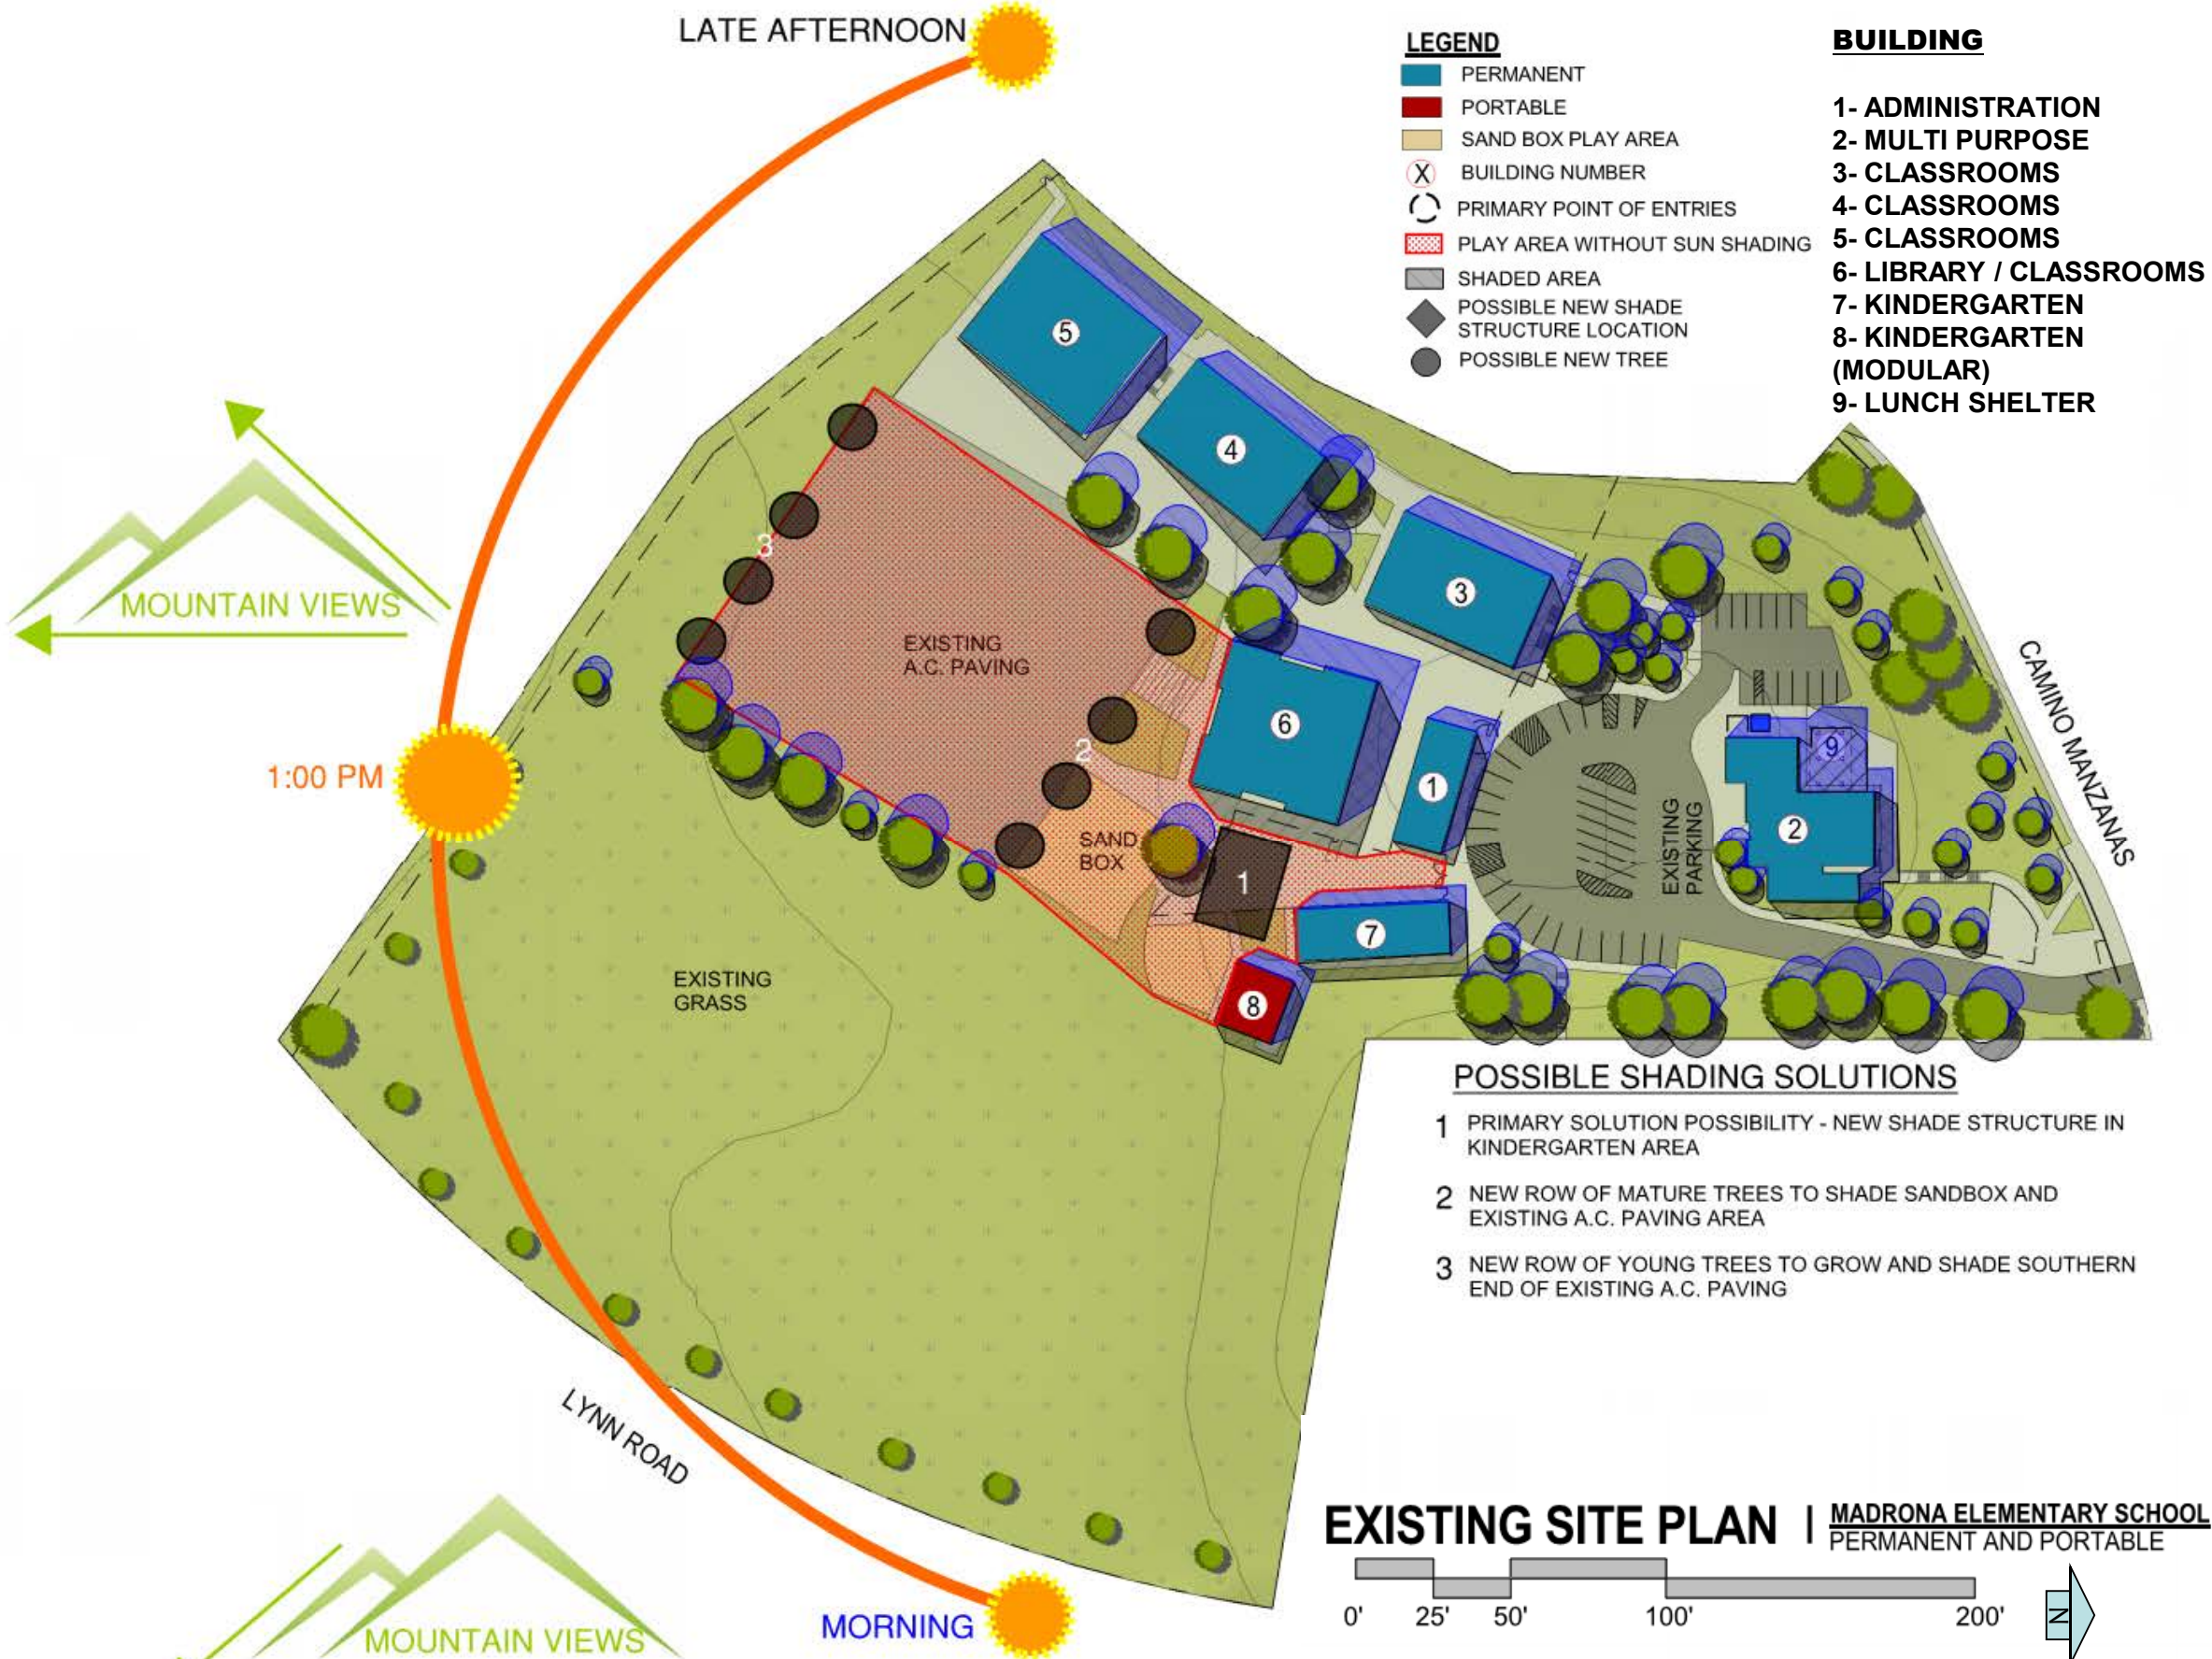
Madrona's building alignment on the site provides very little afternoon shading of the playground area. This is a major area of concern for the school and the parents. Analysis shows that there are no major shaded areas on the playground. There are three levels of priority for the solution.

Opportunity 1 is to build a shade structure in the kindergarten area which would shade the concrete and part of the sand box area.

Opportunity 2 is to plant a row of mature trees along the edge of the black top area and the main sand box. This will provide shade to the sand box area and areas of shade along the blacktop for the kids during the hottest days.

Opportunity 3 is to plant a row of younger trees along the southern portion of the blacktop that will provide shade at the bottom portion of the campus for the kids in the later afternoon as they mature.

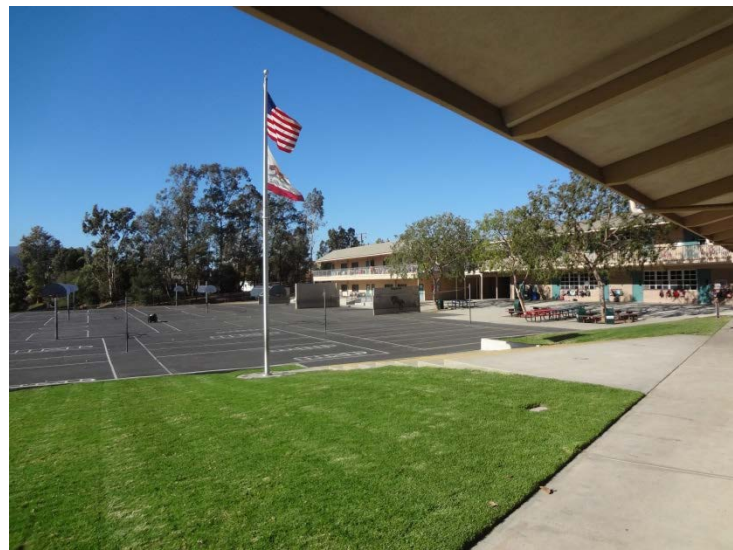
**Photo -1**  
**Curb Appeal – View of Playfield**  
Large Overhangs shade the walkways and building façades. Each building overlooks a large and expansive landscape.

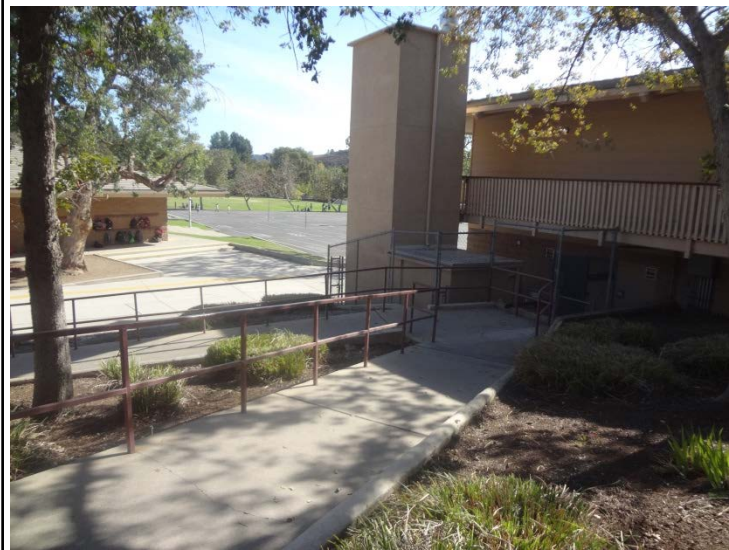
**Photo -2**  
**Curb Appeal – View of Ramp**  
Ramps on campus are well landscaped, shaded and frame different views in the distance with tree canopies.

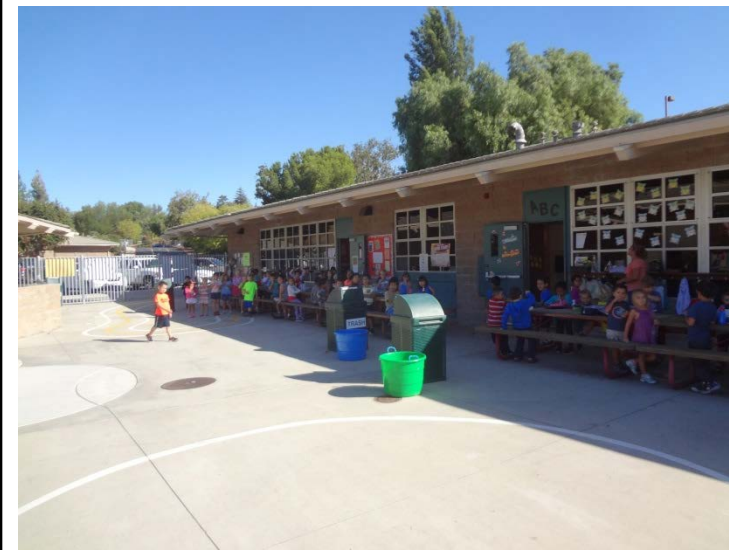
**Photo -3**  
**Curb Appeal – Kindergarten**  
Kindergarten classrooms have split face CMU finish with large overhangs that shade picnic tables for the students to enjoy the outdoor environment.

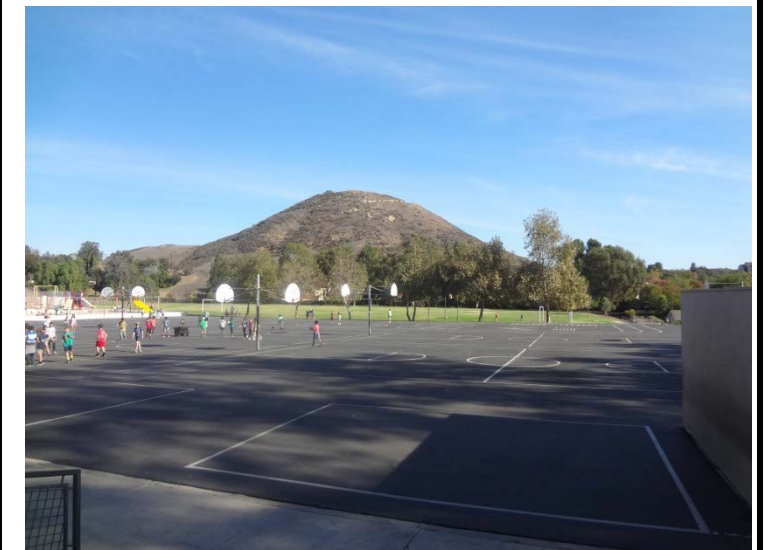
**Photo -4**  
**Curb Appeal – View of Playfield**  
Large gentle sloping site with adequate play area as well as views of mountains that surround the campus in the distance.

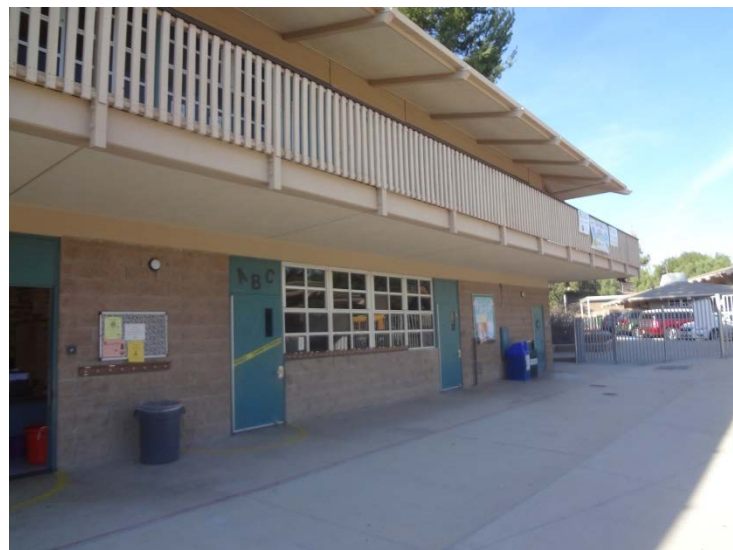
**Photo -5**  
**Curb Appeal – View of Classrooms**  
Classroom buildings have split face CMU finish and large balconies that wrap the second floor.

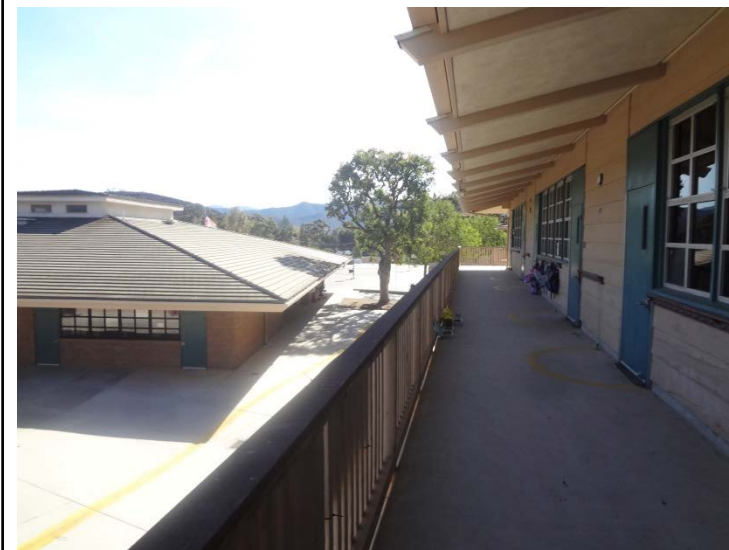
**Photo -6**  
**Curb Appeal – Second Floor View**  
Large second floor balconies provide excellent views of the surrounding mountains and environment.

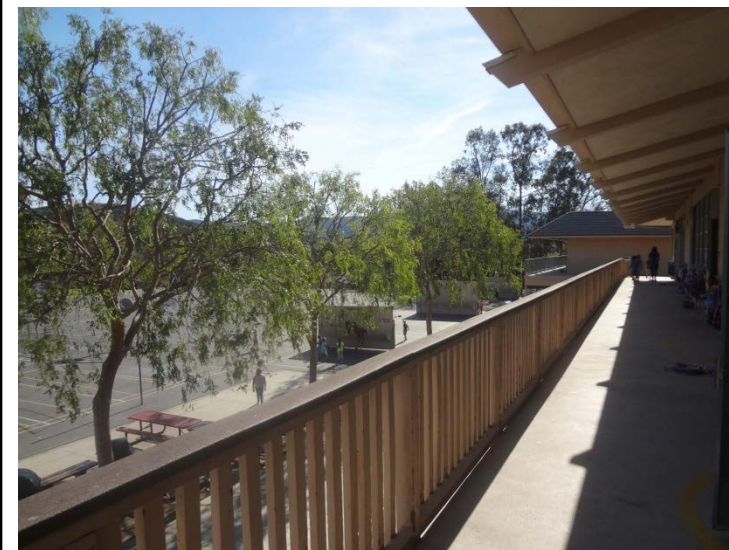
**Photo -7**  
**Curb Appeal – Second Floor View**  
Balconies overlook playground area and mountains in the distance.

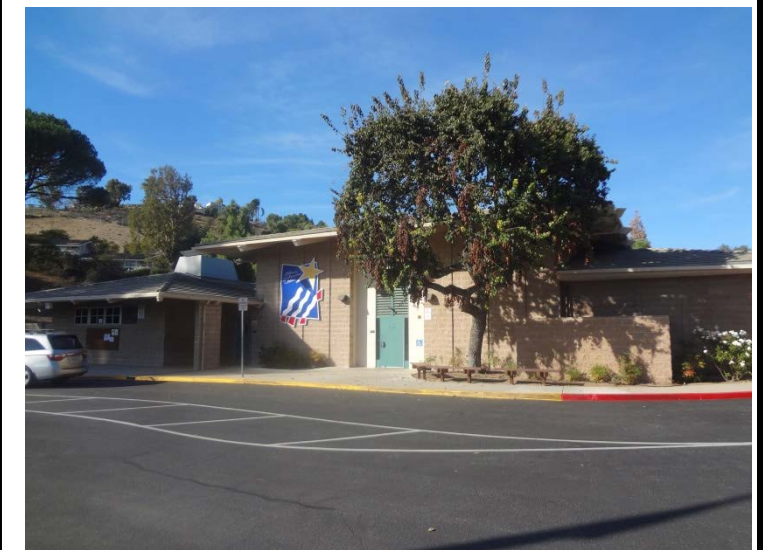
**Photo -8**  
**Curb Appeal – View of MPR**  
Large MPR has split face CMU finish with mature trees and foliage.

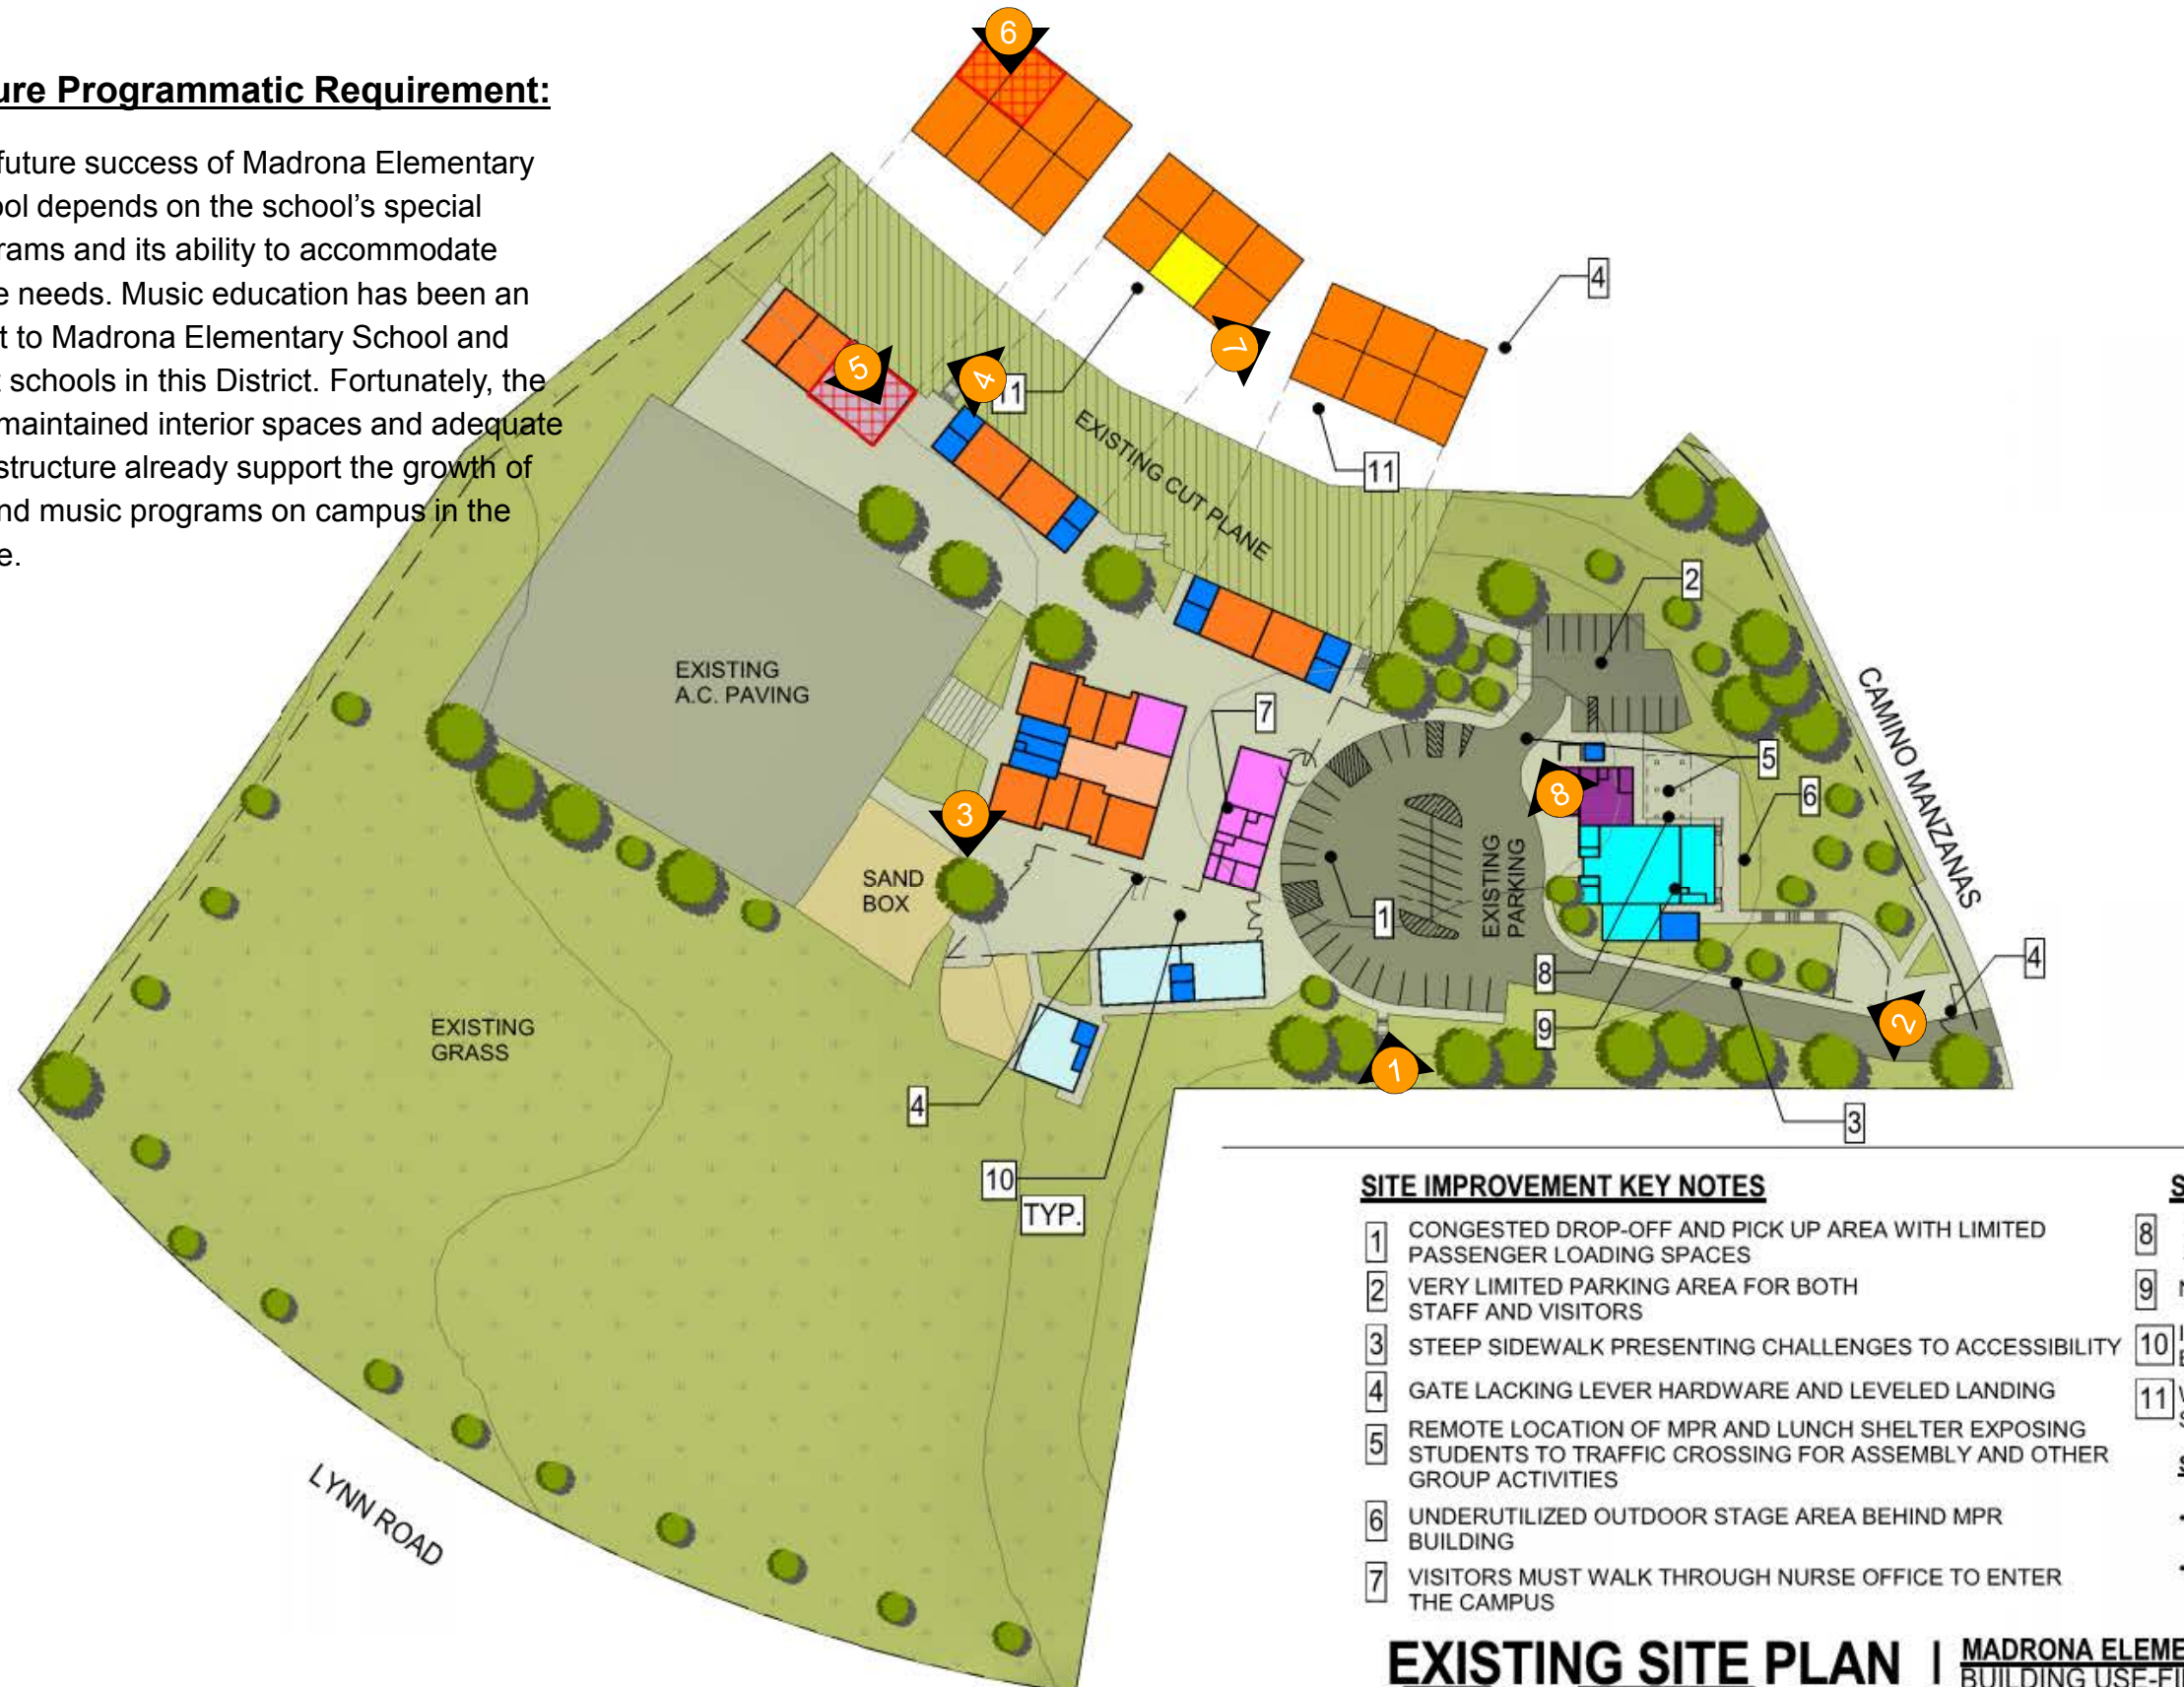
**EXISTING SITE PLAN | MADRONA ELEMENTARY SCHOOL BUILDING USE-FIRST FLOOR**

- 1 CONGESTED DROP-OFF AND PICK UP AREA WITH LIMITED PASSENGER LOADING SPACES
- 2 VERY LIMITED PARKING AREA FOR BOTH STAFF AND VISITORS
- 3 STEEP SIDEWALK PRESENTING CHALLENGES TO ACCESSIBILITY
- 4 GATE LACKING LEVER HARDWARE AND LEVELED LANDING
- 5 REMOTE LOCATION OF MPR AND LUNCH SHELTER EXPOSING STUDENTS TO TRAFFIC CROSSING FOR ASSEMBLY AND OTHER GROUP ACTIVITIES
- 6 UNDERUTILIZED OUTDOOR STAGE AREA BEHIND MPR BUILDING
- 7 VISITORS MUST WALK THROUGH NURSE OFFICE TO ENTER THE CAMPUS

- 8 DETERIORATING CHAINLINK FENCING BETWEEN LUNCH SHELTER AND PARKING AREA
- 9 NO WHEEL CHAIR LIFT FOR MPR PLATFORM
- 10 INSUFFICIENT SHADING AT PLAYGROUND AREA ESPECIALLY OUTSIDE THE KINDERGARTEN
- 11 WOOD HANDRAIL ON SECOND FLOOR BALCONIES SHOW SIGNS OF WATER DAMAGE

- INSUFFICIENT OUTDOOR LIGHTING NEAR ENTRANCE AND PARKING LOT AREA
- SOME CLASSROOMS LACK WINDOW SHADING TREATMENT

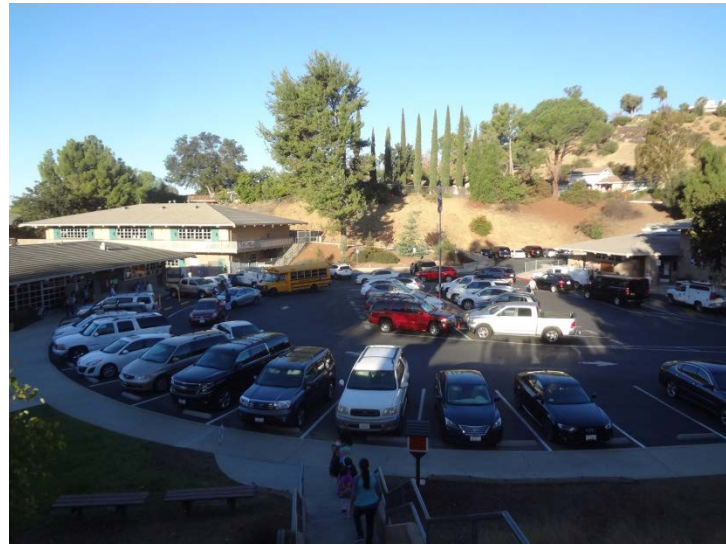
**Photo -1**  
**Parking Lot and Drop Off**  
 Current drop off configuration is very congested. Parking layout may be optimized.

Madrona Elementary School’s current parking and drop off layout is inefficient. The layout causes large amounts of traffic during drop off and pick up. In addition, the parking capacity is insufficient to the needs of the campus.

A new parking layout may be designed that would expand the size of the current parking area allowing for a more efficient drop off and pick up, as well as increasing the parking capacity.

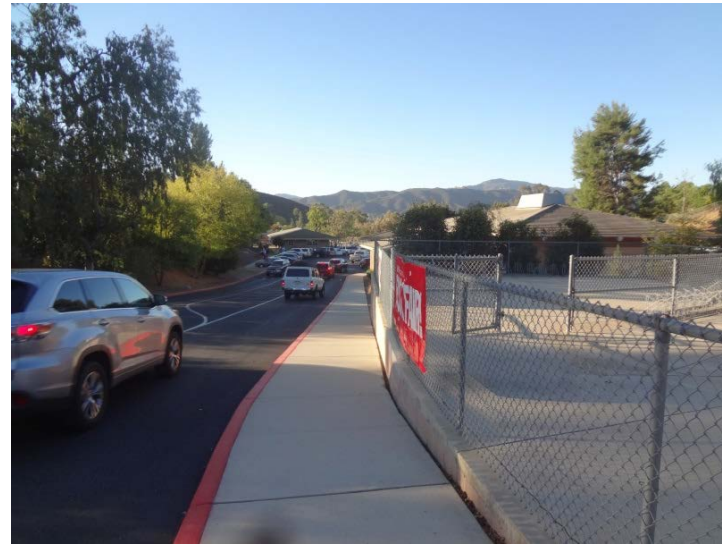
**Photo -2**  
**School Parking Entry**  
 Long Steep sidewalk to school entrance poses a challenge to people in wheelchairs.

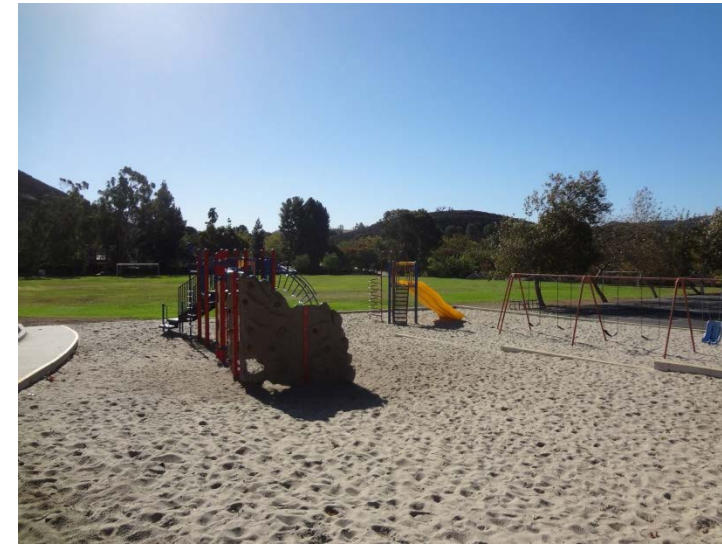
**Photo -3**  
**Insufficient Playground Shading**  
 Current bicycle parking at top of Playground areas do not have sufficient shading and protection for students

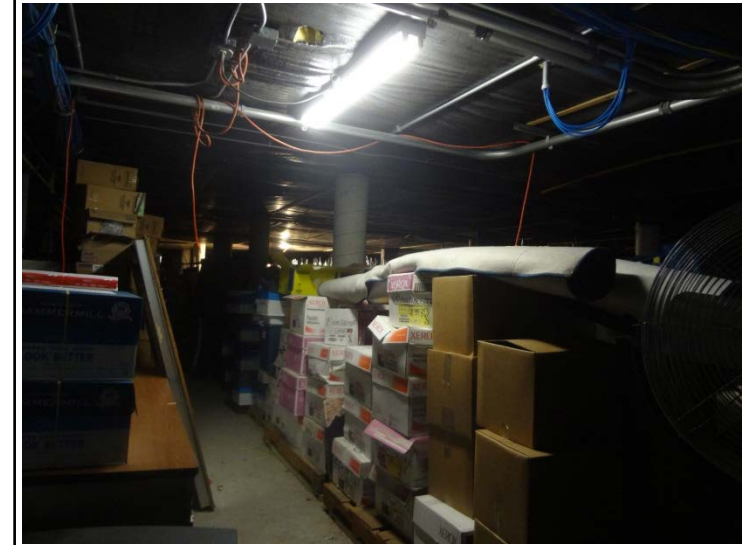
**Photo -4**  
**Storage Under Building**  
 The storage area underneath the southern most building is large and may require fire life and safety related upgrades.

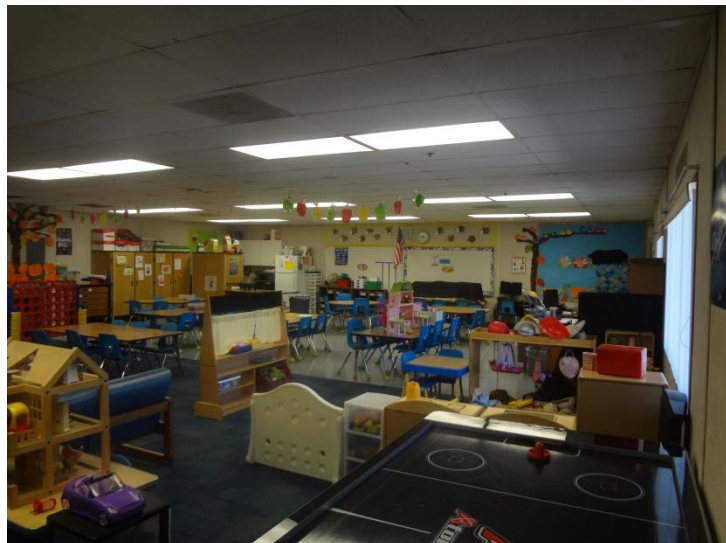
**Photo -5**  
**Under Utilized Classroom**  
 Daycare center is large, but location is too remote and not ideal.

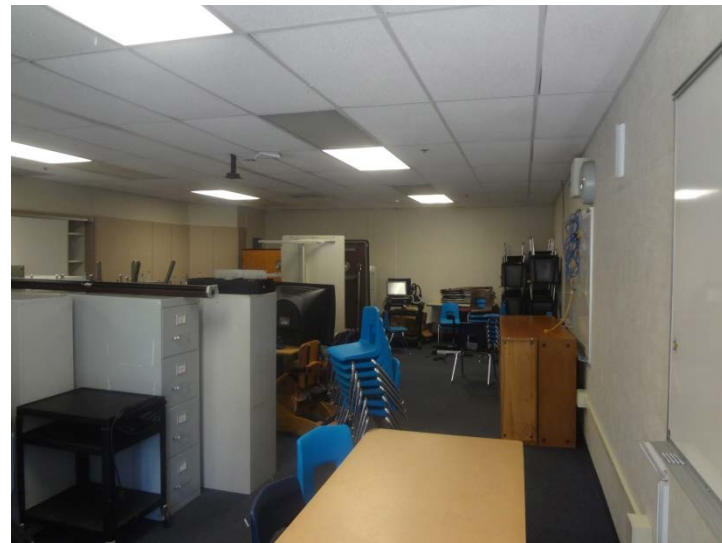
**Photo -6**  
**Under Utilized Classroom**  
 Empty Classroom Used for Storage

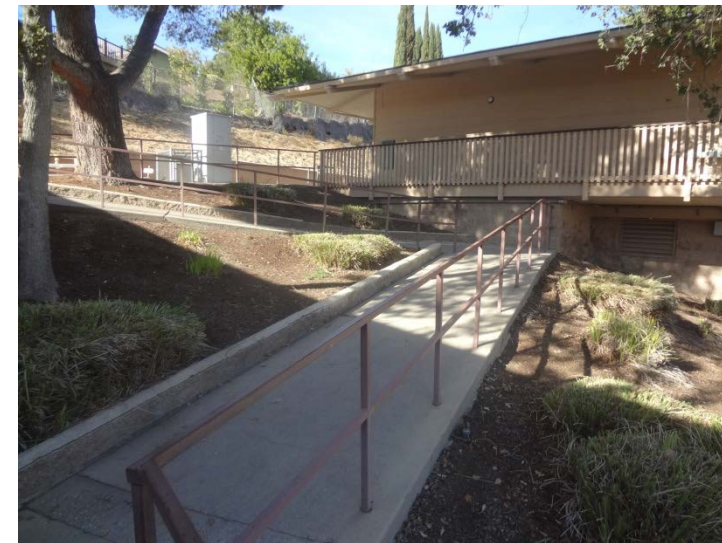
**Photo -7**  
**Ramp to Second Floor**  
 Ramps on campus are not current with accessibility standards which is an issue for fire egress as well

In conjunction, the current non compliant ramp that is in the parking lot would need to be removed and redesigned to met current accessibility standards. The ramp could serve a dual function of providing a secondary entry point to the school if extended along the current ground elevation of the second floor to the street.

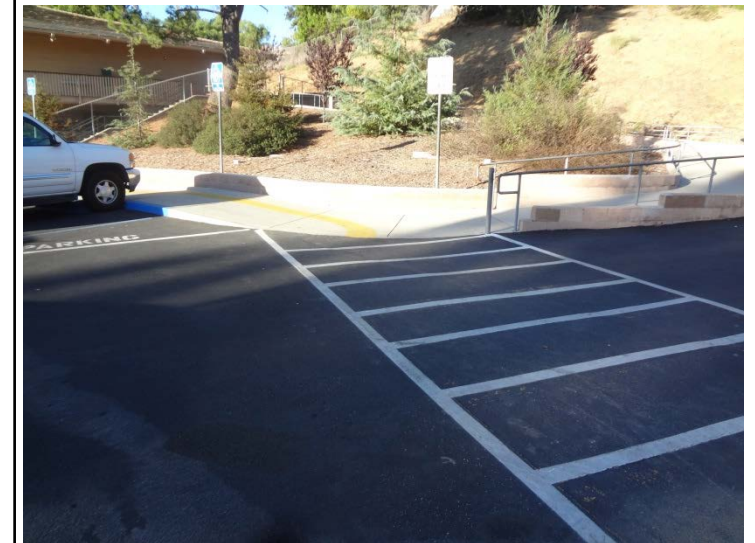
**Photo -8**  
**Access to MPR**  
 Currently the only access to the MPR requires the students to exit the main campus and walk across the parking lot

The new ramp can also be easily configured to provide a safe pedestrian access to the MPR building.

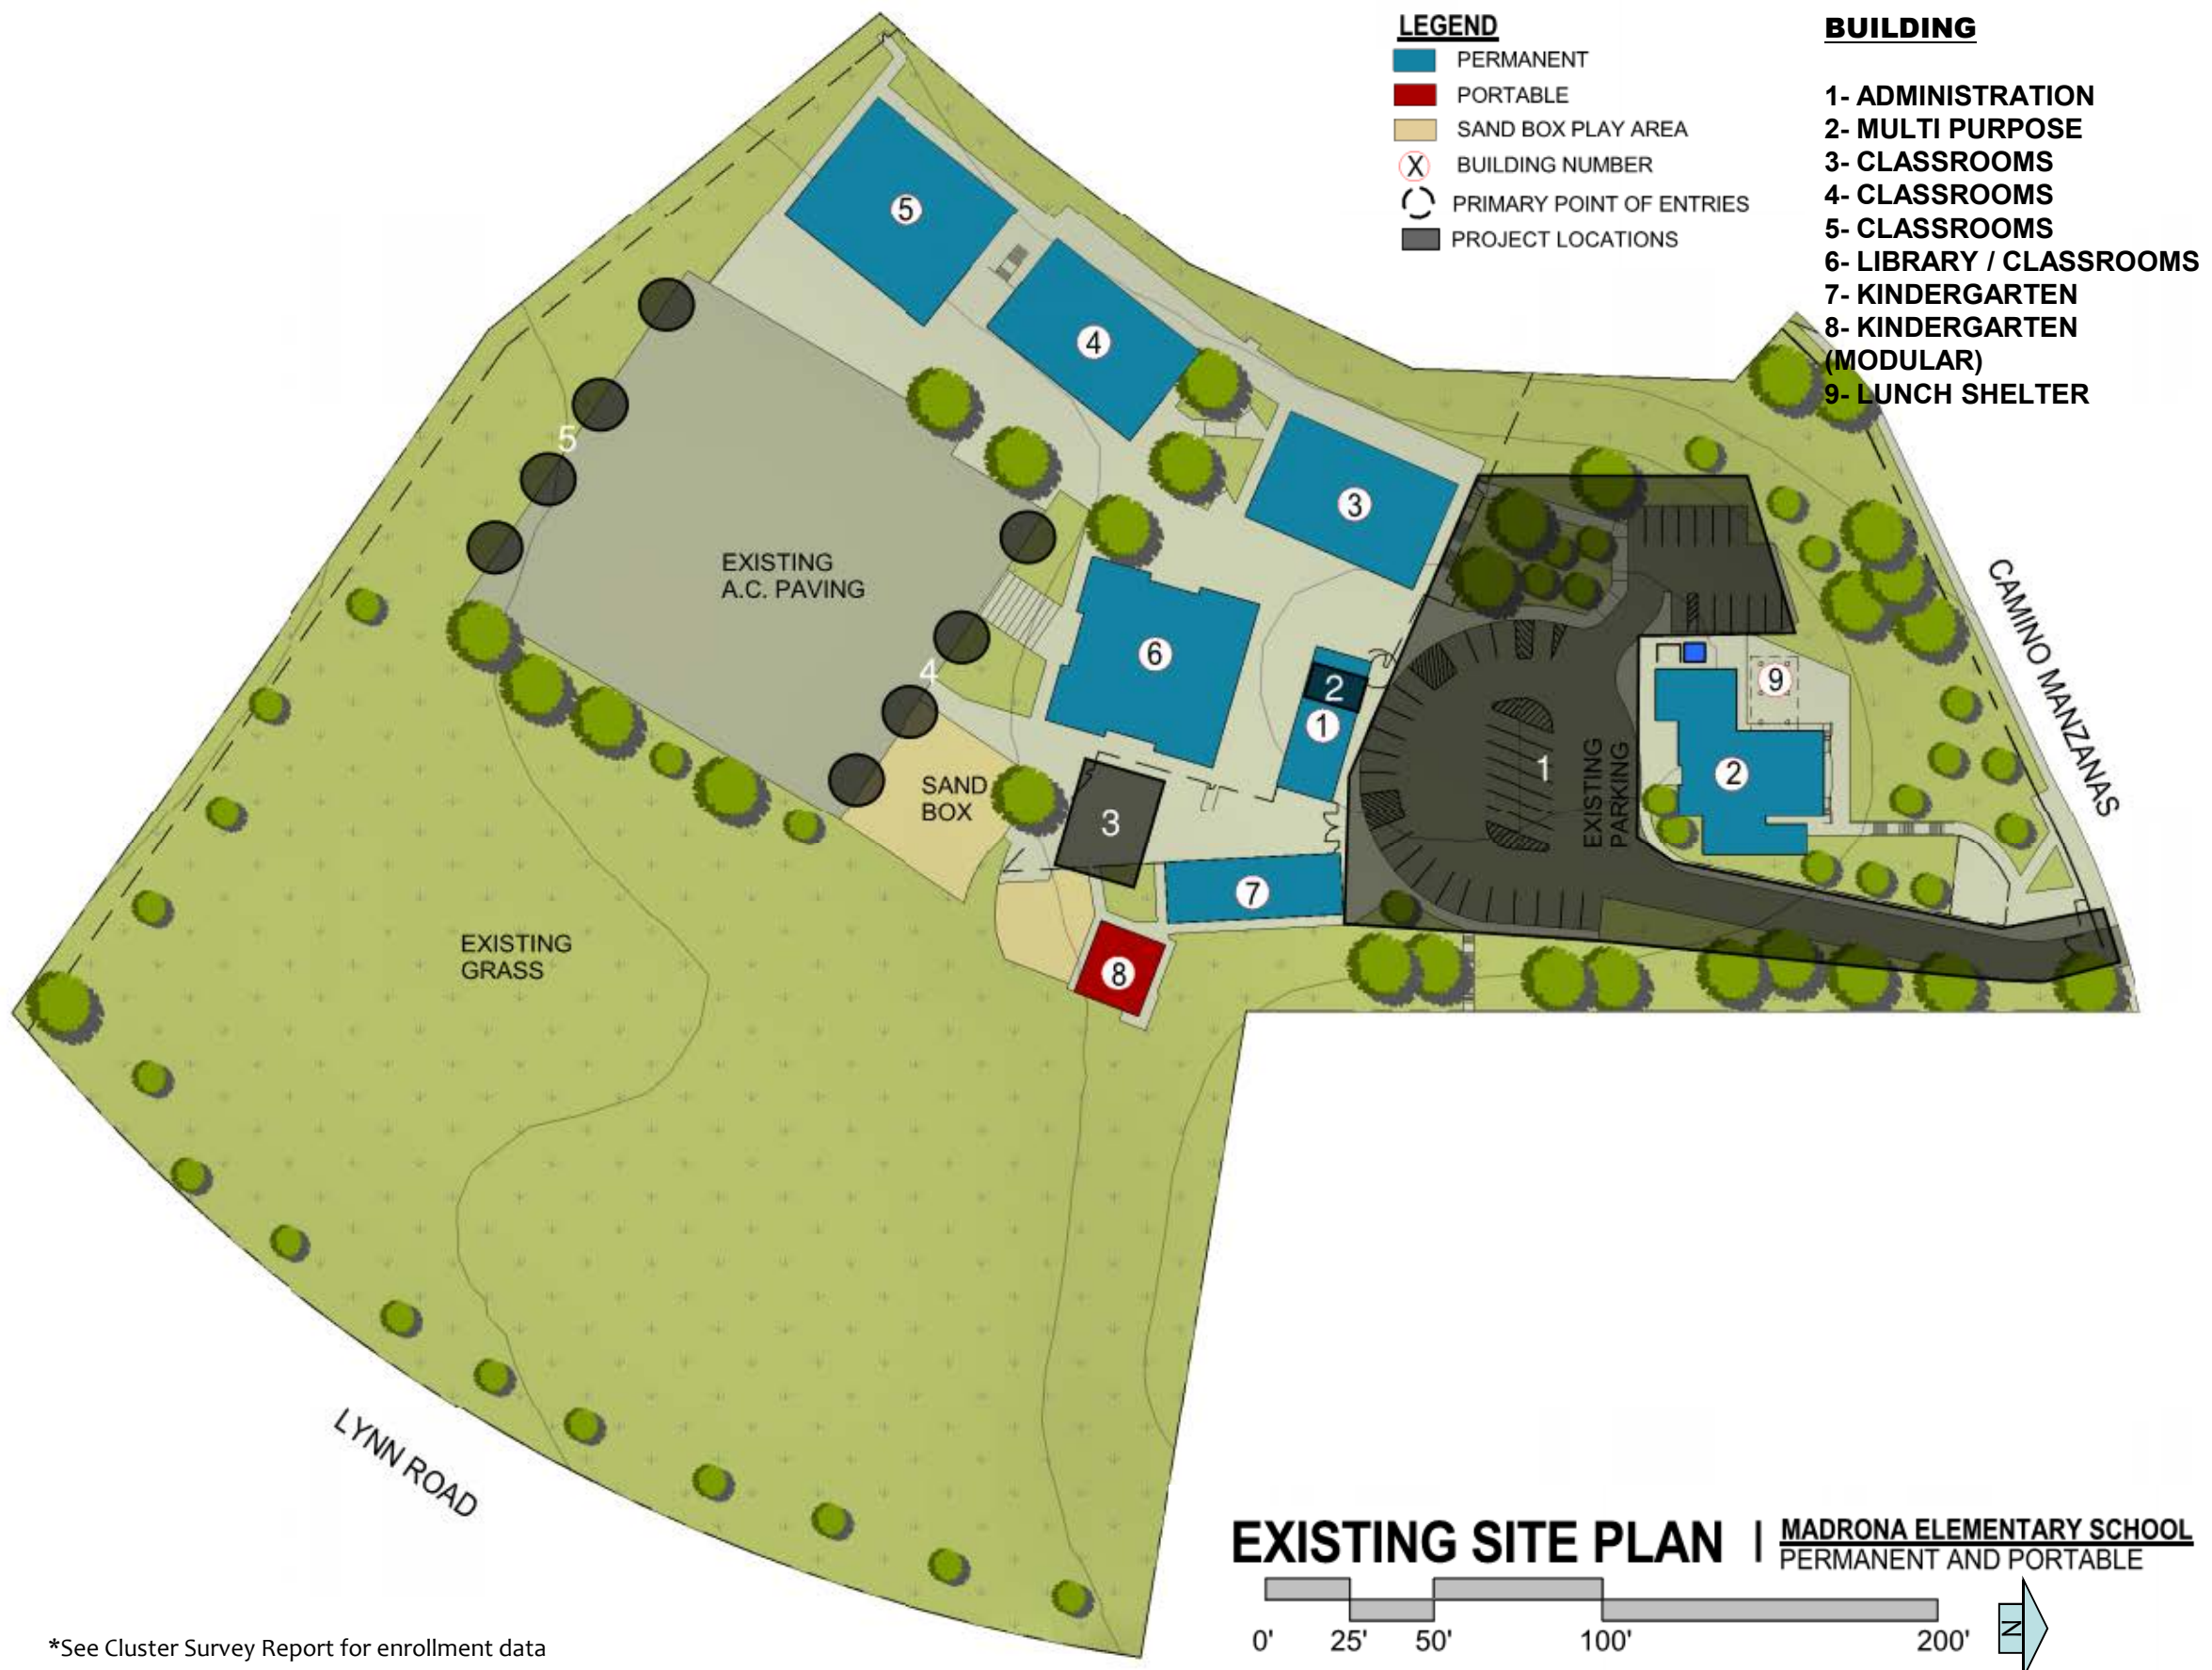
Additionally the current configuration of the administration building requires visitors to the campus to go through the nurses office to enter the campus. This entry may be reconfigured to allow a new path to enter campus that does not go through any other spaces.
