CVUSD – THOUSAND OAKS CLUSTER SURVEY

University Center | *Survey*

2801 Atlas Ave | Thousand Oaks, CA 91360

December 9th, 2016 – DRAFT v1

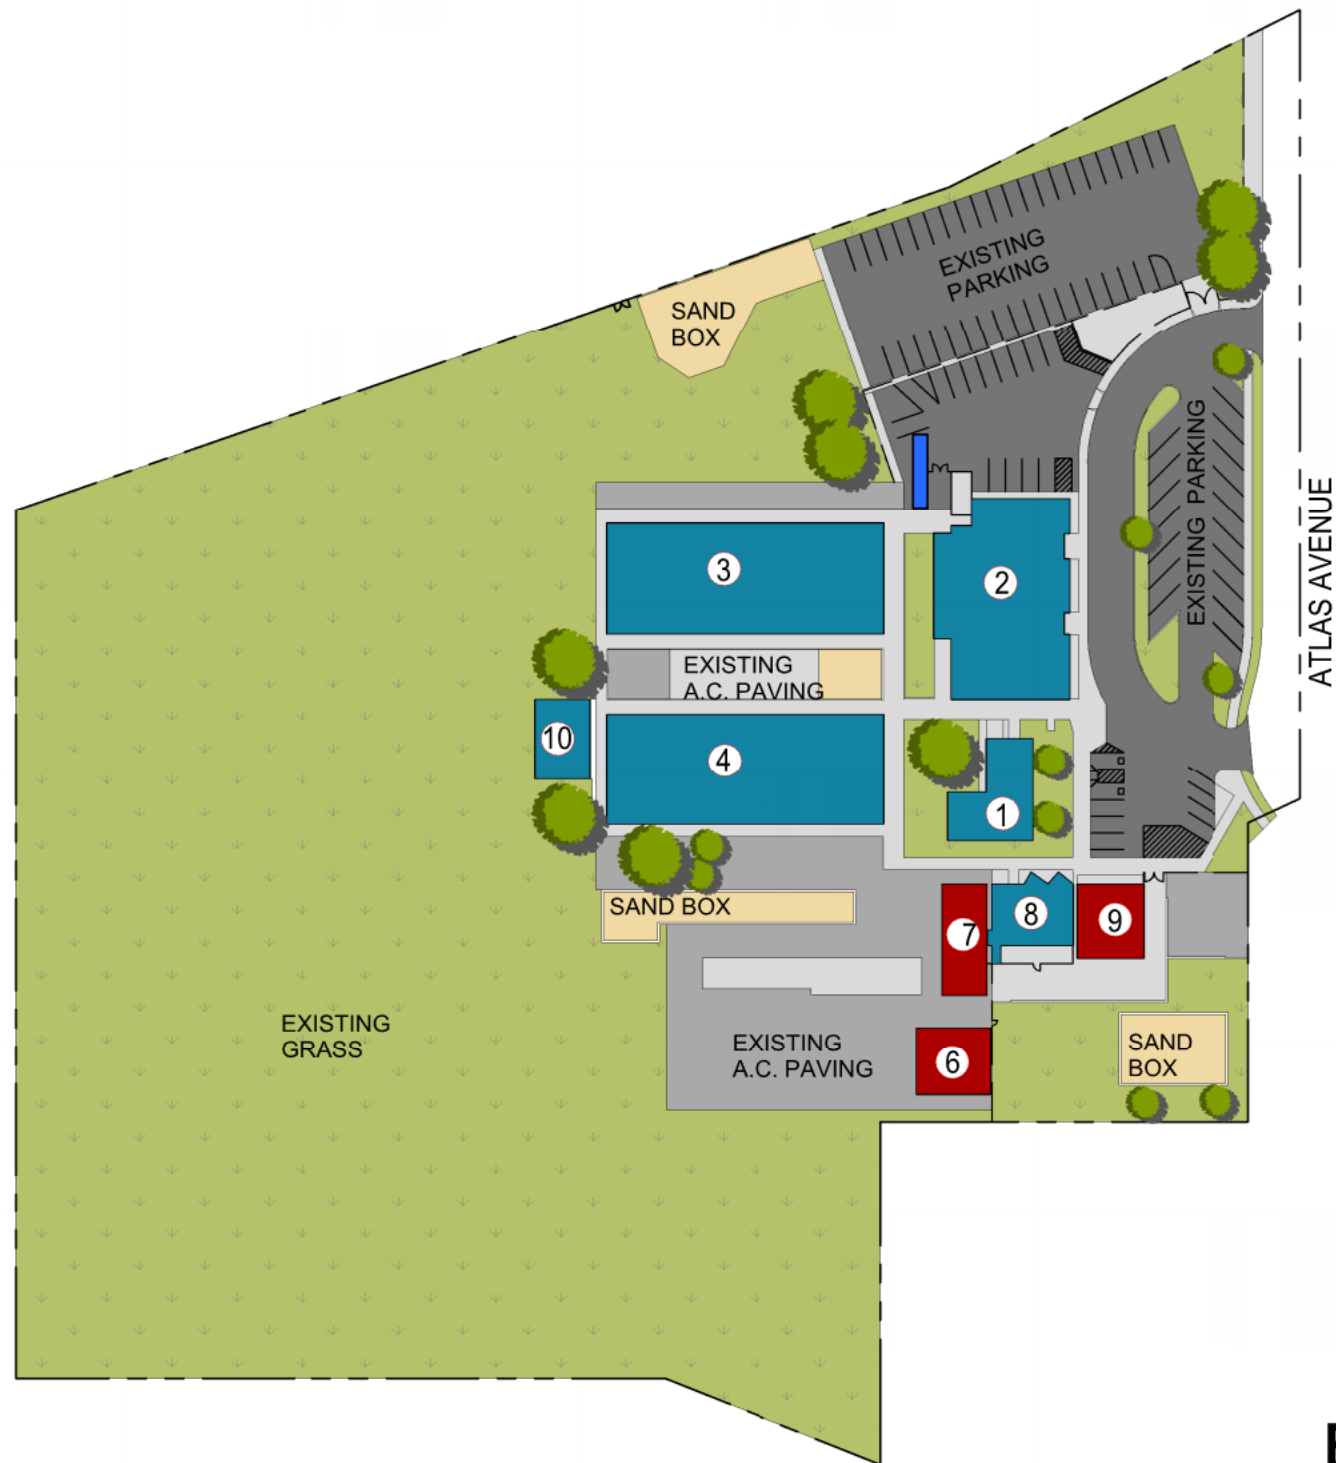
EXISTING SITE PLAN | UNIVERSITY ELEMENTARY SCHOOL
BUILDING USE-FIRST FLOOR

- 1 NEED PERMANENT STAGE
- 2 RAFTERS / FASCIA IN POOR CONDITION, NEED REMOVAL / REPLACEMENT
- 3 CONVERTED PARKING AREA NEEDS ACCESSIBILITY UPGRADES.
- 4 DRAINAGE ISSUE WITH THE TREE ROOTS
- 5 DESIRED SHADE STRUCTURE LOCATION
- 6 PORTABLES ARE IN NEED OF REPLACEMENT

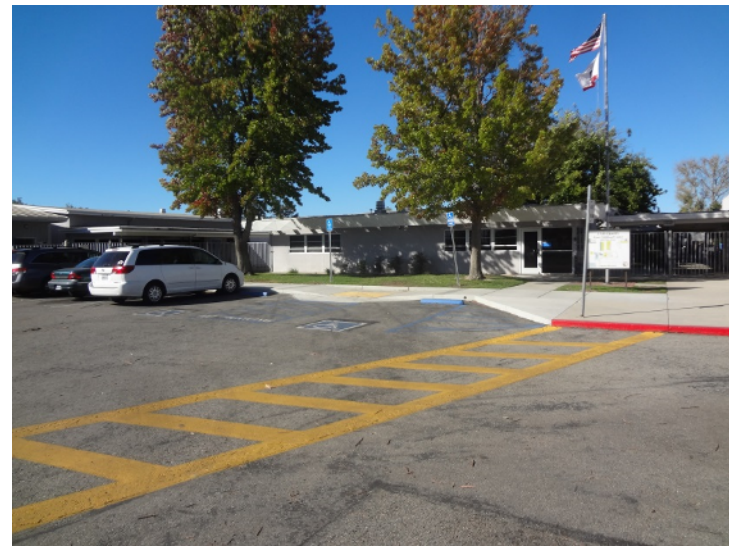
Photo -1
Building 1
Administration building and primary entry location to school.

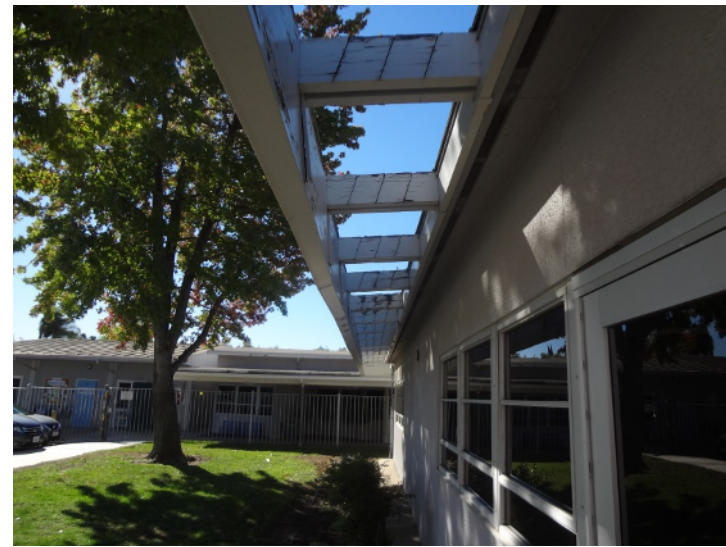
Photo -2
Building 1
Administration building looking toward the kindergarten classrooms. The original overhang over the administration building is deteriorating and should be removed.

The Administration building was constructed in 1963, it has received building system upgrades in 2003, however the roof is over 30 years old and in need of replacement. The building has some issues with the wood beams and fascia that cantilever off the building. They are in need of repairs / replacement.

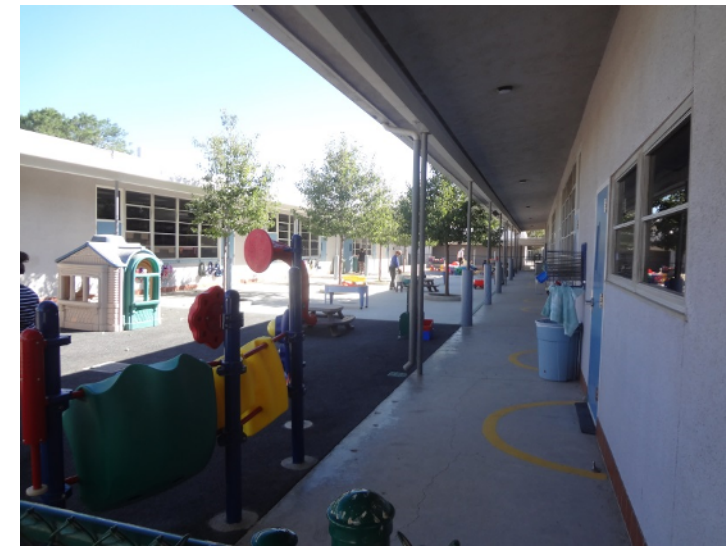
Photo -3
Building 3
Courtyard between permanent classroom buildings has been repurposed to be preschool play area with play equipment and sand area.

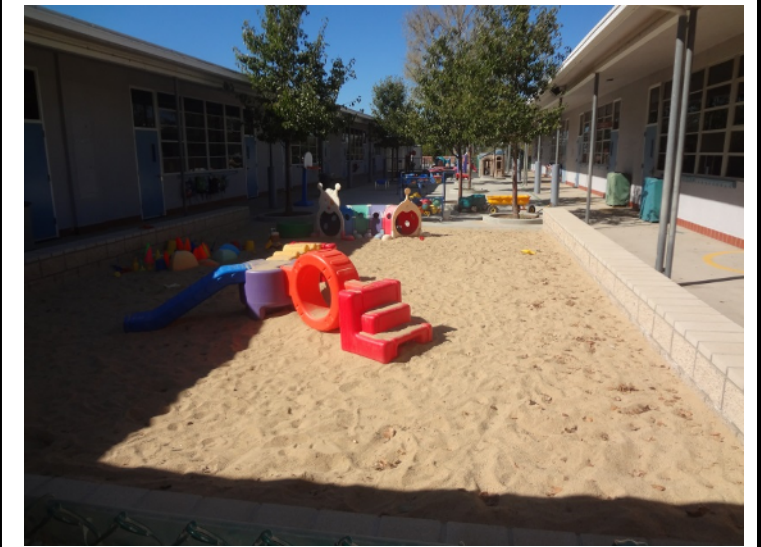
Photo -4
Building 4
Courtyard between permanent classroom buildings has been repurposed to be preschool play area with play equipment and sand area.

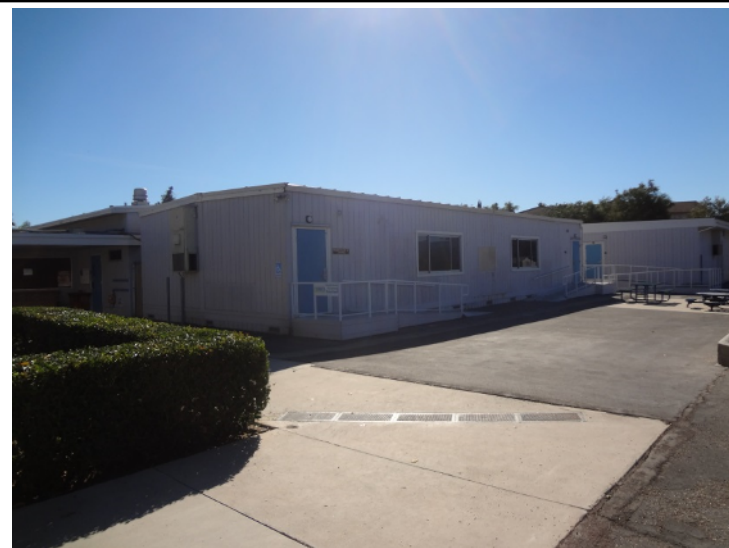
Photo -5
Building 7
Typical portable building on campus.

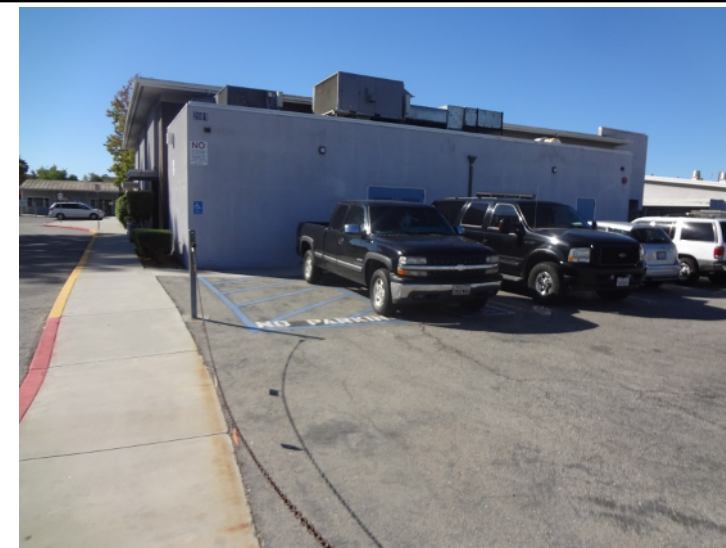
Photo -6
Building 2
Multi purpose building.

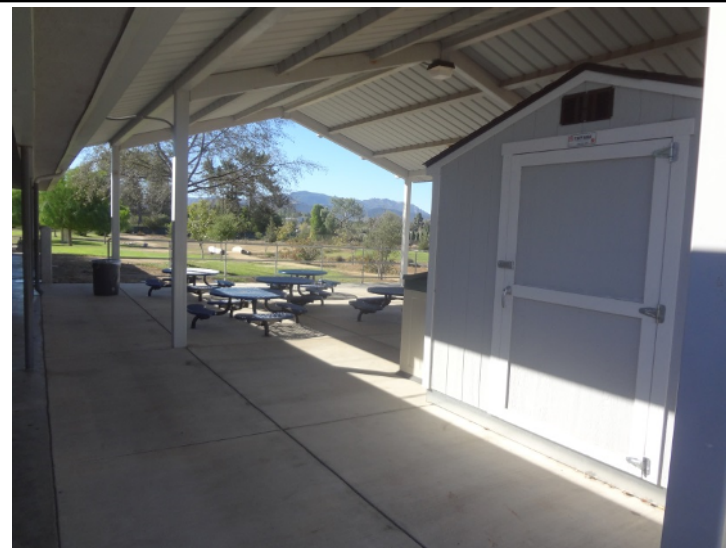
Photo -7
Building 10
Shade structure used for lunch as well as some storage.

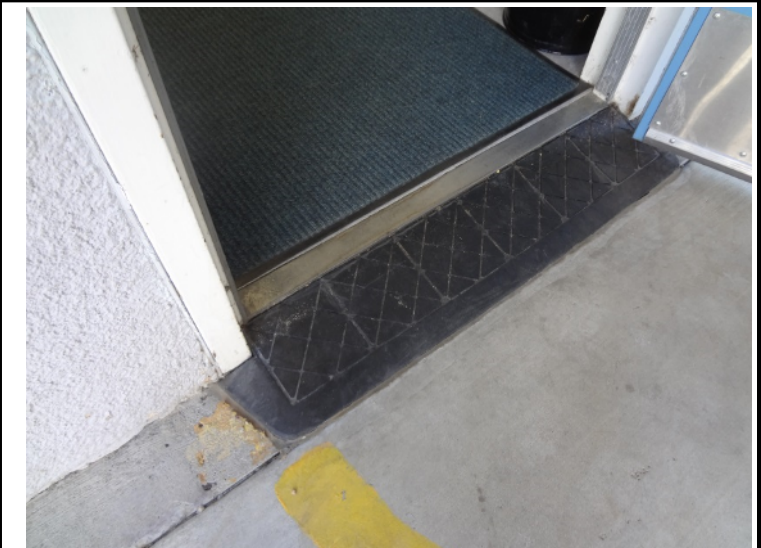
Photo -8
Building 1
Typical threshold condition on campus, not current with accessibility standards.

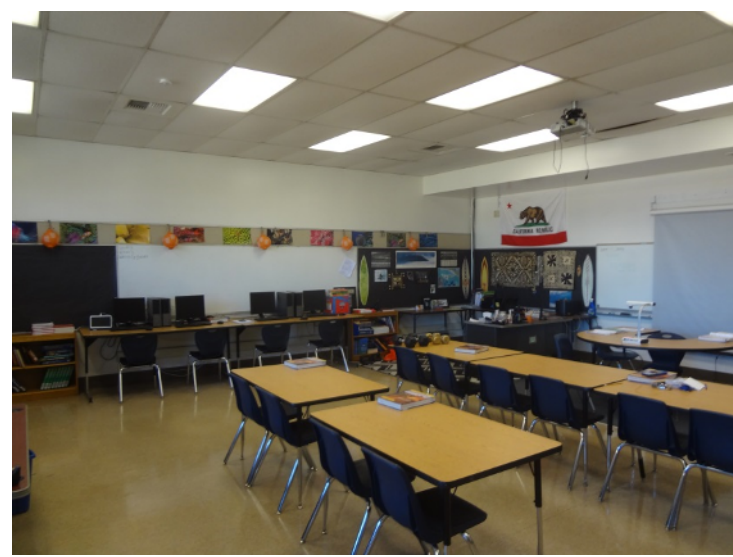
Photo -9
Building 3
 Typical classroom in permanent building. Finishes are older but sufficient to the needs of the campus.

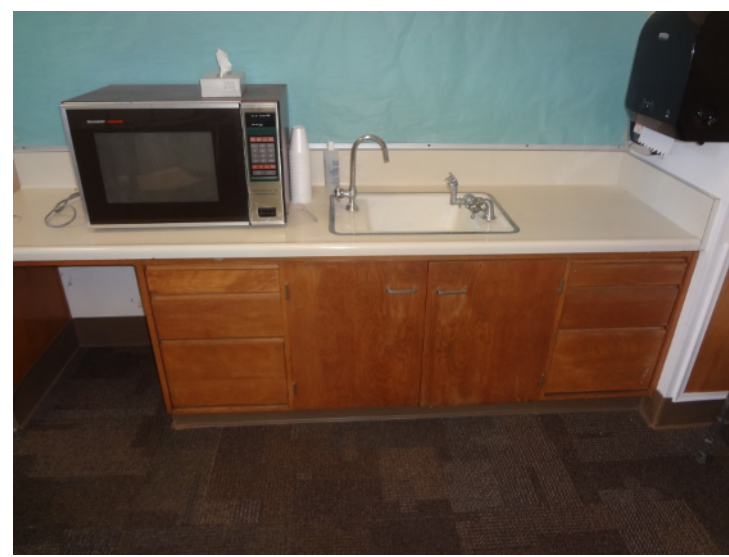
Photo -10
Building 3
 Typical sink in permanent classroom building. Not current with accessibility standards.

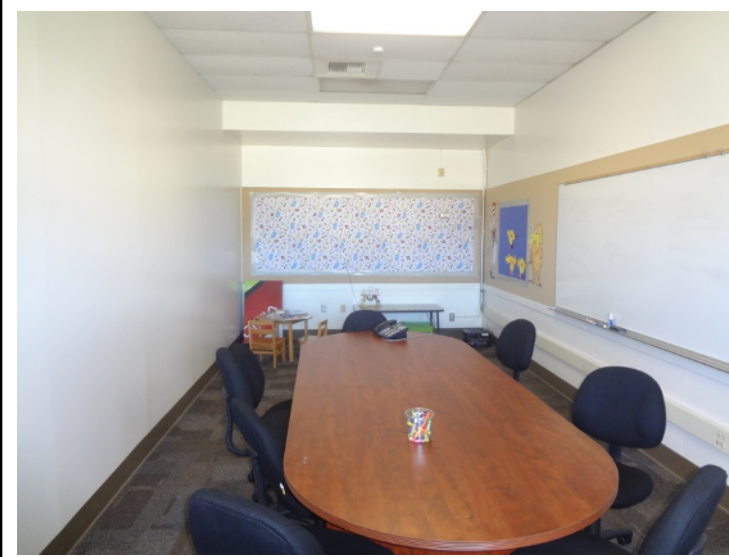
Photo -11
Building 3
 Some of the classrooms in the permanent building have been subdivided and turned into administration spaces including a meeting room.

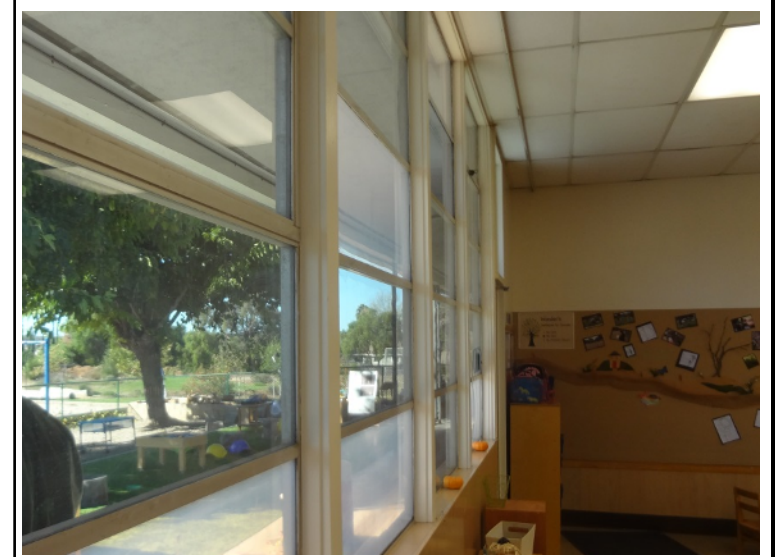
Photo -12
Building 4
 Windows in typical permanent buildings are single pane and have been replaced over the years with mismatched colors of glass

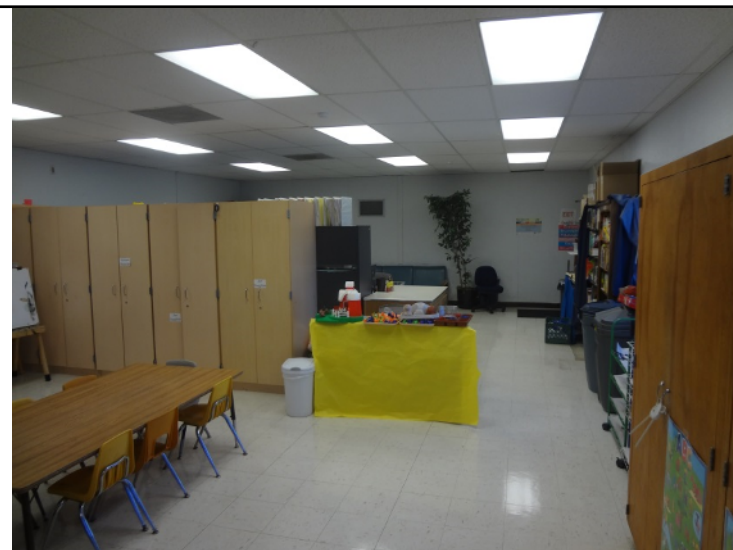
Photo -13
Building 7
 Portable building interior, finishes are sufficient to the needs of the campus.

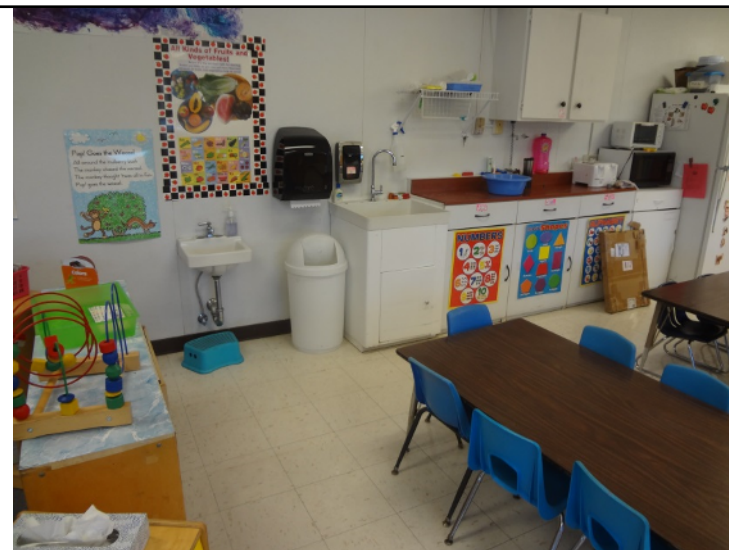
Photo -14
Building 7
 Portable building interior, finishes are sufficient to the needs of the campus. Some buildings have accessible sinks.

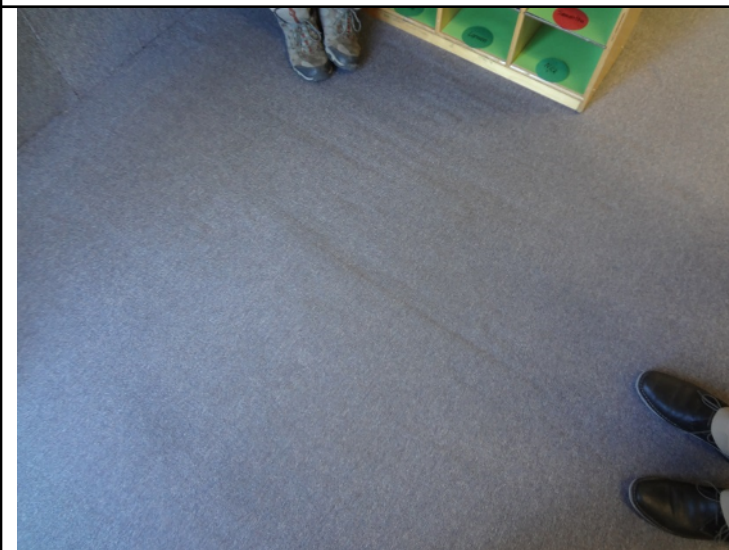
Photo -15
Building 7
 Carpet in portable classroom buildings is old and needs replacement in some location.

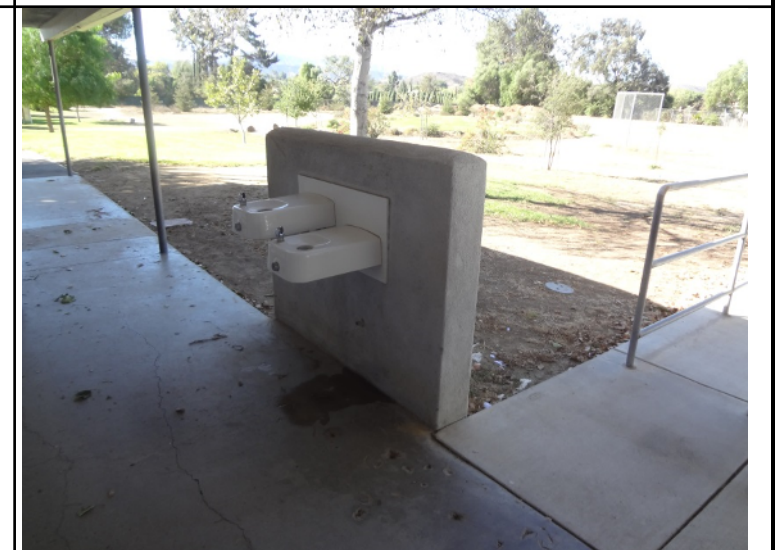
Photo -16
Building 4
 Drinking fountains will need some accessibility upgrades.

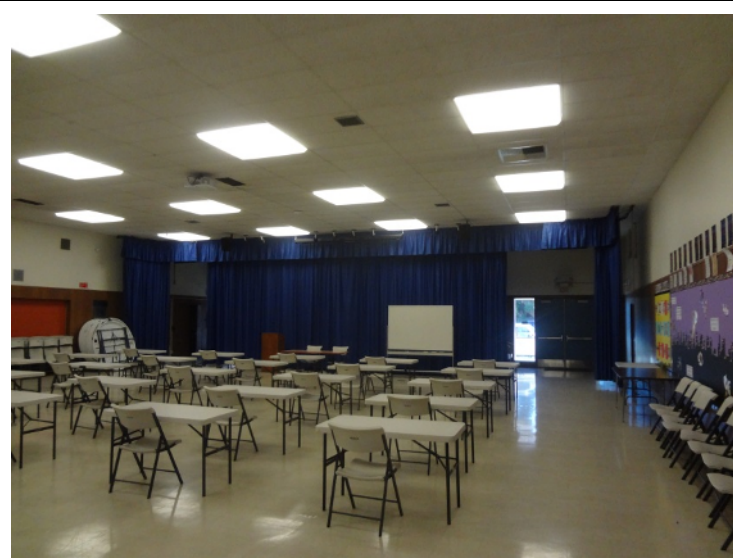
Photo -17
Building 2
 Multi- purpose building is large and spacious, the flooring has some issues but is sufficient to the needs of the campus.

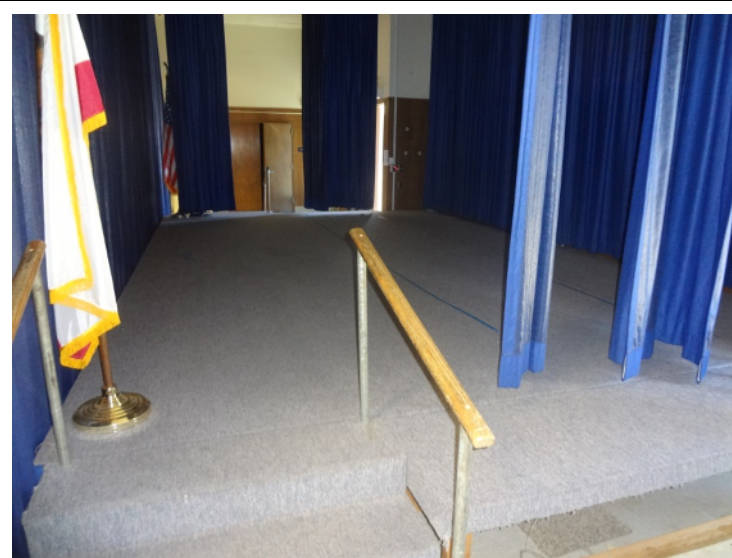
Photo -18
Building 2
 Currently there is no permanent stage in the multi purpose building. A new stage should be installed.

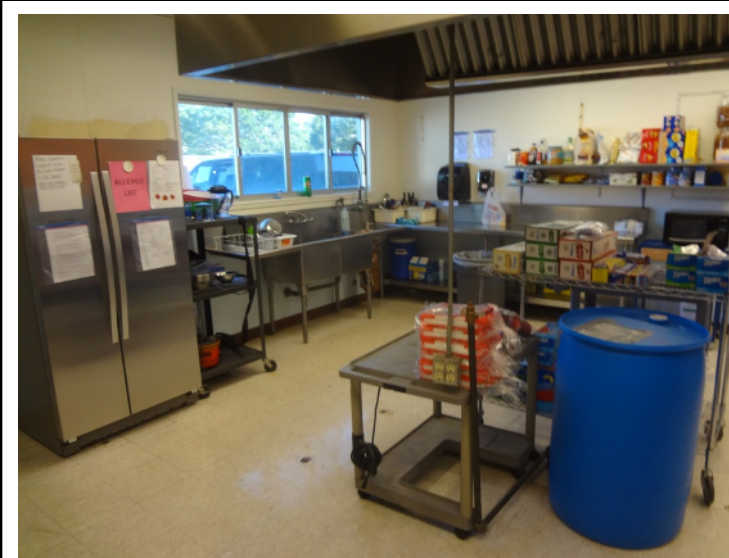
Photo -19
Building 2
 Campus has a warming kitchen which is sufficient to the needs of the campus.

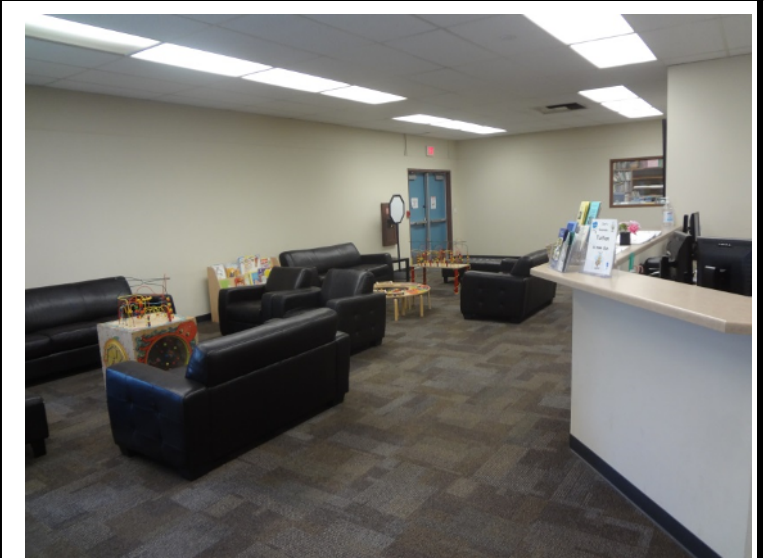
Photo -20
Building 2
 A portion of the multi purpose building is used for administration space. This space has been recently updated and has new finishes and equipment.

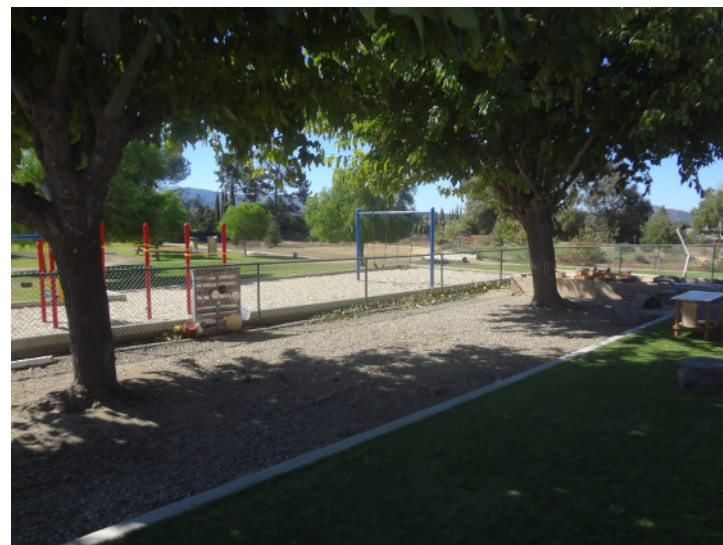
Photo -21
Playground Area
 The playground area is large with several play structures. Each portion of campus has its own play area. Desire for additional shade for kids.

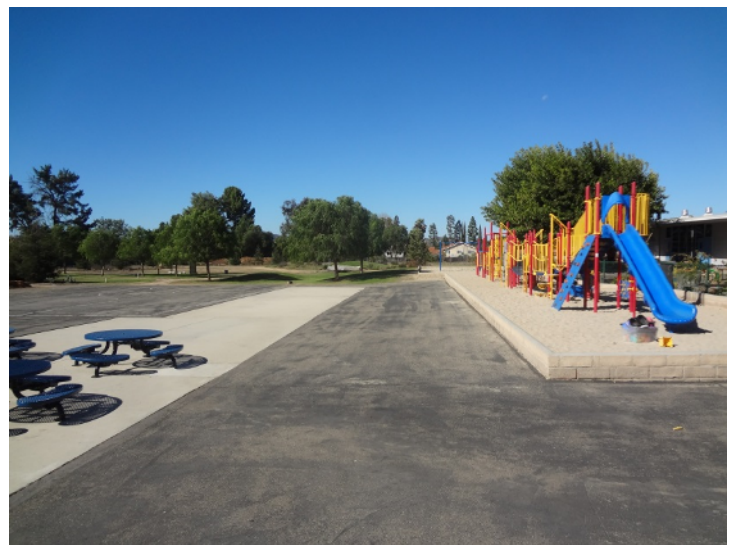
Photo -22
Playground Area
 The playground area is large with several play structures. Each portion of campus has its own play area. Desire for additional shade for kids.

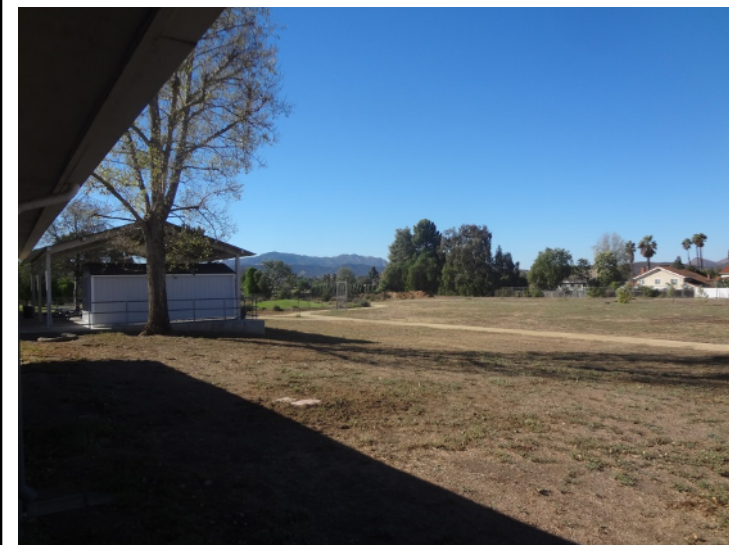
Photo -23
Playground Area
 The playground area is large with several play structures. Each portion of campus has its own play area. Desire for additional shade for kids.

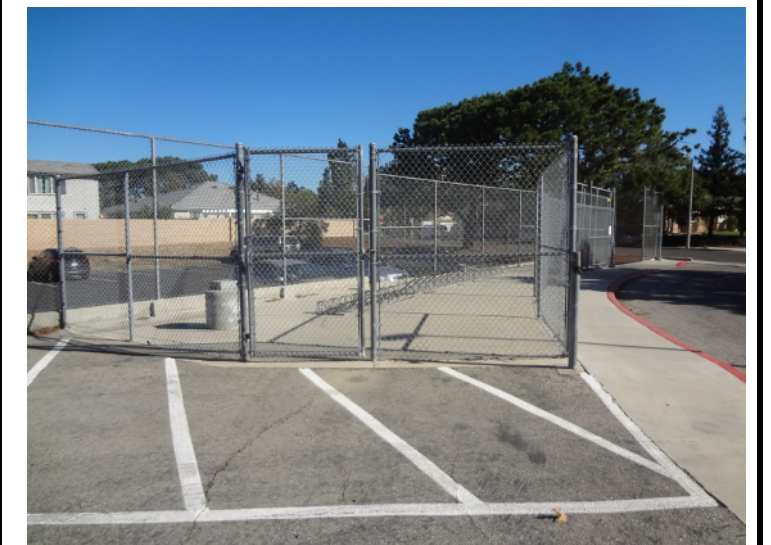
Photo -24
Parking
 Parking has been expanded over the years. The largest expansion is the conversion of the basketball courts to a parking lot. There are some accessibility issues in the parking lot.

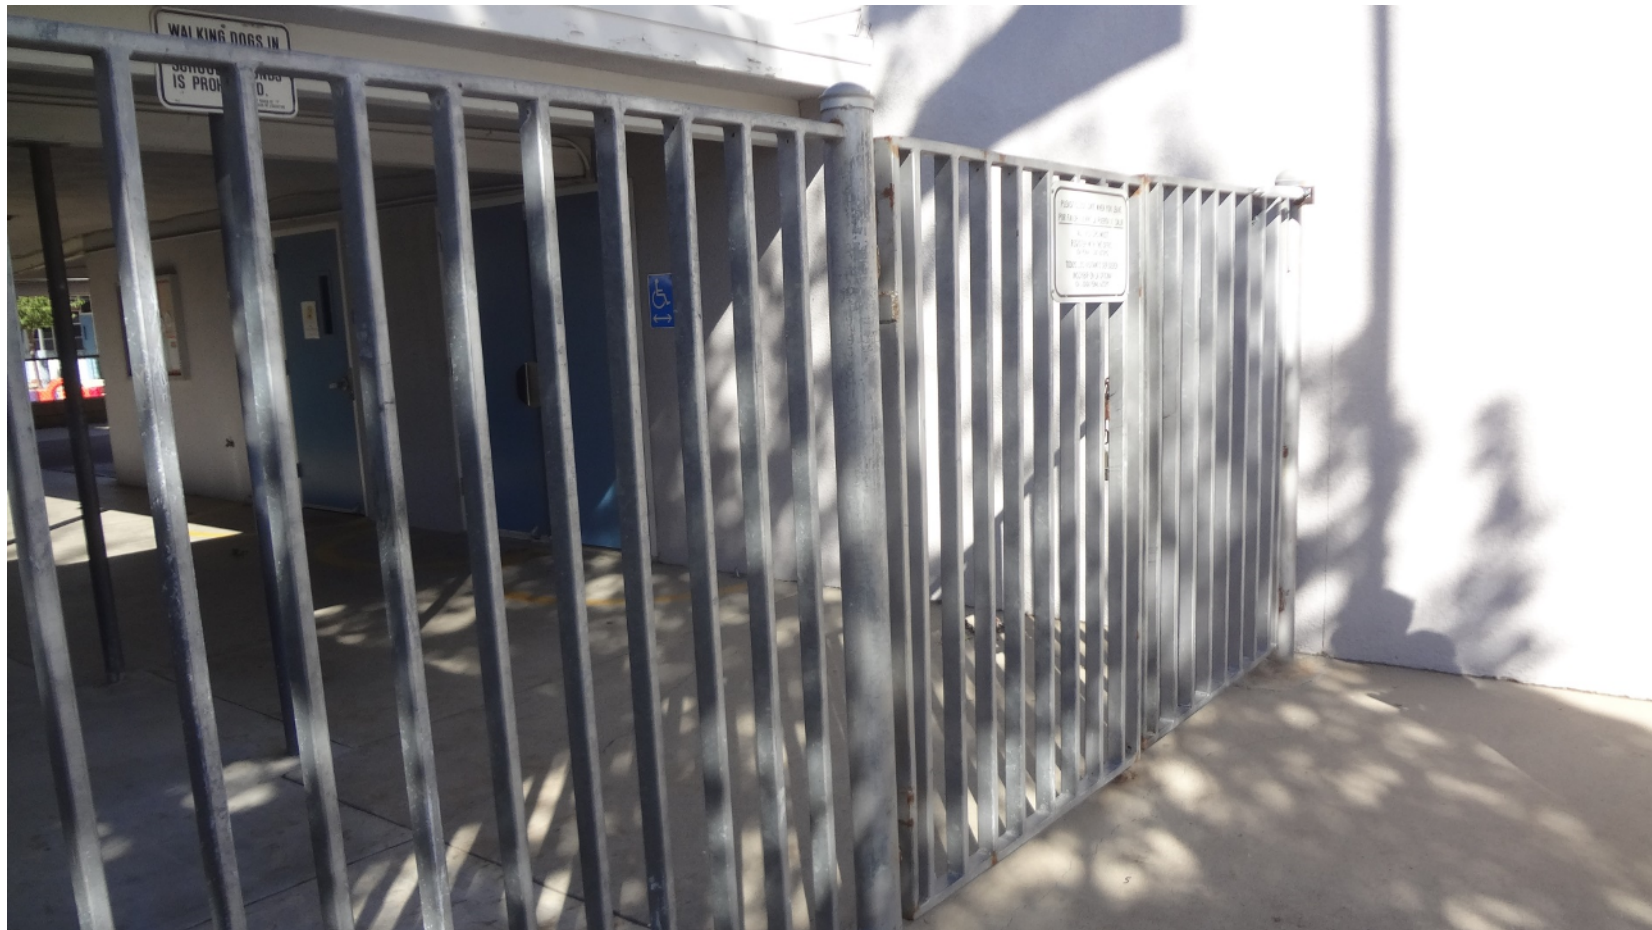
Image 2: Fence is Open during Start and Finish only

- Access during start and finish only
- Access during school hours

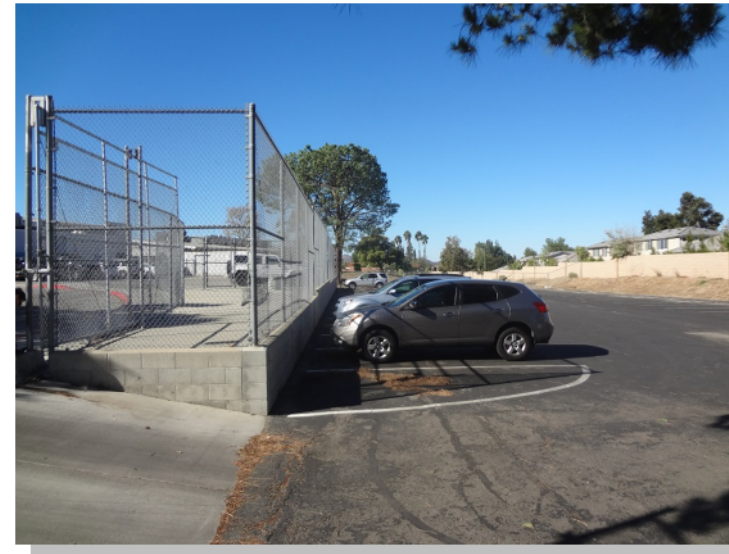
Photo -1
The site has an additional parking lot that was converted from the old basketball court. This parking lot has not been made accessible

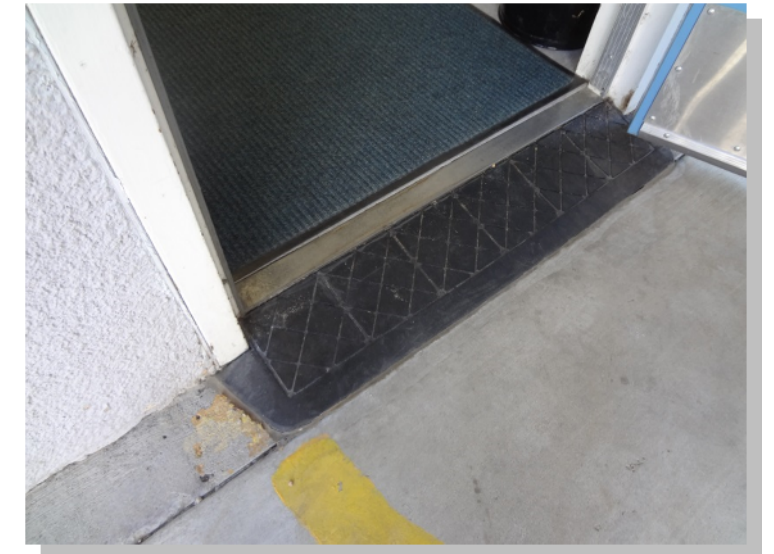
Photo -2
Typical door thresholds are not current with accessibility standards.

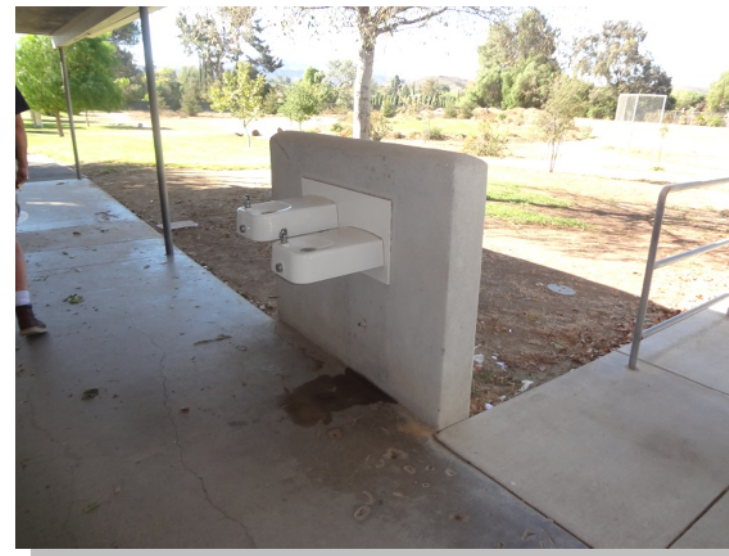
Photo -3
The drinking fountains are not current with accessibility standards.

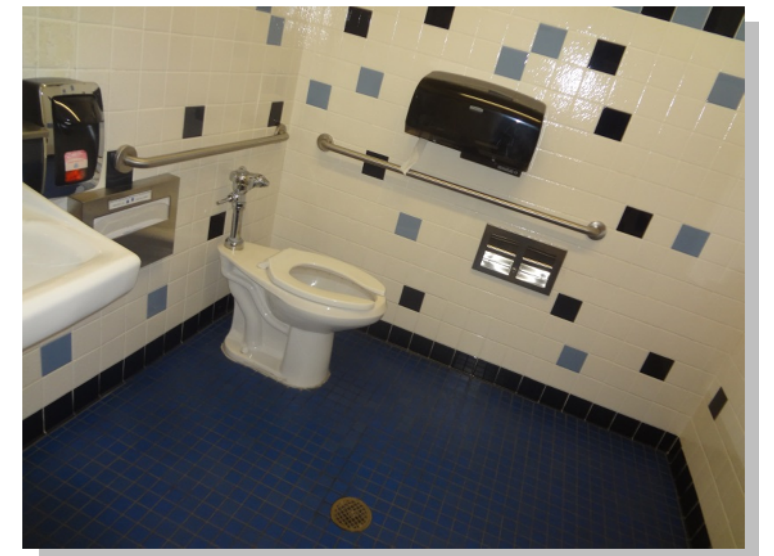
Photo -4
Most of the restrooms have received accessibility upgrades.
