# CVUSD | *Facilities Master Plan*

## Aspen Elementary School | *Site Analysis*

1870 Oberlin Avenue | Thousand Oaks, CA 91360

January 10th, 2017

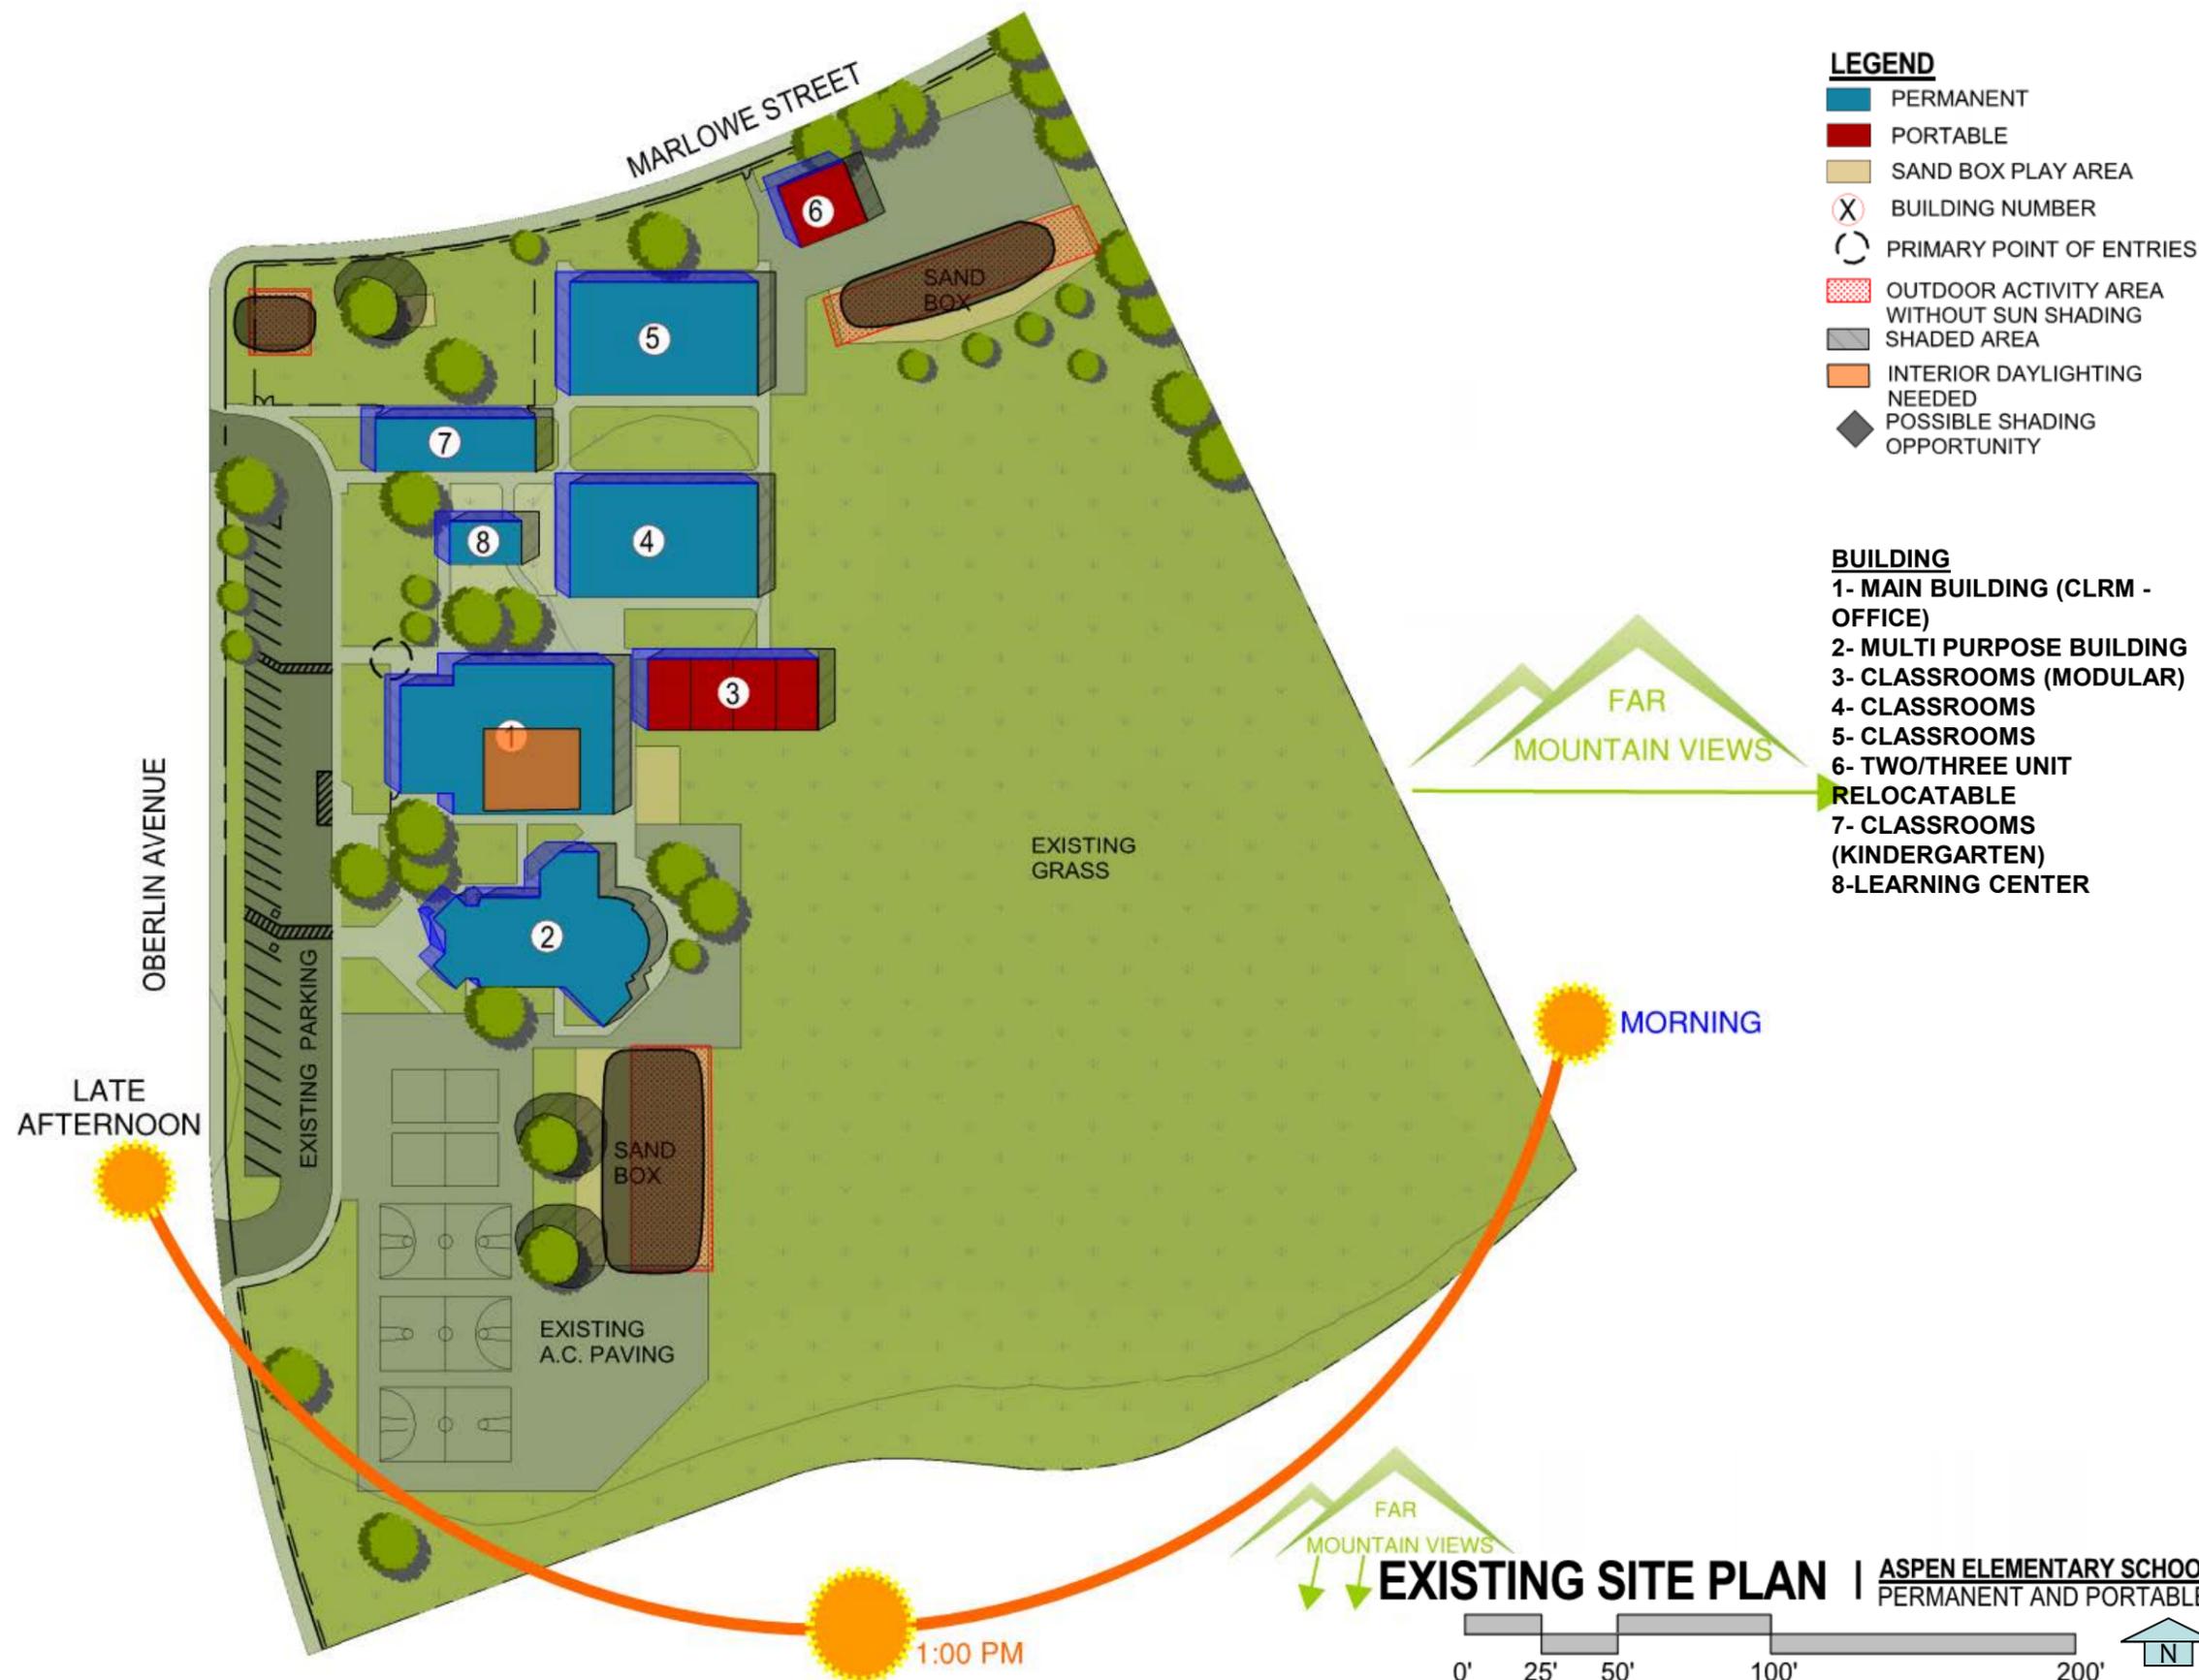
# Aspen Elementary School Site Analysis - Environmental

Aspen Elementary School's Building Alignment and location of trees provide some shading to the playground areas. However, The playground located north east of the site may need additional coverage while the remaining playgrounds may be benefited from possible additional shading by either landscaping or structure.

The library in Building 1 currently has no windows or skylight to bring natural daylight to the space. Potential projects related to adding openings on either interior walls or exterior building envelope may bring daylighting to the space.

The general east-west running buildings provide an opportunity to support solar panels on the roof. However, a feasibility study regarding cost, benefit and regulatory requirement must be conducted prior to moving solar panel project forward.

It should be noted that the topography on the site is relatively flat; however, the school still has several locations that require further improvement to be wheelchair accessible.

If a free standing structure is to be built near the playground, the playground surface and equipment may be upgraded at the same time.

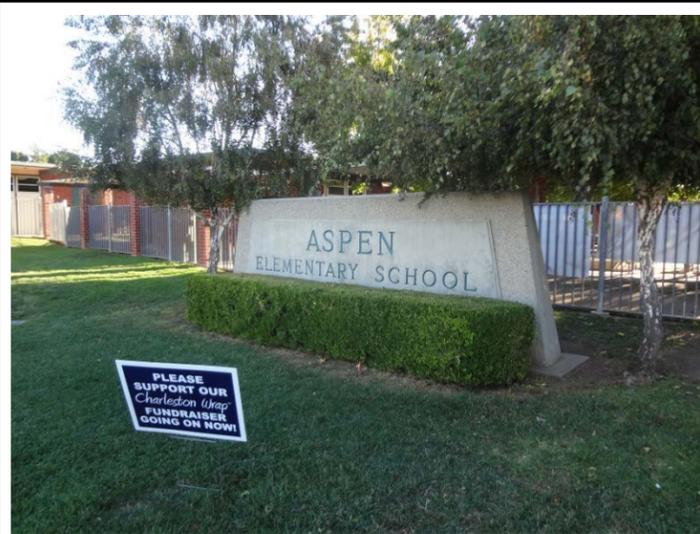
**Photo -1**  
**Curb Appeal – School Entry**  
 Mature landscape and a concrete monument sign mark the entry to the school.

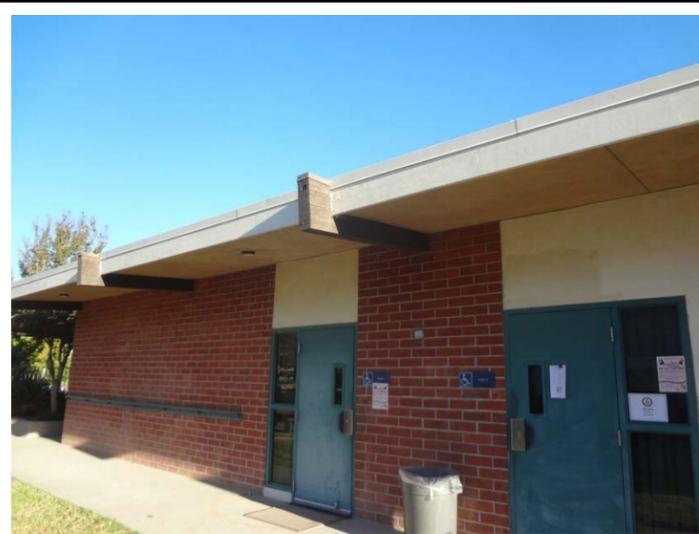
**Photo -2**  
**Curb Appeal – Classroom Buildings**  
 Building have brick façade and projecting wood beams.

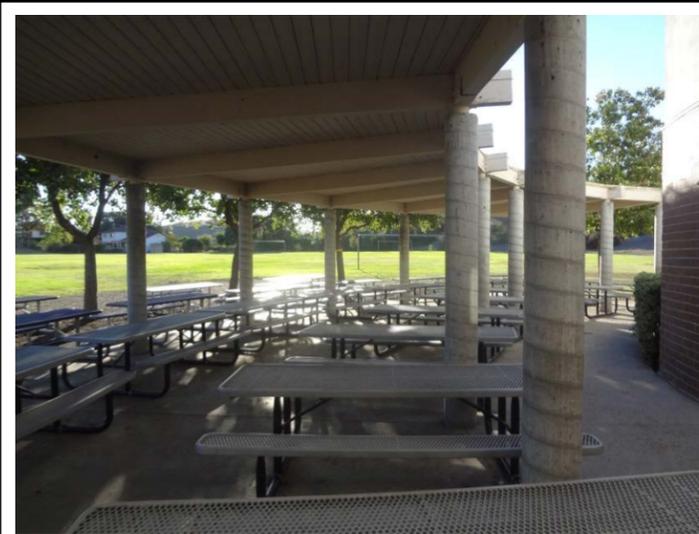
**Photo -3**  
**Curb Appeal – Lunch Shelter**  
 A relatively new multi purpose building and exterior lunch shelter provide excellent refuge from the elements during breaks.

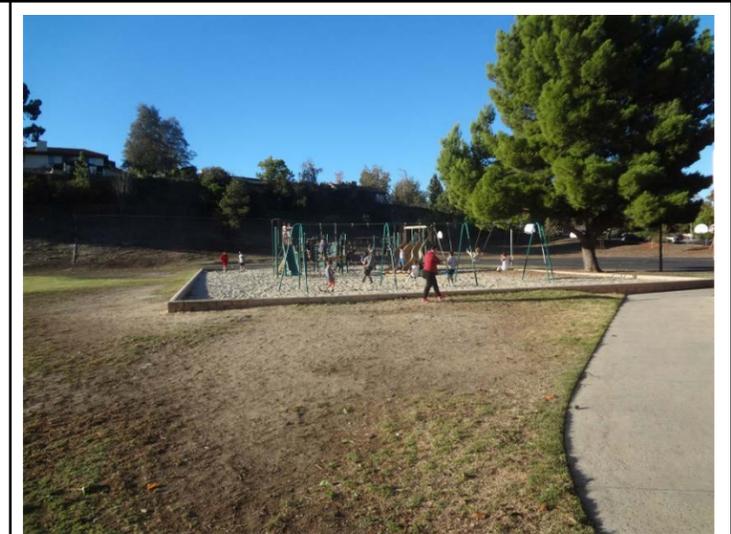
**Photo -4**  
**Curb Appeal – Play Area**  
 The play area is large and has mature trees that provide some shading for the students.

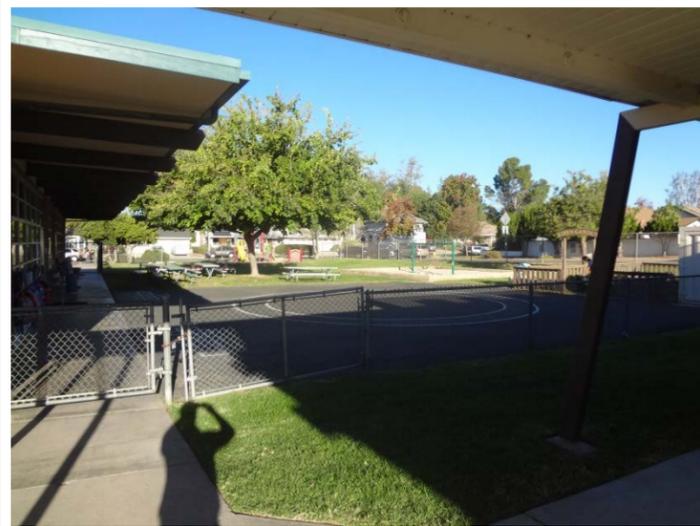
**Photo -5**  
**Curb Appeal – Covered Walkways**  
 The overhangs and large trees provide protection from the elements.

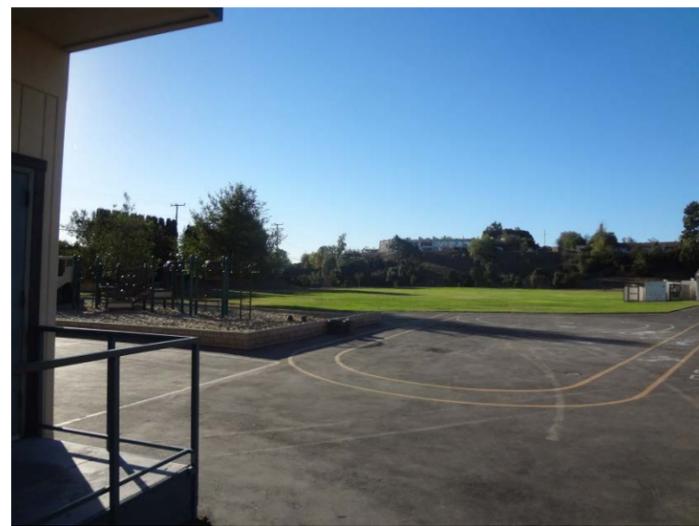
**Photo -6**  
**Curb Appeal – Play Area**  
 Large play area with sufficient play equipment, turf area, and blacktop.

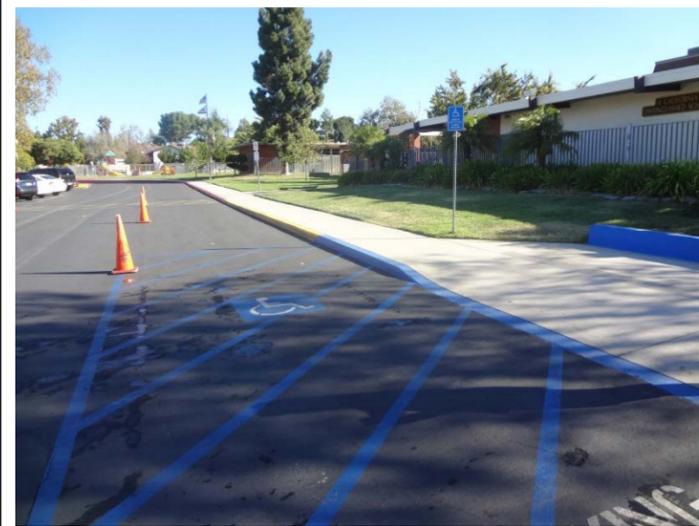
**Photo -7**  
**Curb Appeal – School Entry & Drop Off**  
 The school has a long parking lot and the front of the campus has mature lush landscaping that provide shading for students during pick up and drop off.

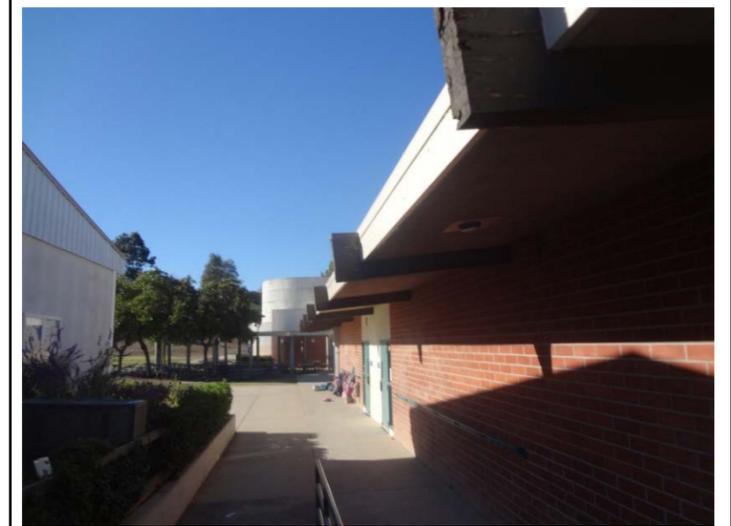
**Photo -8**  
**Curb Appeal – View of MPR**  
 The campus orientation and repetitive structural elements create focal points throughout the campus, highlighting different features, in this case showcasing the MPR.

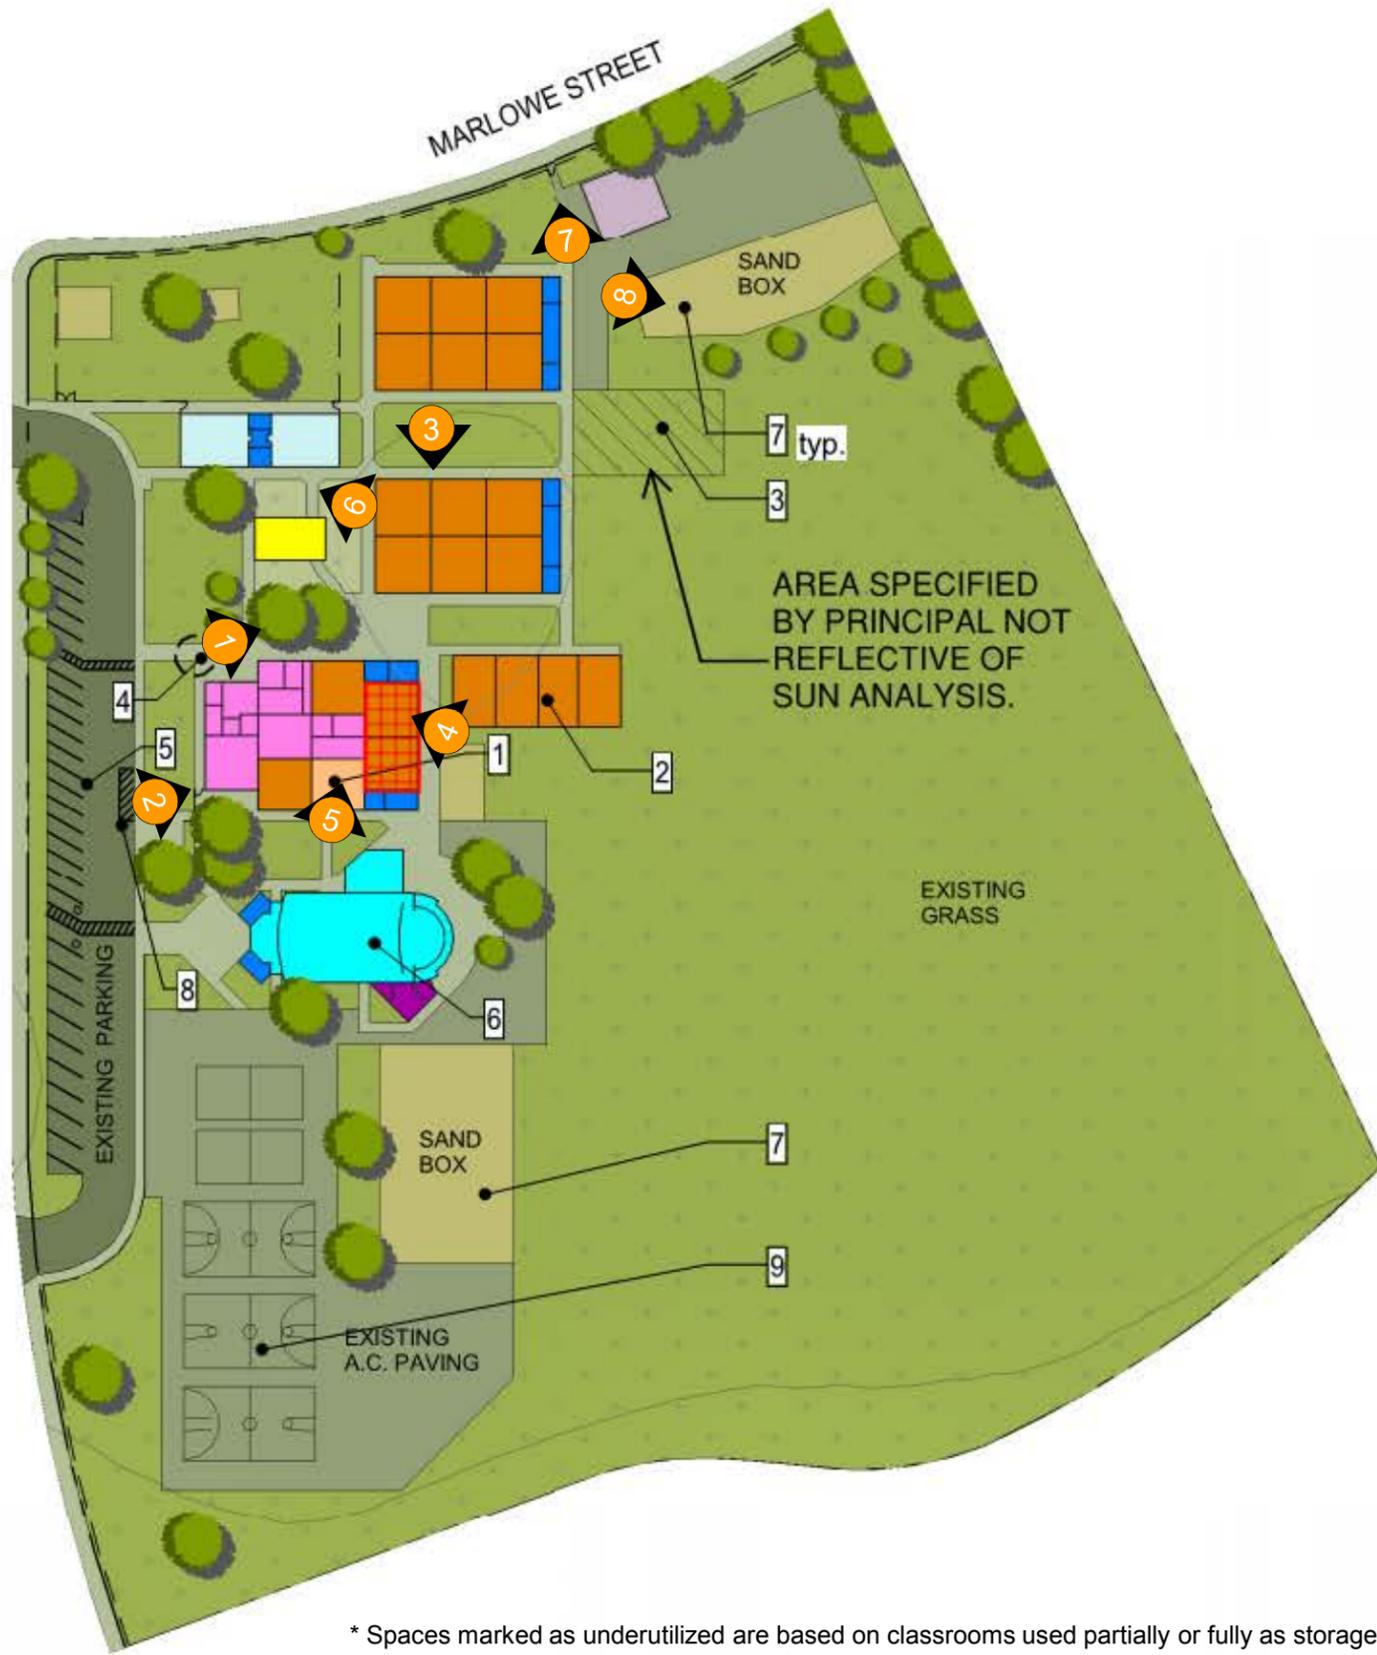
**EXISTING SITE PLAN | ASPEN ELEMENTARY SCHOOL BUILDING USE**

- 1 ORIGINAL MPR CONVERTED TO LIBRARY, NO WINDOWS OR NATURAL DAYLIGHT.
- 2 NO RUNNING WATER IN PORTABLES AND CARPET IS IN POOR CONDITION.
- 3 POSSIBLE/DESIRED NEW SHADE STRUCTURE LOCATION REQUESTED BY FACULTY.
- 4 ENTRY GATE RELIES ON BUZZER TO CONTROL STUDENT ACCESS.
- 5 INSUFFICIENT IN PARKING LOT.
- 6 NO LIGHT SWITCHES IN MPR SPACE
- 7 DATED PLAYGROUND EQUIPMENT AND PROTECTIVE SURFACES WHICH DOES NOT PROVIDE WHEEL CHAIR ACCESS.
- 8 ACCESSIBLE DROP-OFF IS LOCATED IN THE MIDDLE OF THE LOADING ZONE, DECREASING THE EFFICIENCY OF THE DROP-OFF AREA.
- 9 GROUND SURFACE SHOWS EXTENSIVE CRACKS, WEAR AND TEAR.

- OLDER CLASSROOMS WILL NEED ACCESSIBILITY UPGRADES ON HARDWARE THRESHOLDS AND SINKS.
- EXTERIOR DRINKING FOUNTAINS WILL NEED TO BE MADE ACCESSIBLE.
- ACCESSIBILITY UPGRADES NEEDED IN PARKING, GATE LOCATIONS, DOORS, AND SOME PATHWAYS.
- SOME ROOF RAFTERS ARE DETERIORATED AND IN NEED OF IMPROVEMENT THROUGHOUT CAMPUS.
- POSSIBLE TRANSITE PANELS BELOW WINDOWS IN ALL CLASSROOMS.
- SPALLING CONCRETE STEPS IN MULTIPLE LOCATIONS.
- NON-MATCHING WINDOW GLAZING THROUGHOUT THE CAMPUS.
- LACK OF WINDOW SHADING IN TYPICAL CLASSROOM.

Music and art education has been an asset to Aspen Elementary School and most schools in this District. The school may want to improve the existing music classrooms by refreshing the interior finishes or relocating the music classroom to other spaces better suitable for the band and chorus practice. A potential permanent building may replace some portable classroom buildings and provide dedicated music and art learning classrooms in addition to other maker or project based classrooms.

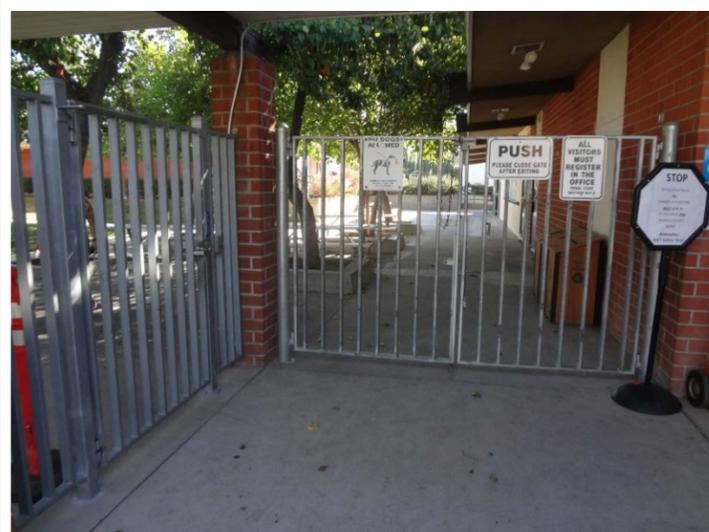
**Photo -1**  
**School Entrance**  
Current configuration of gates requires a buzzer to control student access to adjacent administration space.

**Area 1:** Possible reconfiguration of entry gate and fencing may eliminate the current access protocol, which depends on buzzer and constant monitoring of staff. Improvement in the library space may bring additional daylighting while reconfiguration of adjacent spaces may create a flexible learning space inside or next to the library. On the other hand, the adjacent administration spaces as well as the exterior of the building may be further improved and beautified to create a cohesive appearance. The goal of this cluster of potential improvement is to beautify spaces, increase efficiency and functionality.

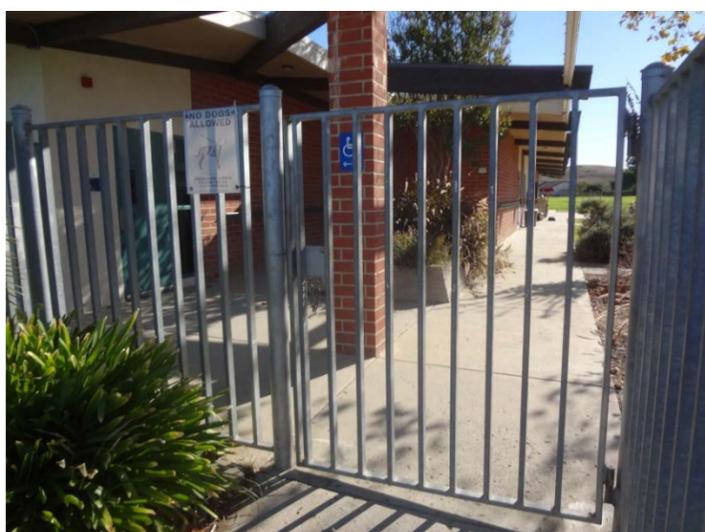
**Photo -2**  
**Gates**  
None of the gates have panic hardware and some of these gates are used as major points of egress out of the campus.

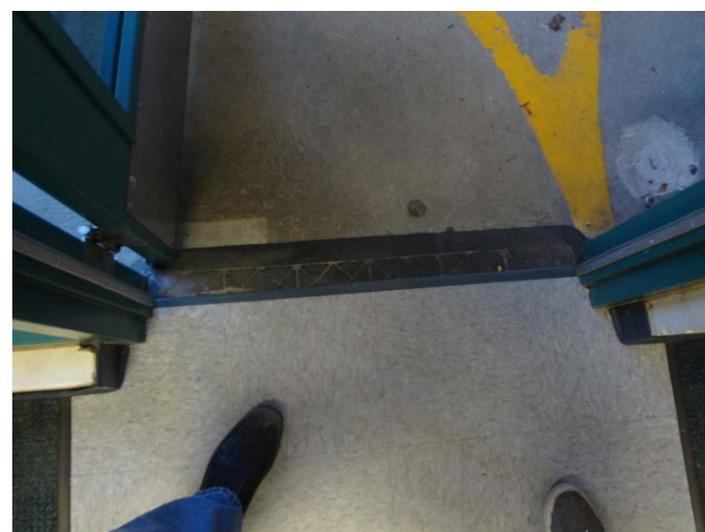
**Photo -3**  
**Door Thresholds**  
Not current with accessibility standards and may need to be updated.

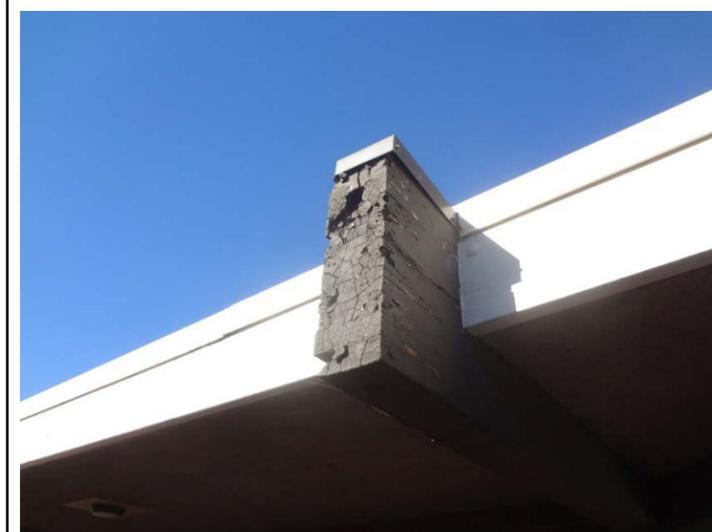
**Photo -4**  
**Beam/Rafter Deterioration**  
Many of the major structural rafters are deteriorated and may need to be investigated for structural integrity.

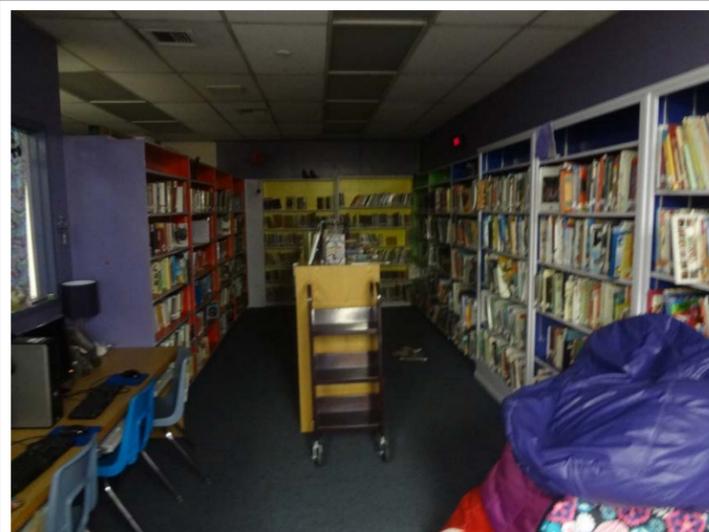
**Photo -5**  
**Daylight in Library**  
There is currently no daylighting or windows in the library.

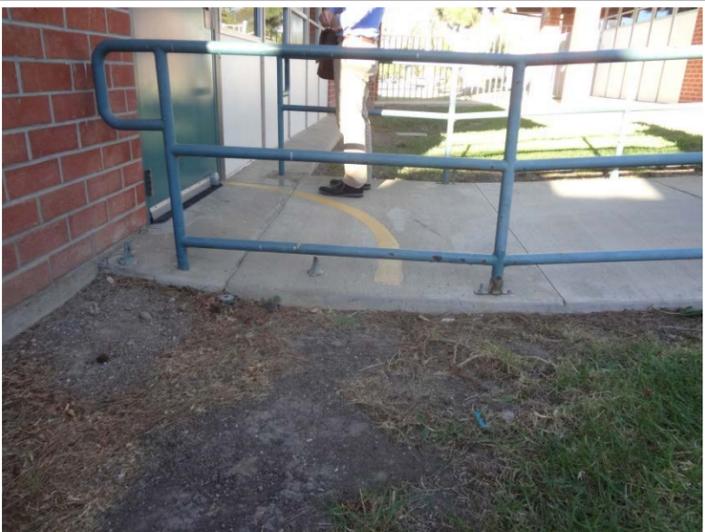
**Photo -6**  
**Ramp Compliance Issues**  
This ramp does not have a wheelchair compliant landing.

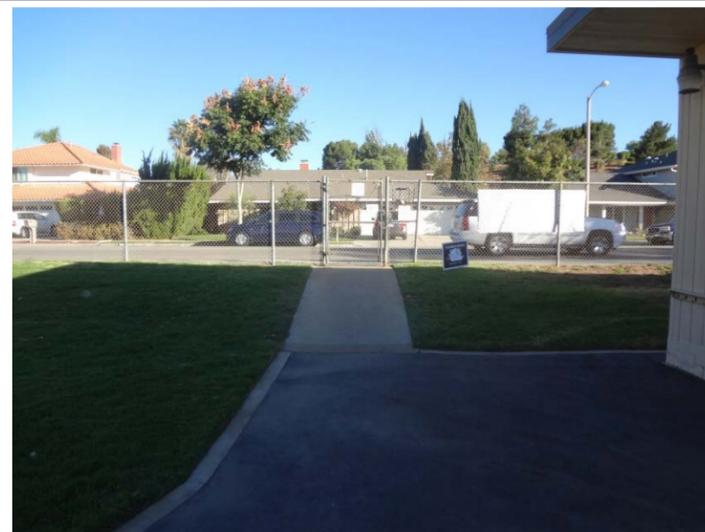
**Photo -7**  
**Secondary Entry to Campus**  
The path is not compliant with wheelchair accessibility standards and the gate does not have an accessible levered hardware.

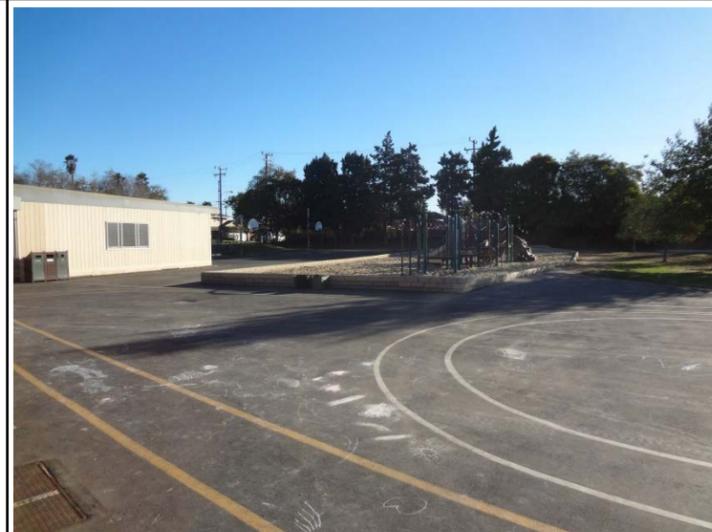
**Photo -8**  
**Site Shading**  
Some playground areas do not have complete shading coverage from existing trees or buildings.

**Area 3:** Additional shading may be added to playgrounds. Shading opportunities may be accomplished by either structure or landscaping. Play surfaces and equipment may also be upgraded as a part of the scope.

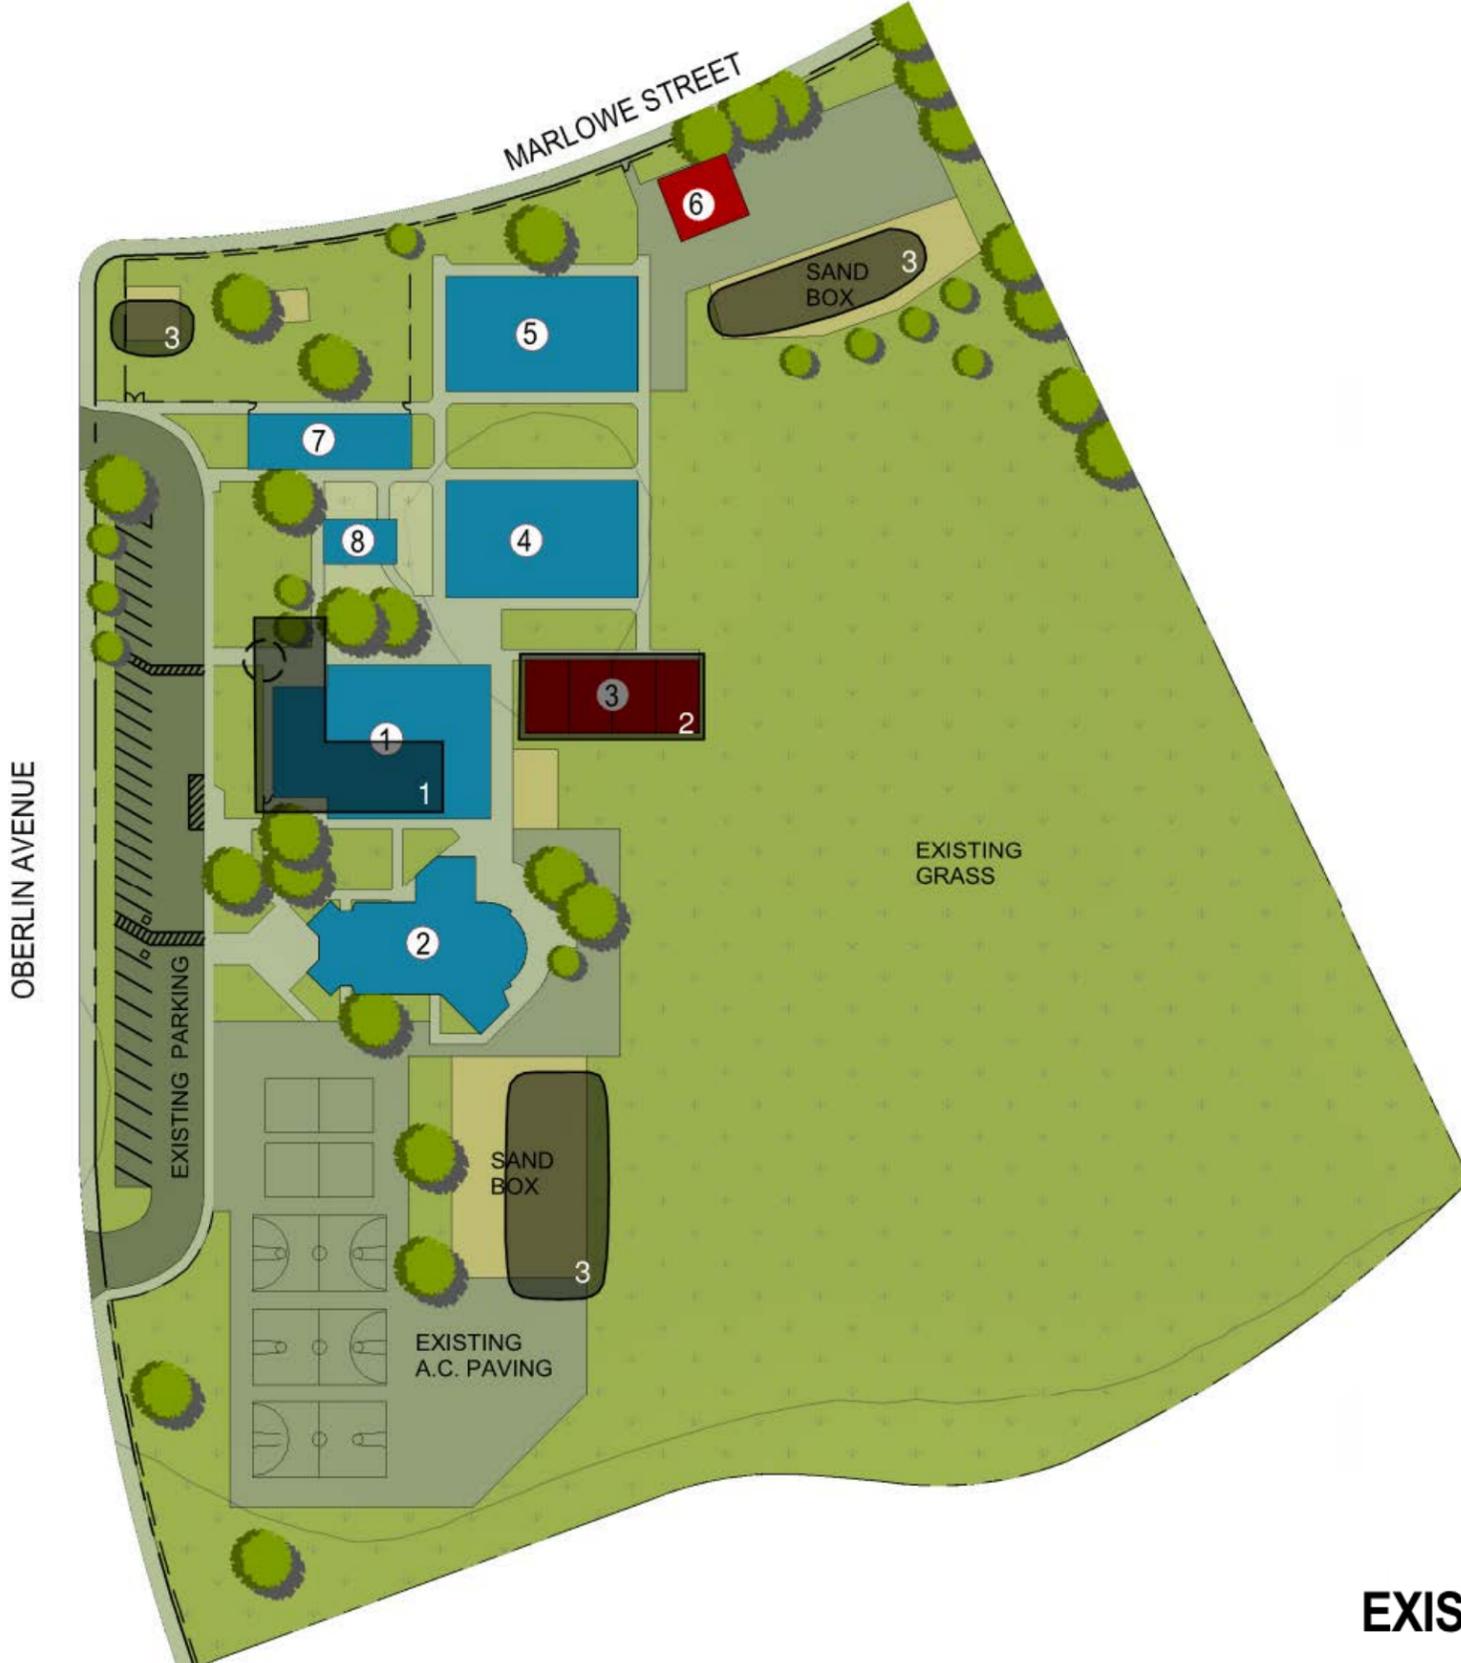
**EXISTING SITE PLAN** | ASPEN ELEMENTARY SCHOOL  
PERMANENT AND PORTABLE

**Area 2:** There is an opportunity to replace this cluster of temporary classroom buildings with a permanent building, which may house spaces sized for flexible, project based learning experience. Alternatively, there is also a potential for interior remodeling to provide plumbing and replace finishes.
