CVUSD | *Facilities Master Plan*

Colina Middle School | *Site Analysis*

1500 East Hillcrest Drive | Thousand Oaks, CA 91362
Conejo Valley Unified School District
March 31, 2017

Campus Findings

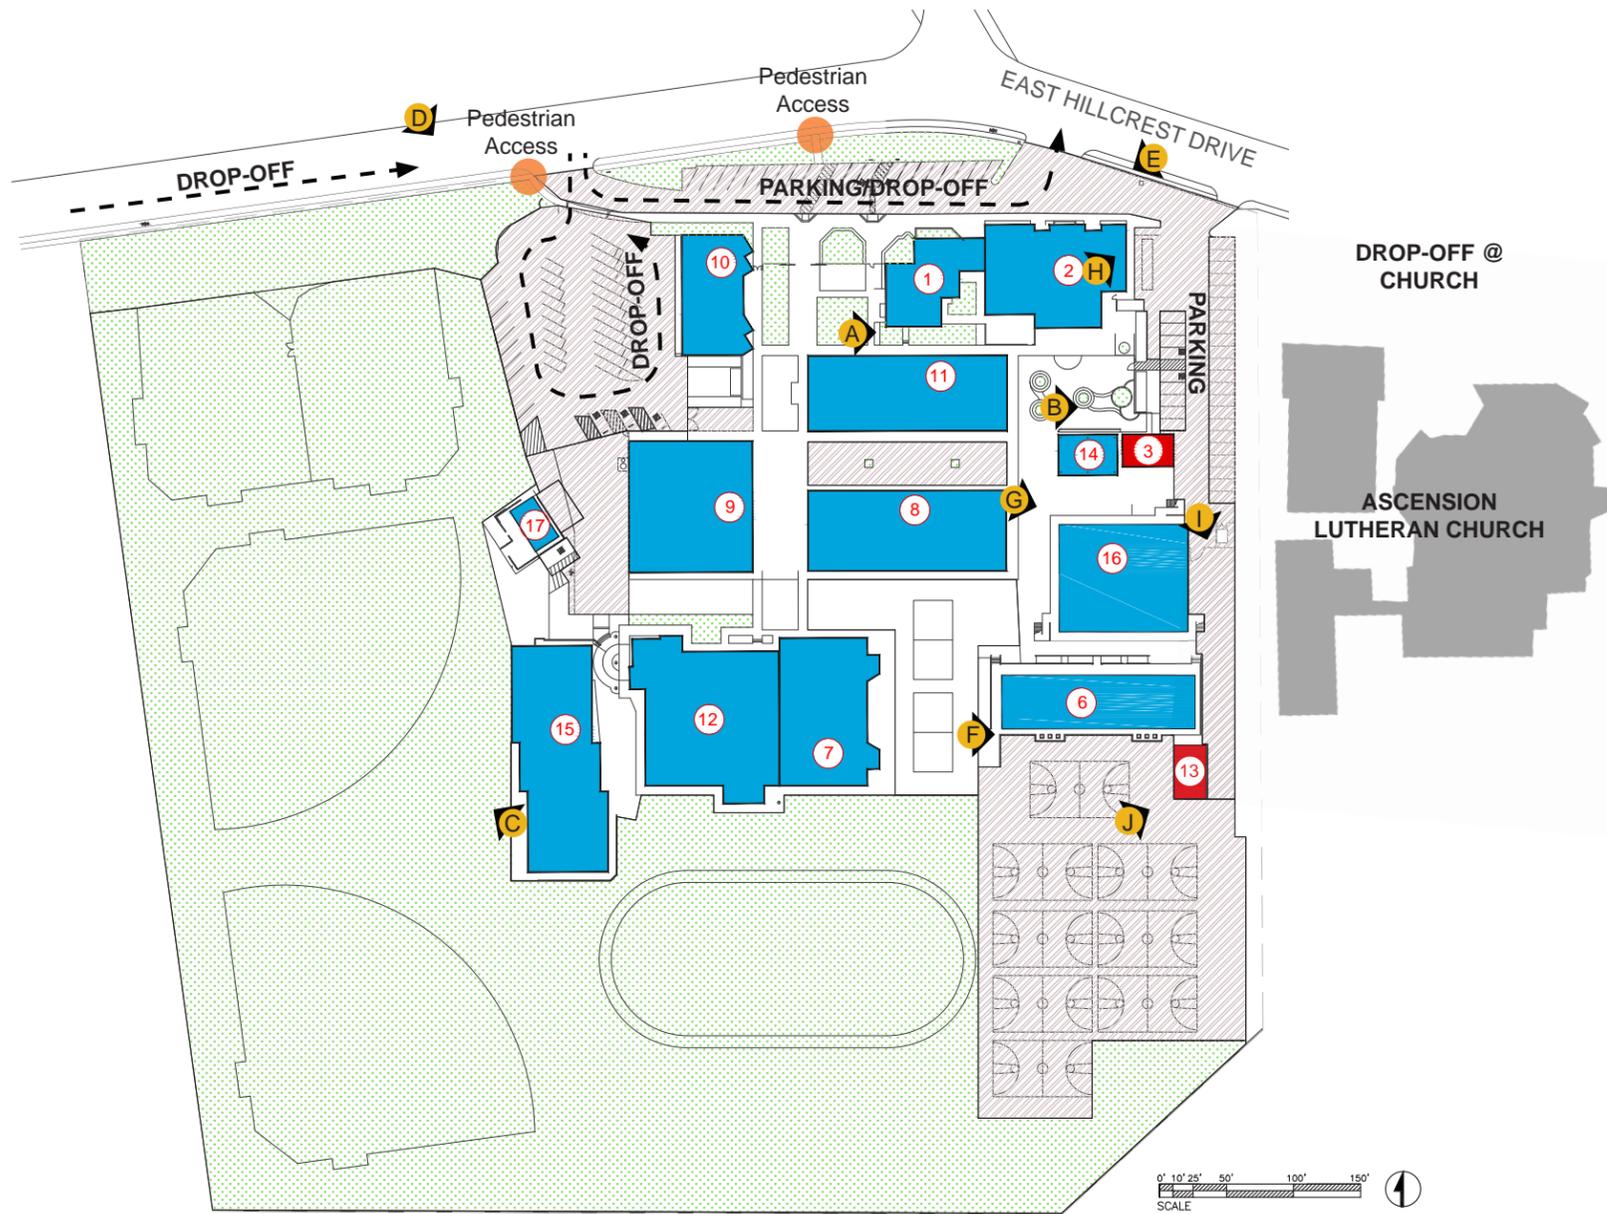
- Topography presents accessibility, safety and site drainage challenges
- Administration Building and Multi-Purpose Building HVAC systems and roofing are aging
- Interior and exterior finishes are aging
- Portable buildings are aging
- Parking lots & drop-off zones are undersized
- Lack of conference rooms
- Congested lunch time queuing
- Campus perimeter fencing is low
- Typical accessibility challenges

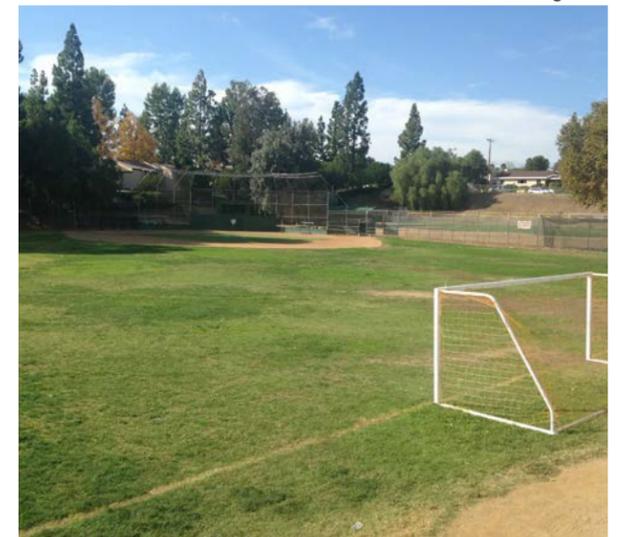
Image C

- Pockets of academic courtyards
- Generous playfields
- Large windows at main Classroom Buildings

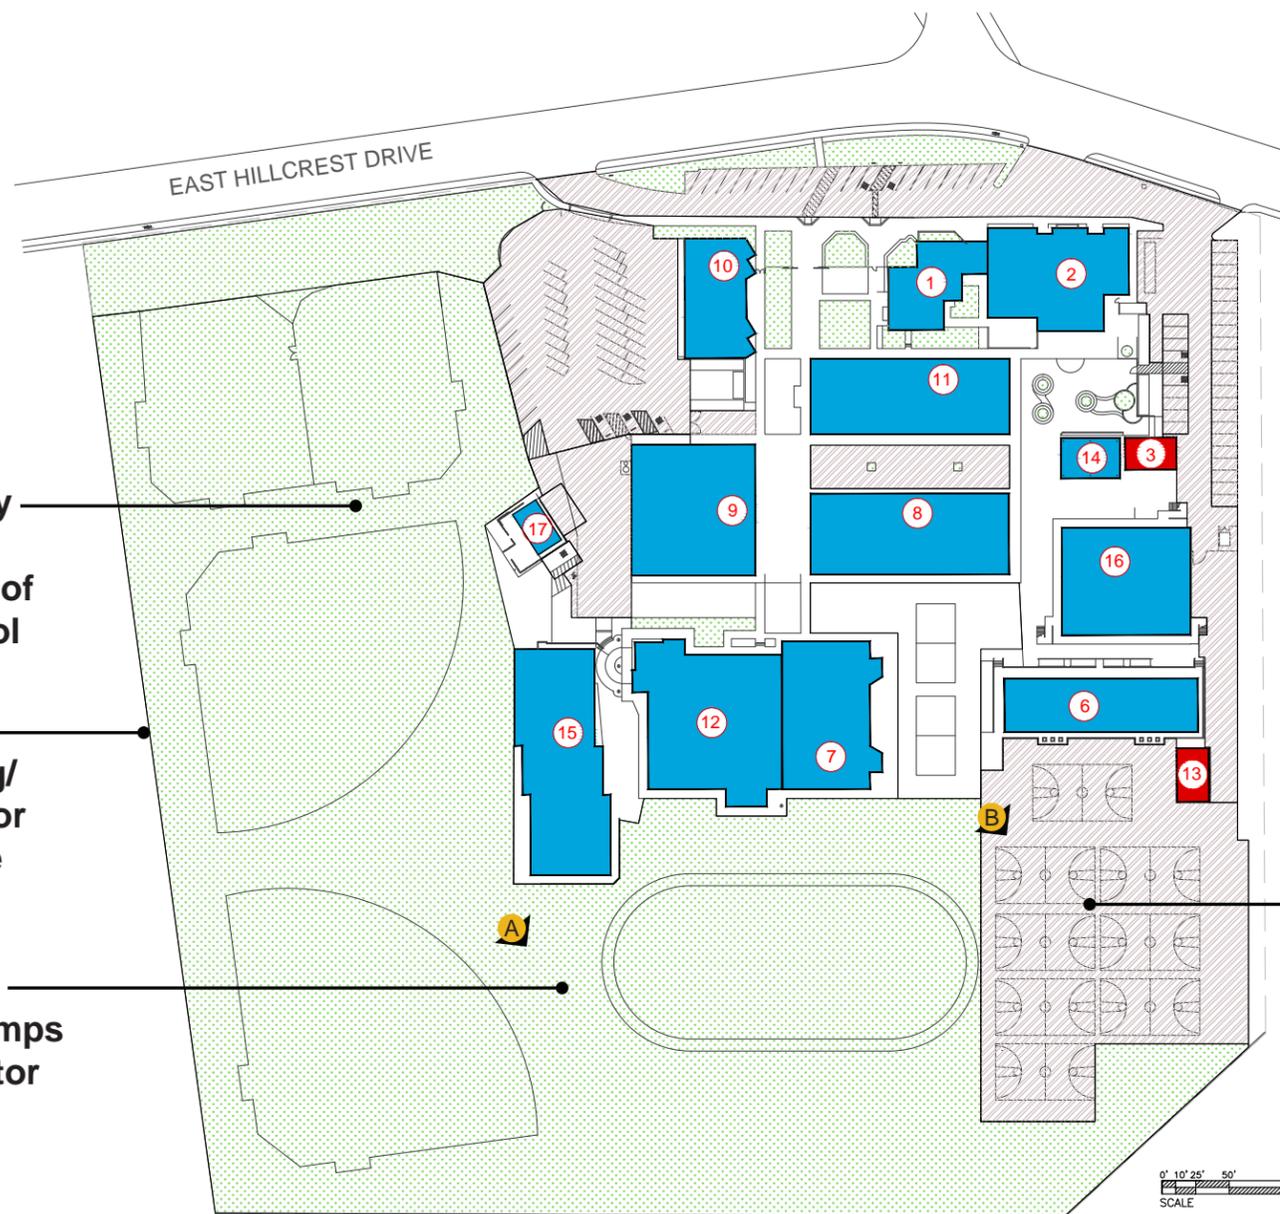
The topography of the site presents safety, accessibility and drainage challenges. The grade change between the southern play fields may be mediated through the use of stairs, ramps and rails. Spectator seating may also be incorporated to allow the school and visitors to utilize the outdoor amenities more effectively.

Safety and usability of play space would be much improved through erosion control at the south edge of the t-ball fields. Moreover, campus security would be bolstered with higher perimeter fencing.

Colina Middle School plays a large role in the neighborhood, with visitors often making use of the campus facilities. The southeast basketball courts may be replaced with pickle ball courts, giving the students and community an added activity to enjoy.

Improve safety and function with methods of erosion control

Improve with higher fencing/landscaping for a more secure perimeter

Mediate slope with stairs, ramps and/or spectator seating

Improve with pickle ball courts to bring in community

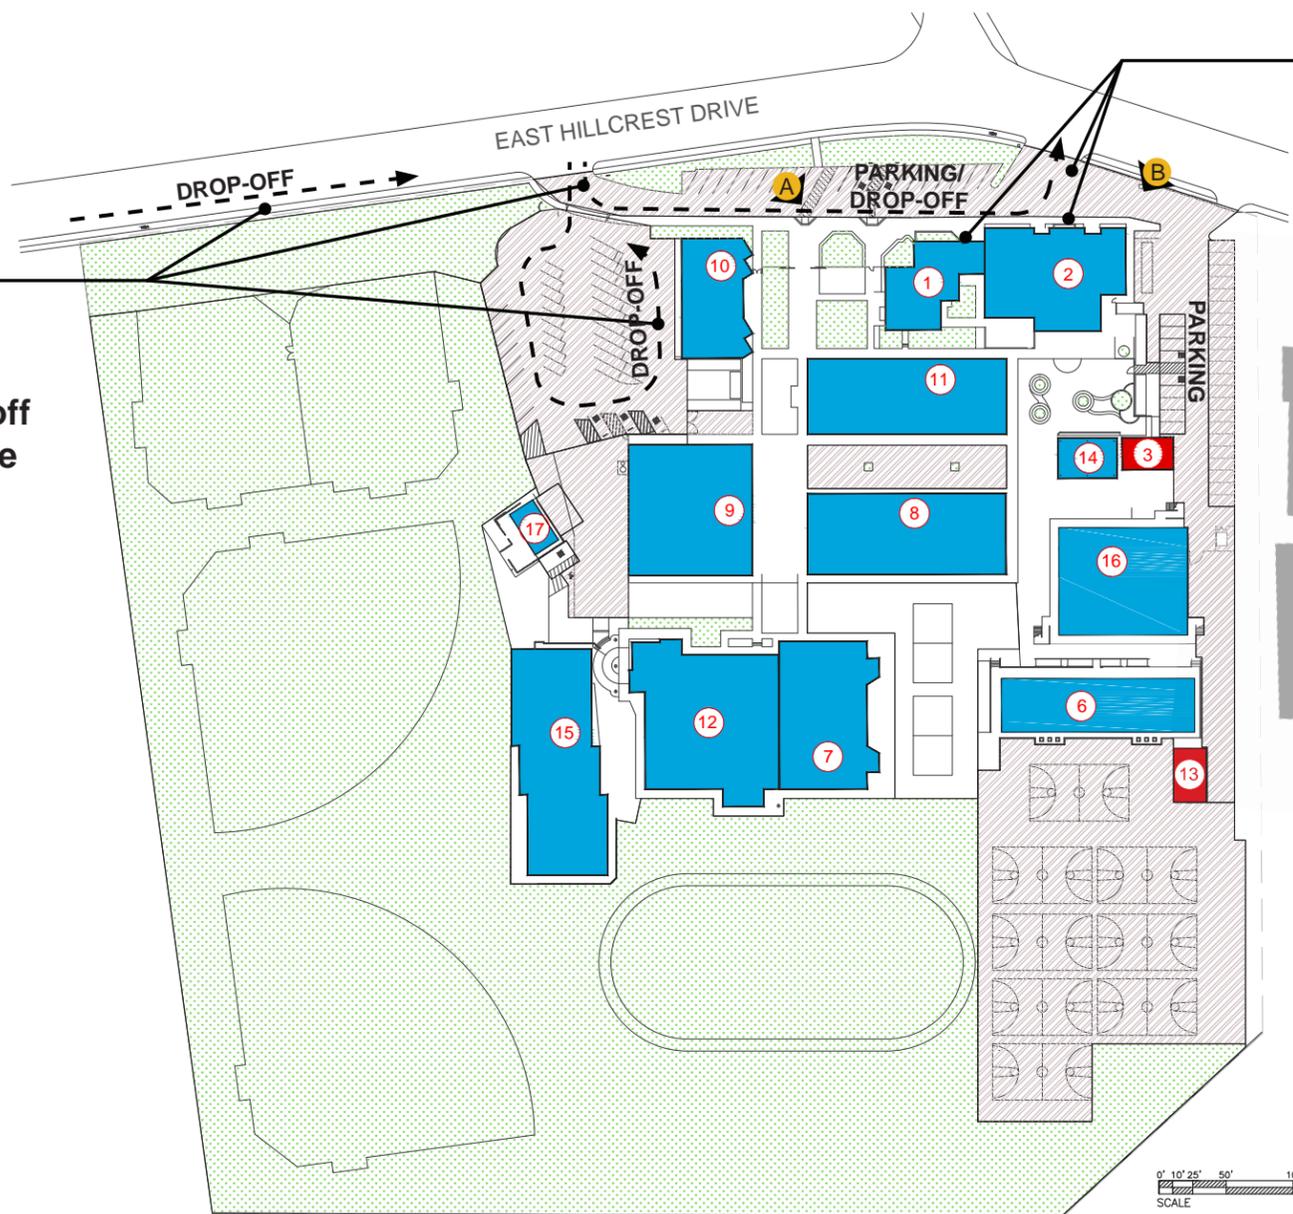
Three parking lots and drop-off zones are utilized on campus. These facilities do not meet the needs of the school. Mitigation measures such as dual morning start times and drop-off at the adjacent church help with congestion. However, a more clearly organized and consolidated parking layout may be more effective. Moreover, a separation between drop-off circulation and parking circulation, and development of traffic flow that leads to longer lengths of queuing may also be beneficial.

Modernization of exterior finishes at Buildings 1 and 2, as well as formalization of the main campus entrance would improve the school's street presence. Demarcation of the entrance may be accomplished through landscaping, signage, structure and allowing the school building to meet the street rather than the parking lot.

Consider reconfiguration/ expansion of parking & drop-off layout to improve traffic flows

Modernize campus entry & enhance street presence.

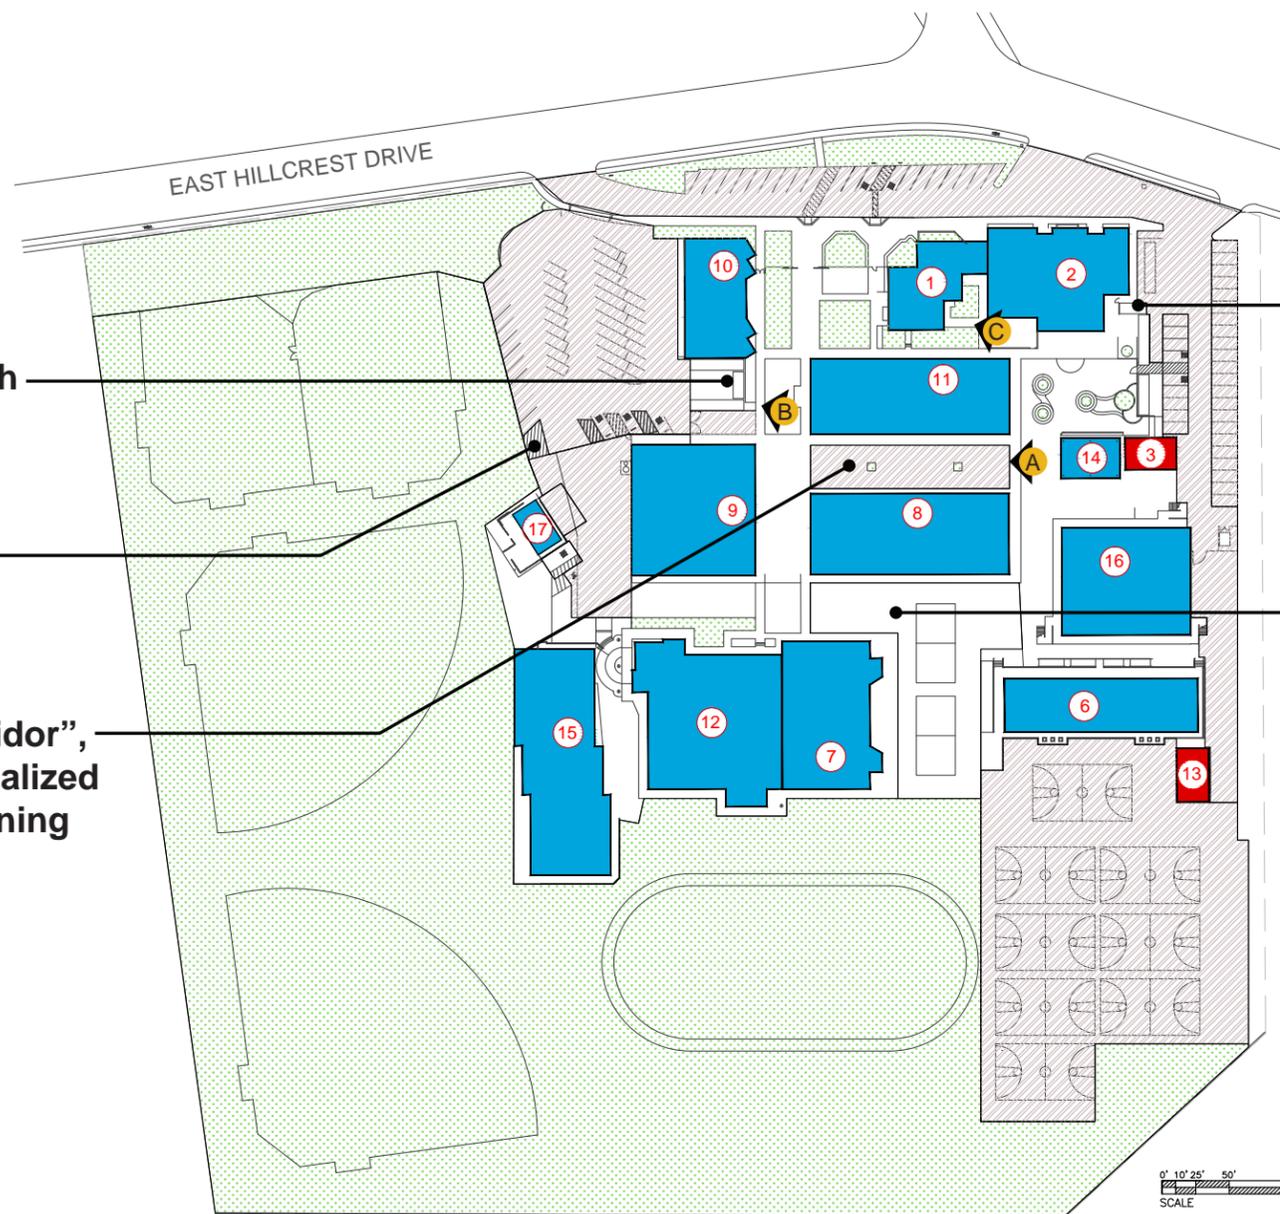
The campus is organized with multiple academic courtyards nestled between buildings. The zone between Buildings 8 and 11 may be improved into a “6th Grade Corridor,” giving students a formalized place to play and learn. Moreover, students would greatly benefit from shade structures.

Multiple storage containers to serve the needs of the school occupy the site. More permanent and consolidated storage solutions may improve the aesthetics of the site, and provide opportunities for expansion of undersized servery, queuing and parking facilities.

A decorative block wall that surrounds storage containers is a safety concern, as it has ridges which students can climb on. This may be replaced with a flat-surfaced site wall.

Replace wall with a less textured alternative

Provide secure enclosure for trash bins.

“6th Grade Corridor”, a space for formalized playing and learning

Improve storage solutions & recapture parking and/or expand servery

Improve courtyards with shade structures

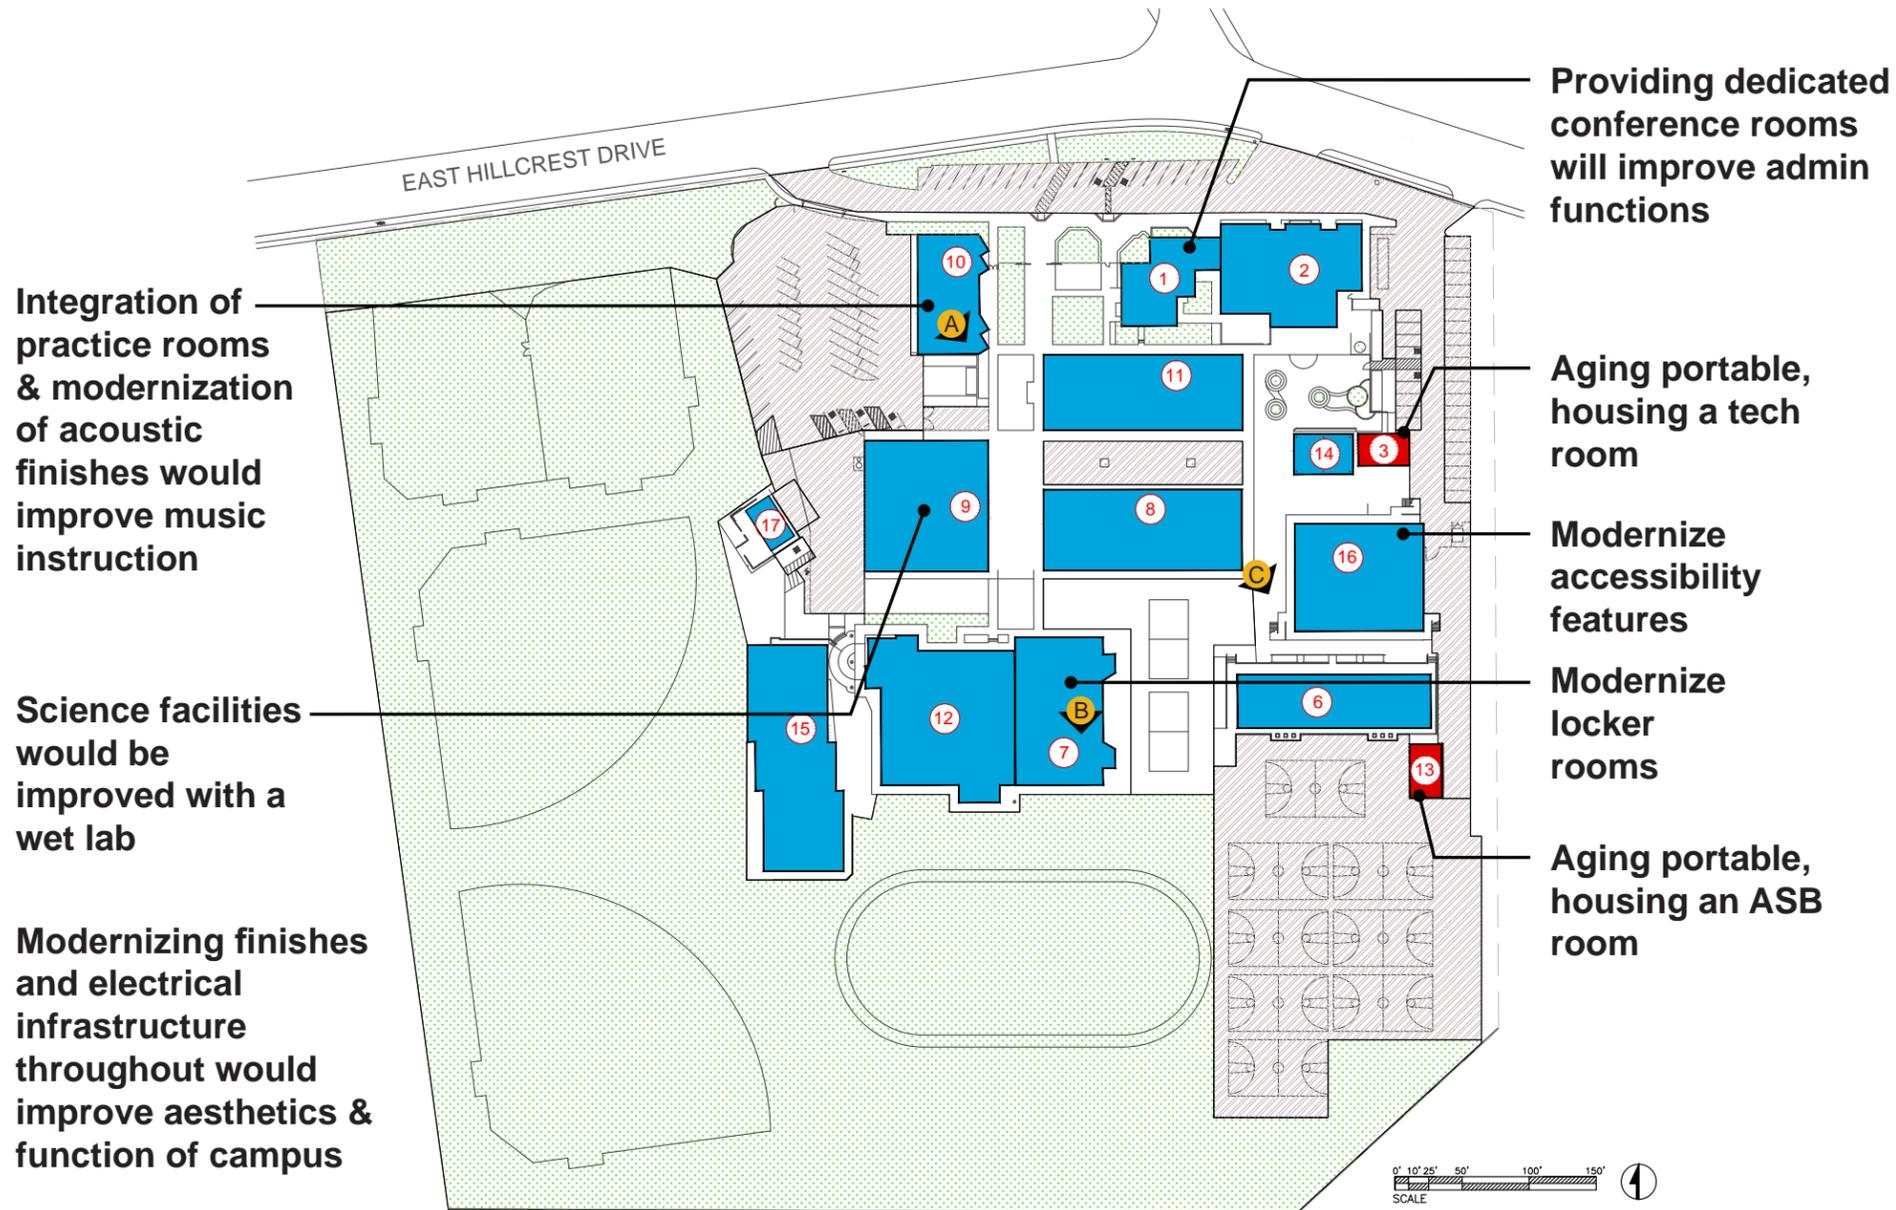
Aging portable, housing a tech room

Aging portable, housing an ASB room

Modernization of interior and exterior finishes, and replaced roofing and HVAC systems would improve the function and aesthetics of the campus. Most notably, the band classrooms, music practice rooms and multi-purpose room would benefit greatly from new finishes, lighting, sound and electrical infrastructure that cater to those rooms' specific needs.

Administrative spaces are undersized, and are especially deficient in conference room space. The addition of dedicated meeting rooms would improve collaboration amongst faculty and staff greatly. Integration of practice rooms for the music program and a wet lab for the science program would benefit the school's instructional goals.

The boy's and girl's locker rooms are in need of repair, and are not utilized to their fullest extent. Modernizing the facilities' finishes, furnishings, and ventilation systems, and re-evaluating the required number of student showers would enhance the spaces greatly. Portables on campus are also aging and in need of repair.

The 2-Story Modular Building is in need of accessibility modernization, which is currently in progress. This structure would also benefit from maintenance of exterior finishes.

Integration of practice rooms & modernization of acoustic finishes would improve music instruction

Science facilities would be improved with a wet lab

Modernizing finishes and electrical infrastructure throughout would improve aesthetics & function of campus

Providing dedicated conference rooms will improve admin functions

Modernize accessibility features

Modernize locker rooms
