CVUSD | *Facilities Master Plan*

Los Cerritos Middle School | *Site Analysis*

2100 East Avenida De Las Flores | Thousand Oaks, CA 91362
Conejo Valley Unified School District
March 31, 2017

Campus Findings

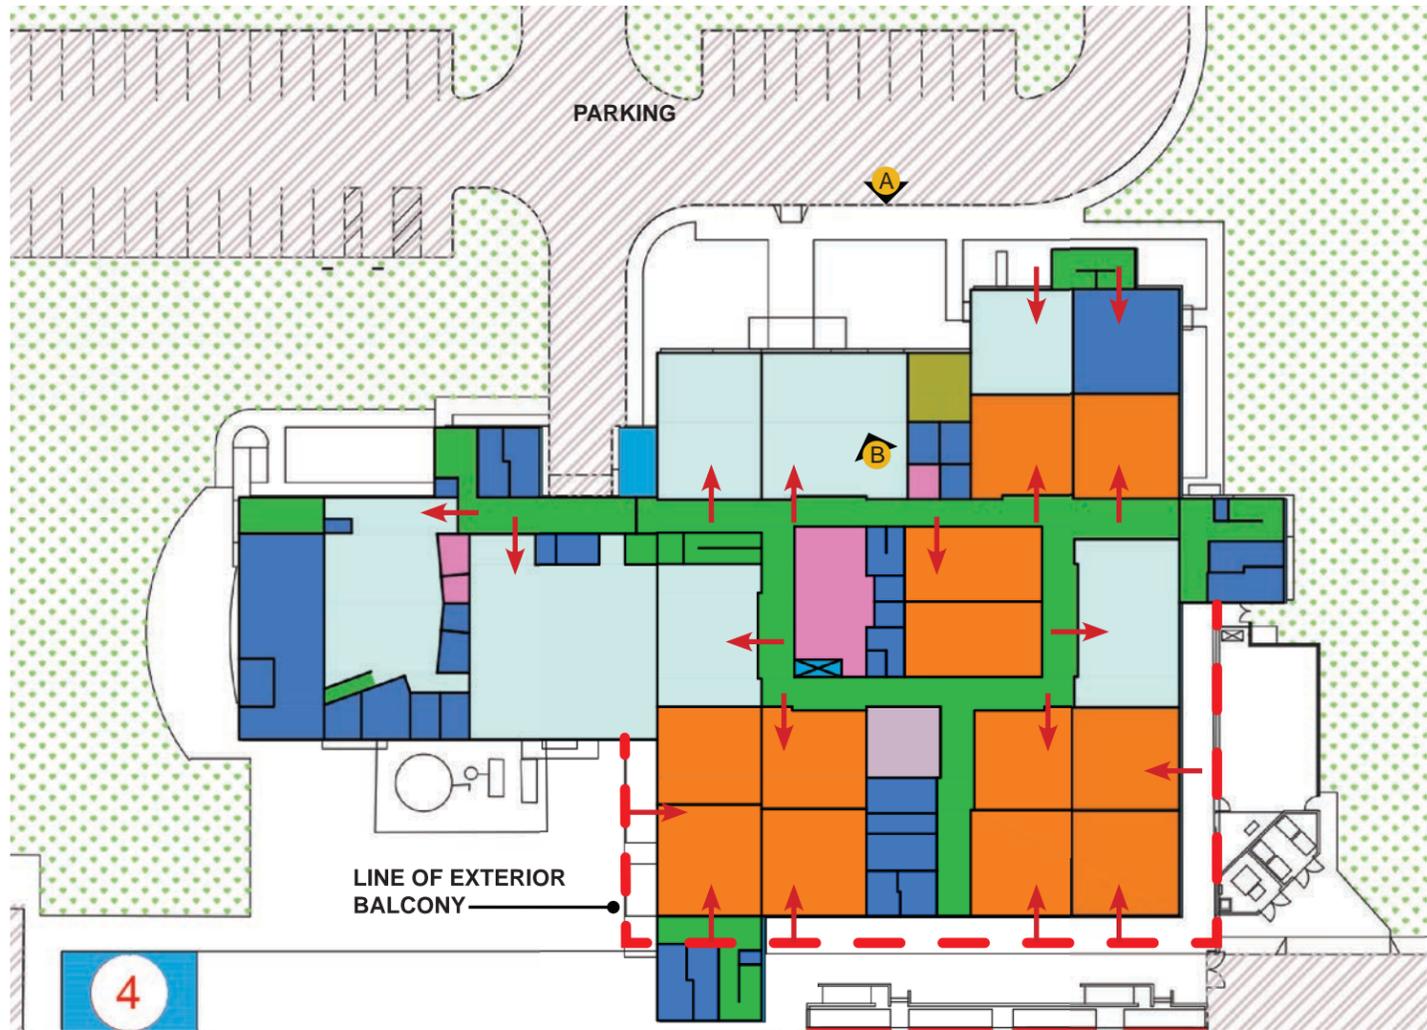
There are several challenges at Building 1, most of which stem from the general layout, shape and materiality of the structure. Reconfiguration of classrooms, simplification of circulation, clarification of points of entry, and modernization of wall materials may aid in improving the function of spaces. Moreover, hallway congestion may be improved through the widening of hallways and/or relocation of lockers.

There is currently one vertical section of windows at Building 1. Daylighting is a great benefit to the educational and working environment. More fenestration may be incorporated through the use of windows, skylights, tubular skylights and atriums.

- Integrate daylighting
- Clarify circulation
- Improve safety & security
- Improve acoustics

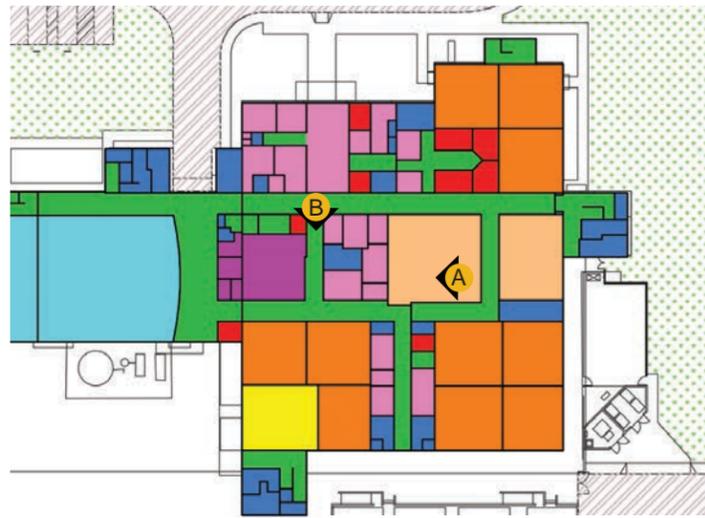
First floor

Improve circulation for lunch activities

Improve library acoustics

New interior finishes and storage solutions

Improve circulation in administration

Update central plant

Modernize specialty classrooms

There are several programmatic improvements that may be made at Building 1. The location of the library may be reconsidered to improve its acoustic separation from its surroundings.

The lunch time queuing area may also be relocated, as its current position in the hallway leads to congestion.

General interior finishes may be modernized, as well as integration of casework and furniture solutions to provide classrooms much needed storage space.

Well-used specialty classrooms would benefit greatly from modernization to accommodate today's instructional needs. Notably, the band classroom contains infrastructure from the home economics classroom that used to occupy the space. Moreover, a dedicated space for the choir classroom would allow the multi-purpose room to be used to its fullest extent.

The main administrative offices are congested. Reconfiguration of spaces may improve circulation and access to meeting rooms. Proximity of offices to restroom spaces may be improved.

The central plant is currently inefficient and aging. Overall user comfort and energy performance of the building may be improved by replacing this system.

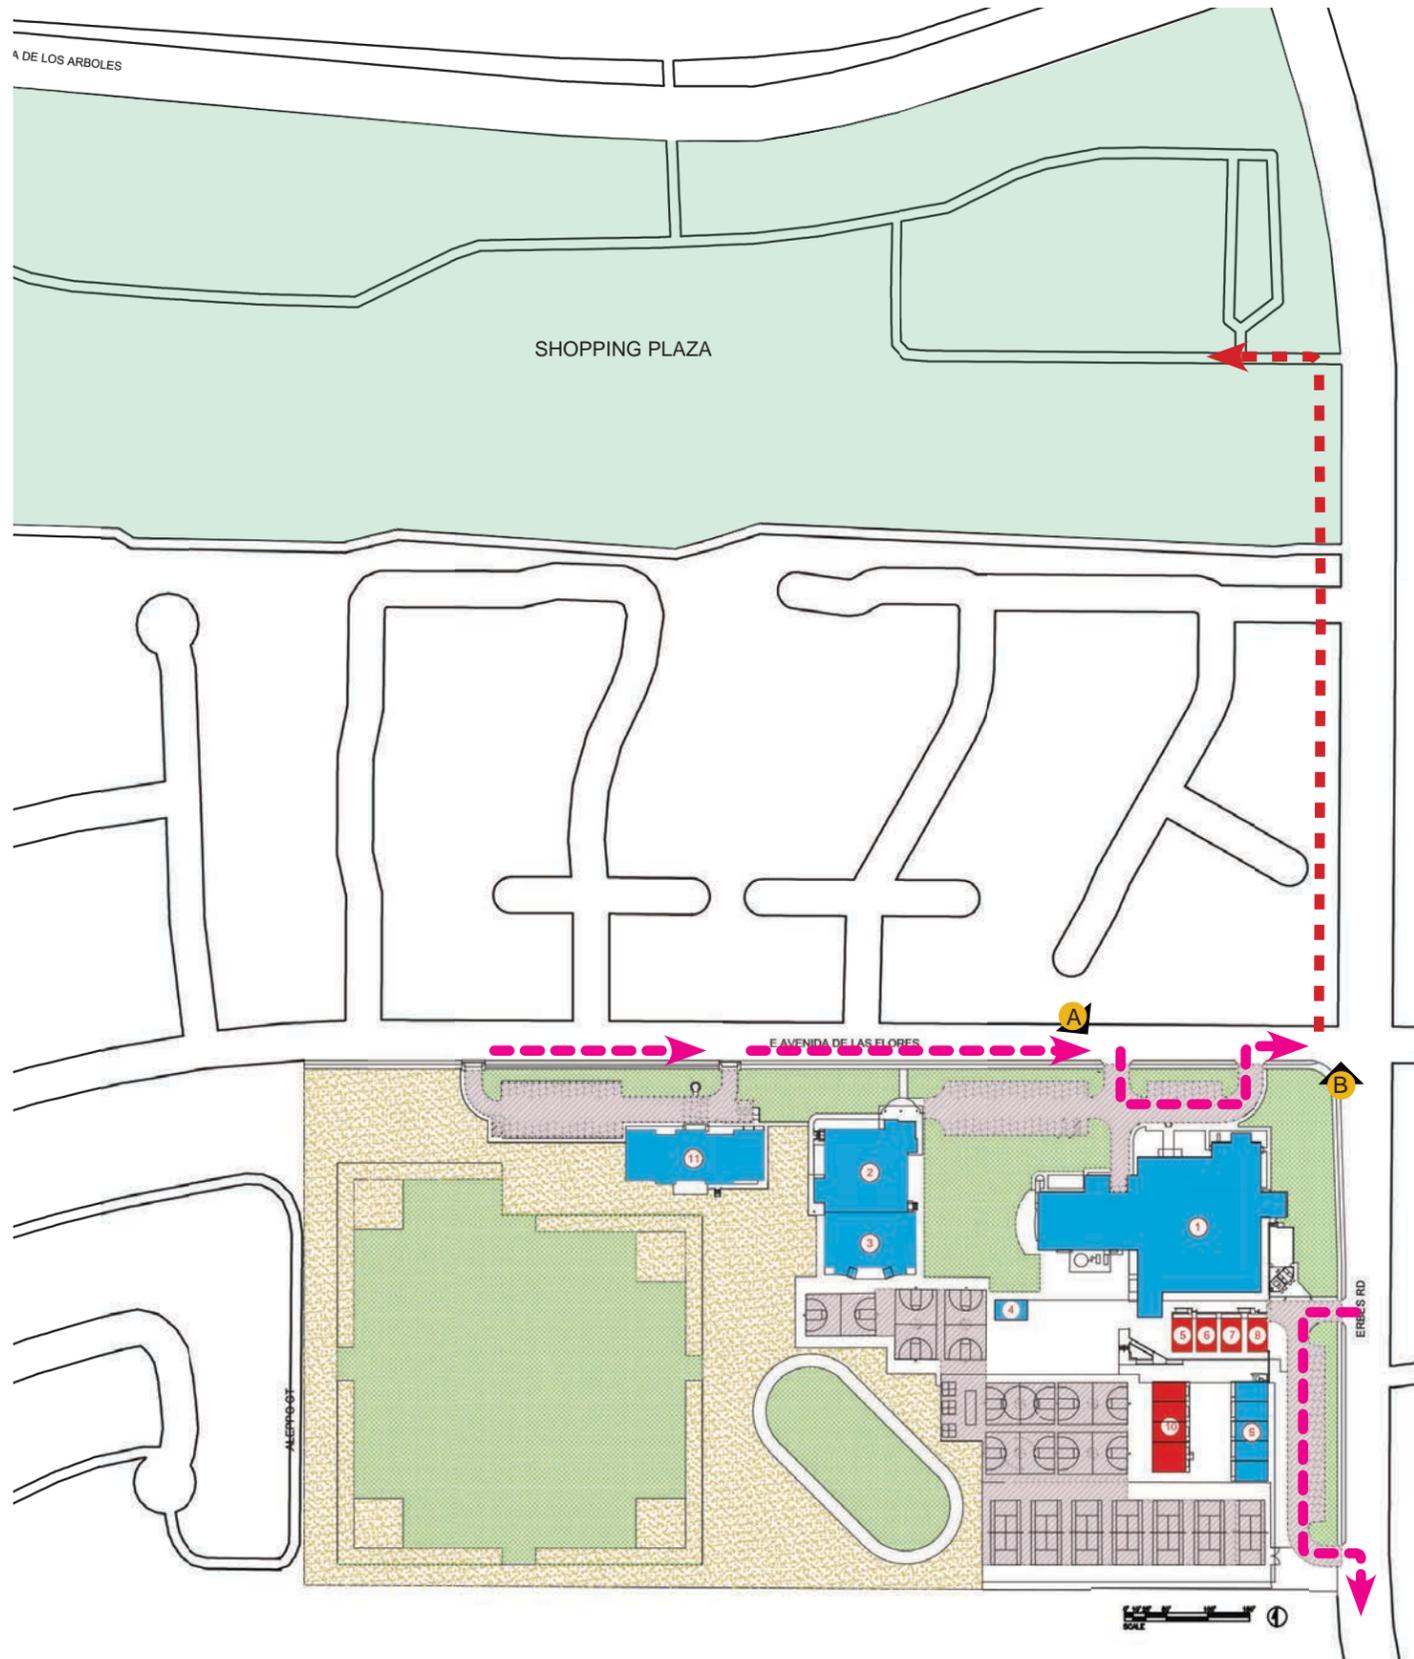
Improve undersized drop-off and pick-up areas

Reconfigure parking to meet campus needs

Improve campus identity

The current parking count does not accommodate the needs of the school. Moreover, the multiple drop-off areas are not sufficient. The adjacent mall is often times used as an alternate pick-up area. There is no path of travel from the Erbes Street drop-off area to Building 1.

A consolidated parking lot that increases parking count, and accommodates longer lines of queuing for drop-off may improve the undersized facilities. Moreover, the face of the school may be modernized in the same effort to bolster the campus' identity within the neighborhood. This may include reconfiguring the parking north of Building 1, and providing the main campus building a stronger presence on the street.

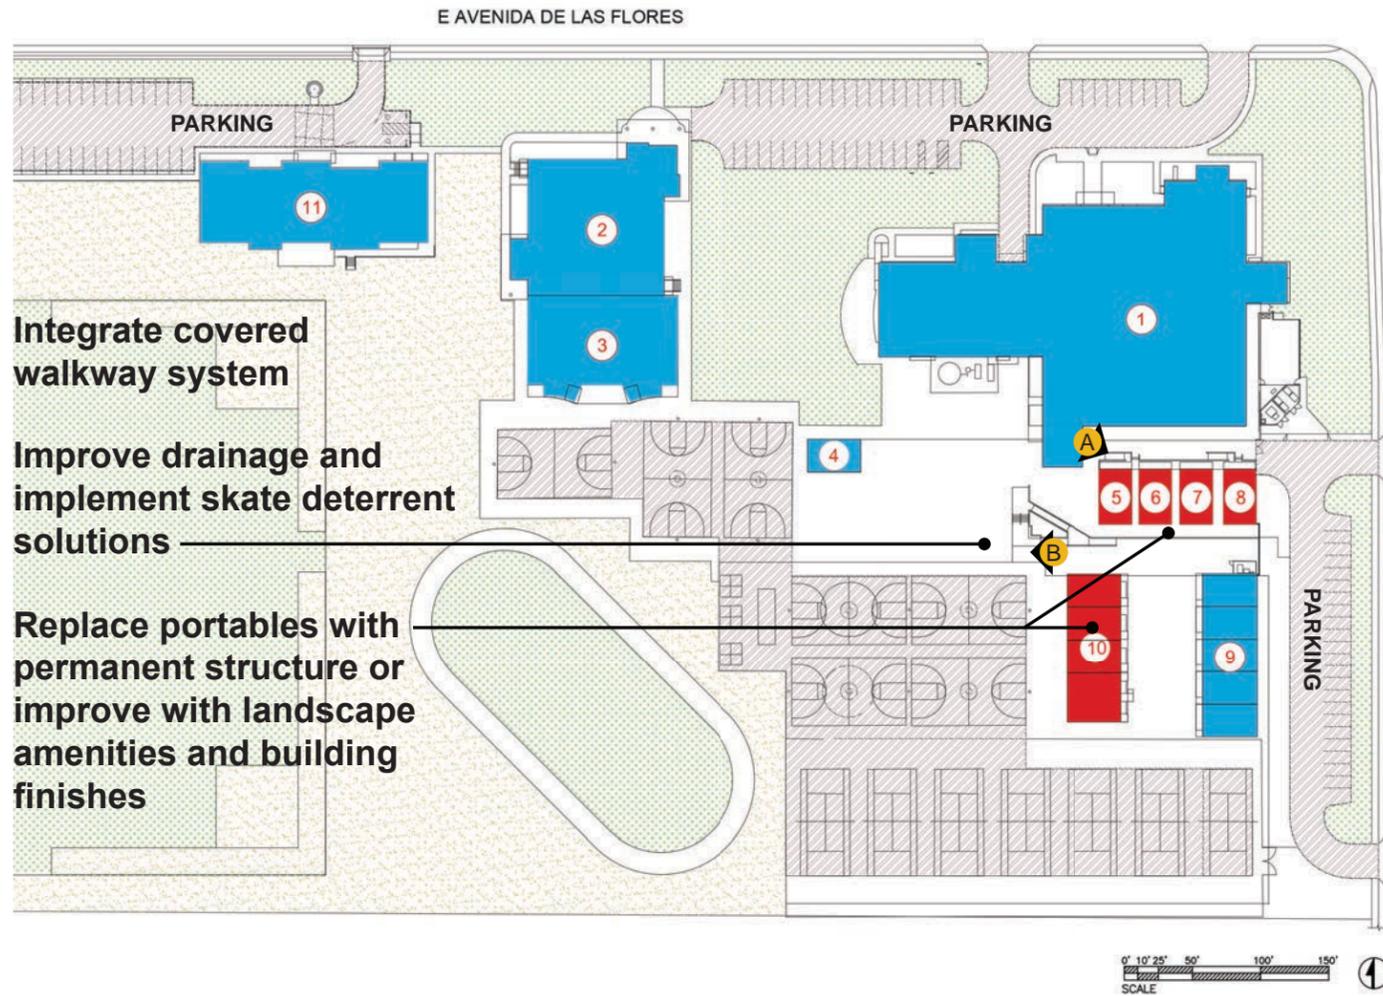
Several uncertified portable buildings occupy the campus. Between 13 and 19 years old, they are in working condition. They may be replaced with permanent structures, absorbing adjacent auxiliary storage structures in the process. Or, the portables may be improved with landscaping and courtyard amenities.

This campus has generous outdoor spaces. They may be greatly improved through the use of site furniture, landscaping and shade structures to create distinct areas of rest and play.

The sloped walkway and stair zone south of the eating area poses challenges of drainage and misuse. Drainage may be improved through the replacement of the existing drainage grate.

Integration of covered walkways throughout the campus would improve use of the facilities during inclement weather.
