## **ASPEN ELEMENTARY SCHOOL**

CVUSD - THOUSAND OAKS CLUSTER MASTER PLAN & PROJECTS

April 2017

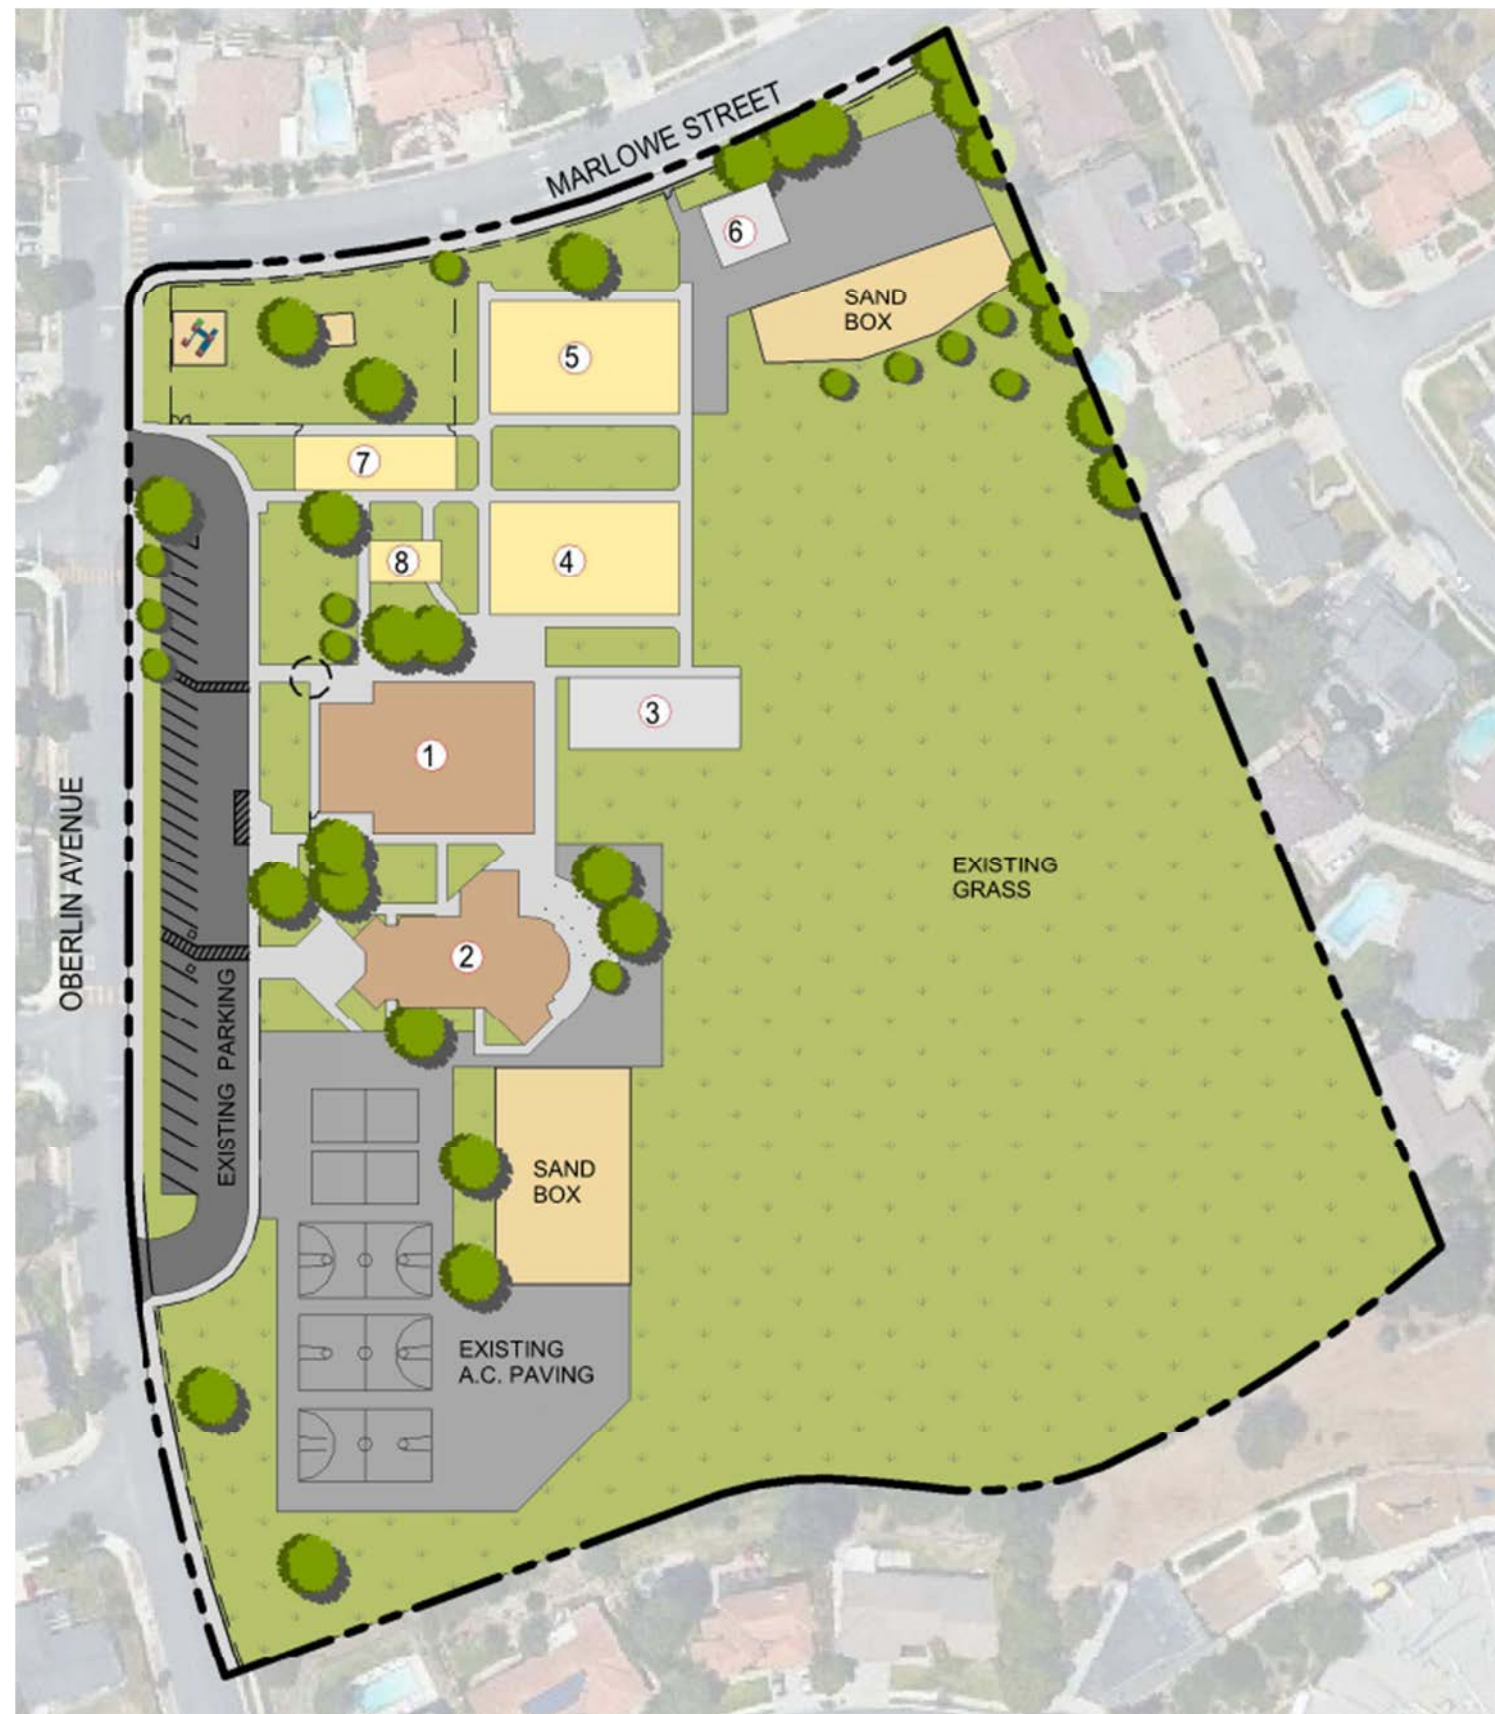
## BUILDING CONDITIONS

- Good Condition Permanent Building
- Fair Condition Permanent Building
- Poor Condition Permanent Building
- Fair Condition Portable Building
- Poor Condition Portable Building
- Seismic Evaluation Required

Overall condition of the buildings are fair. The school has received major HVAC and system upgrades as well as lighting upgrades. The multi purpose building is relatively new being only 20 years old and is in excellent condition. Most of the roofing is in need of upgrades based on age but is working well and have no significant issues.

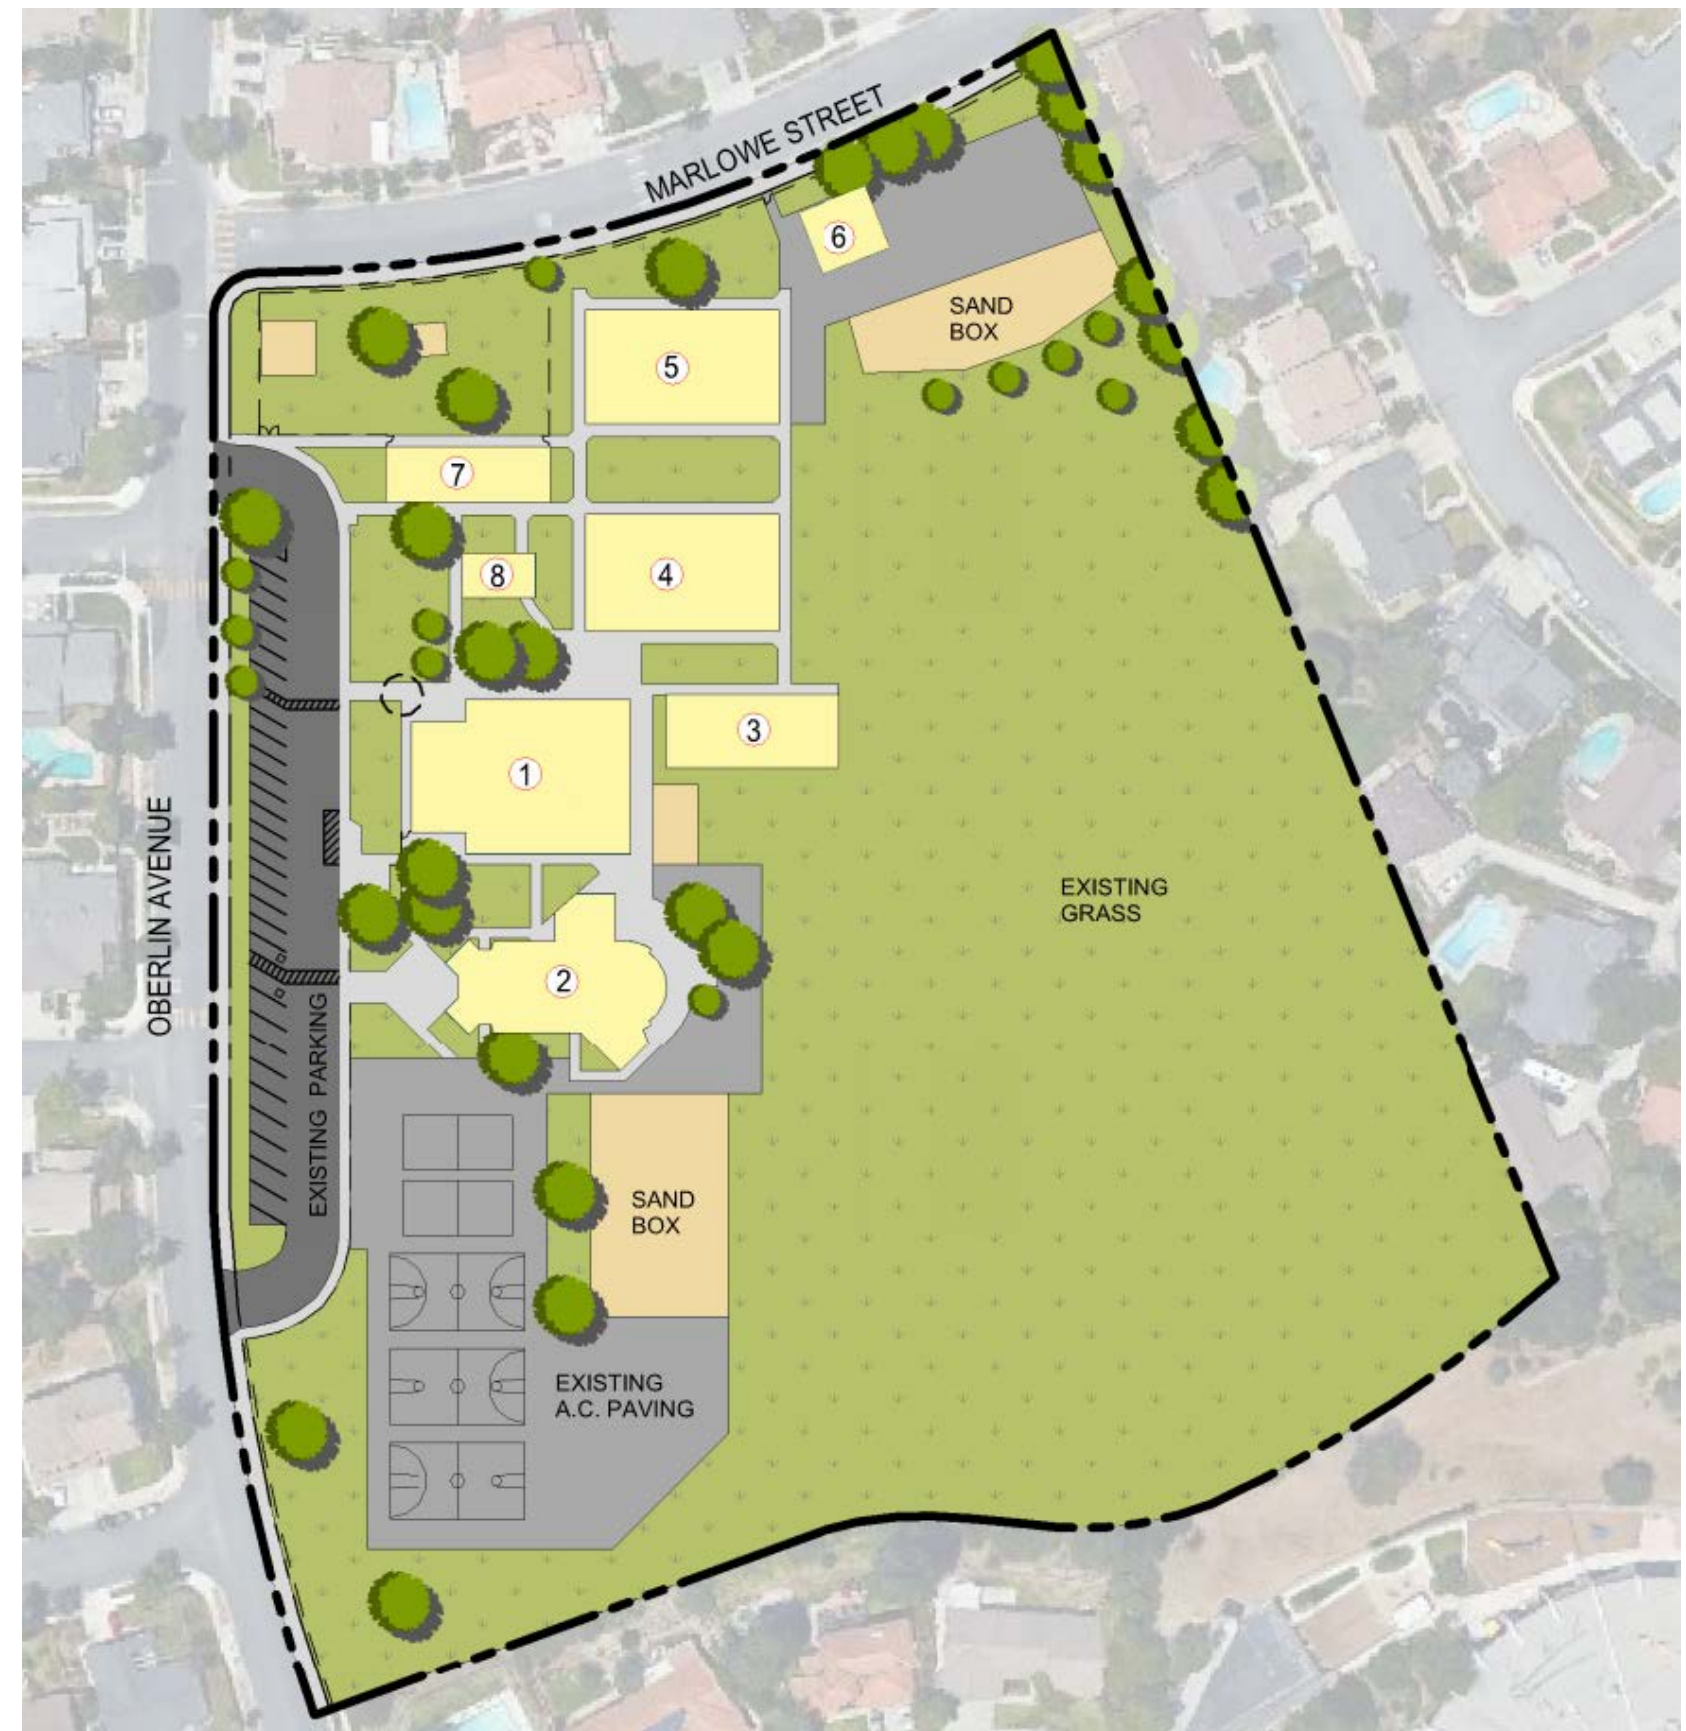
### EXISTING BASE PLAN

- New landscaping at front of campus and new paint for the entire campus. Correct some of the accessibility issues on site
- Reconfigure the entry to the school to remove existing buzzer system. Some reconfiguration and modernization of the administration office will be needed to accommodate the entry change.
- New playground equipment with shading and new fall protection surfaces. Play Equipment Area will be made current with accessibility standards. Remove Existing low CMU walls around the play surface.
- Modernization of existing library and addition of new solar tubes to increase daylight levels.
- Regrade and landscape are needed to resolve drainage issues and create outdoor learning space.
- Incorporate principals of sustainability into the design.
- Upgrade campus accessibility to be in line with

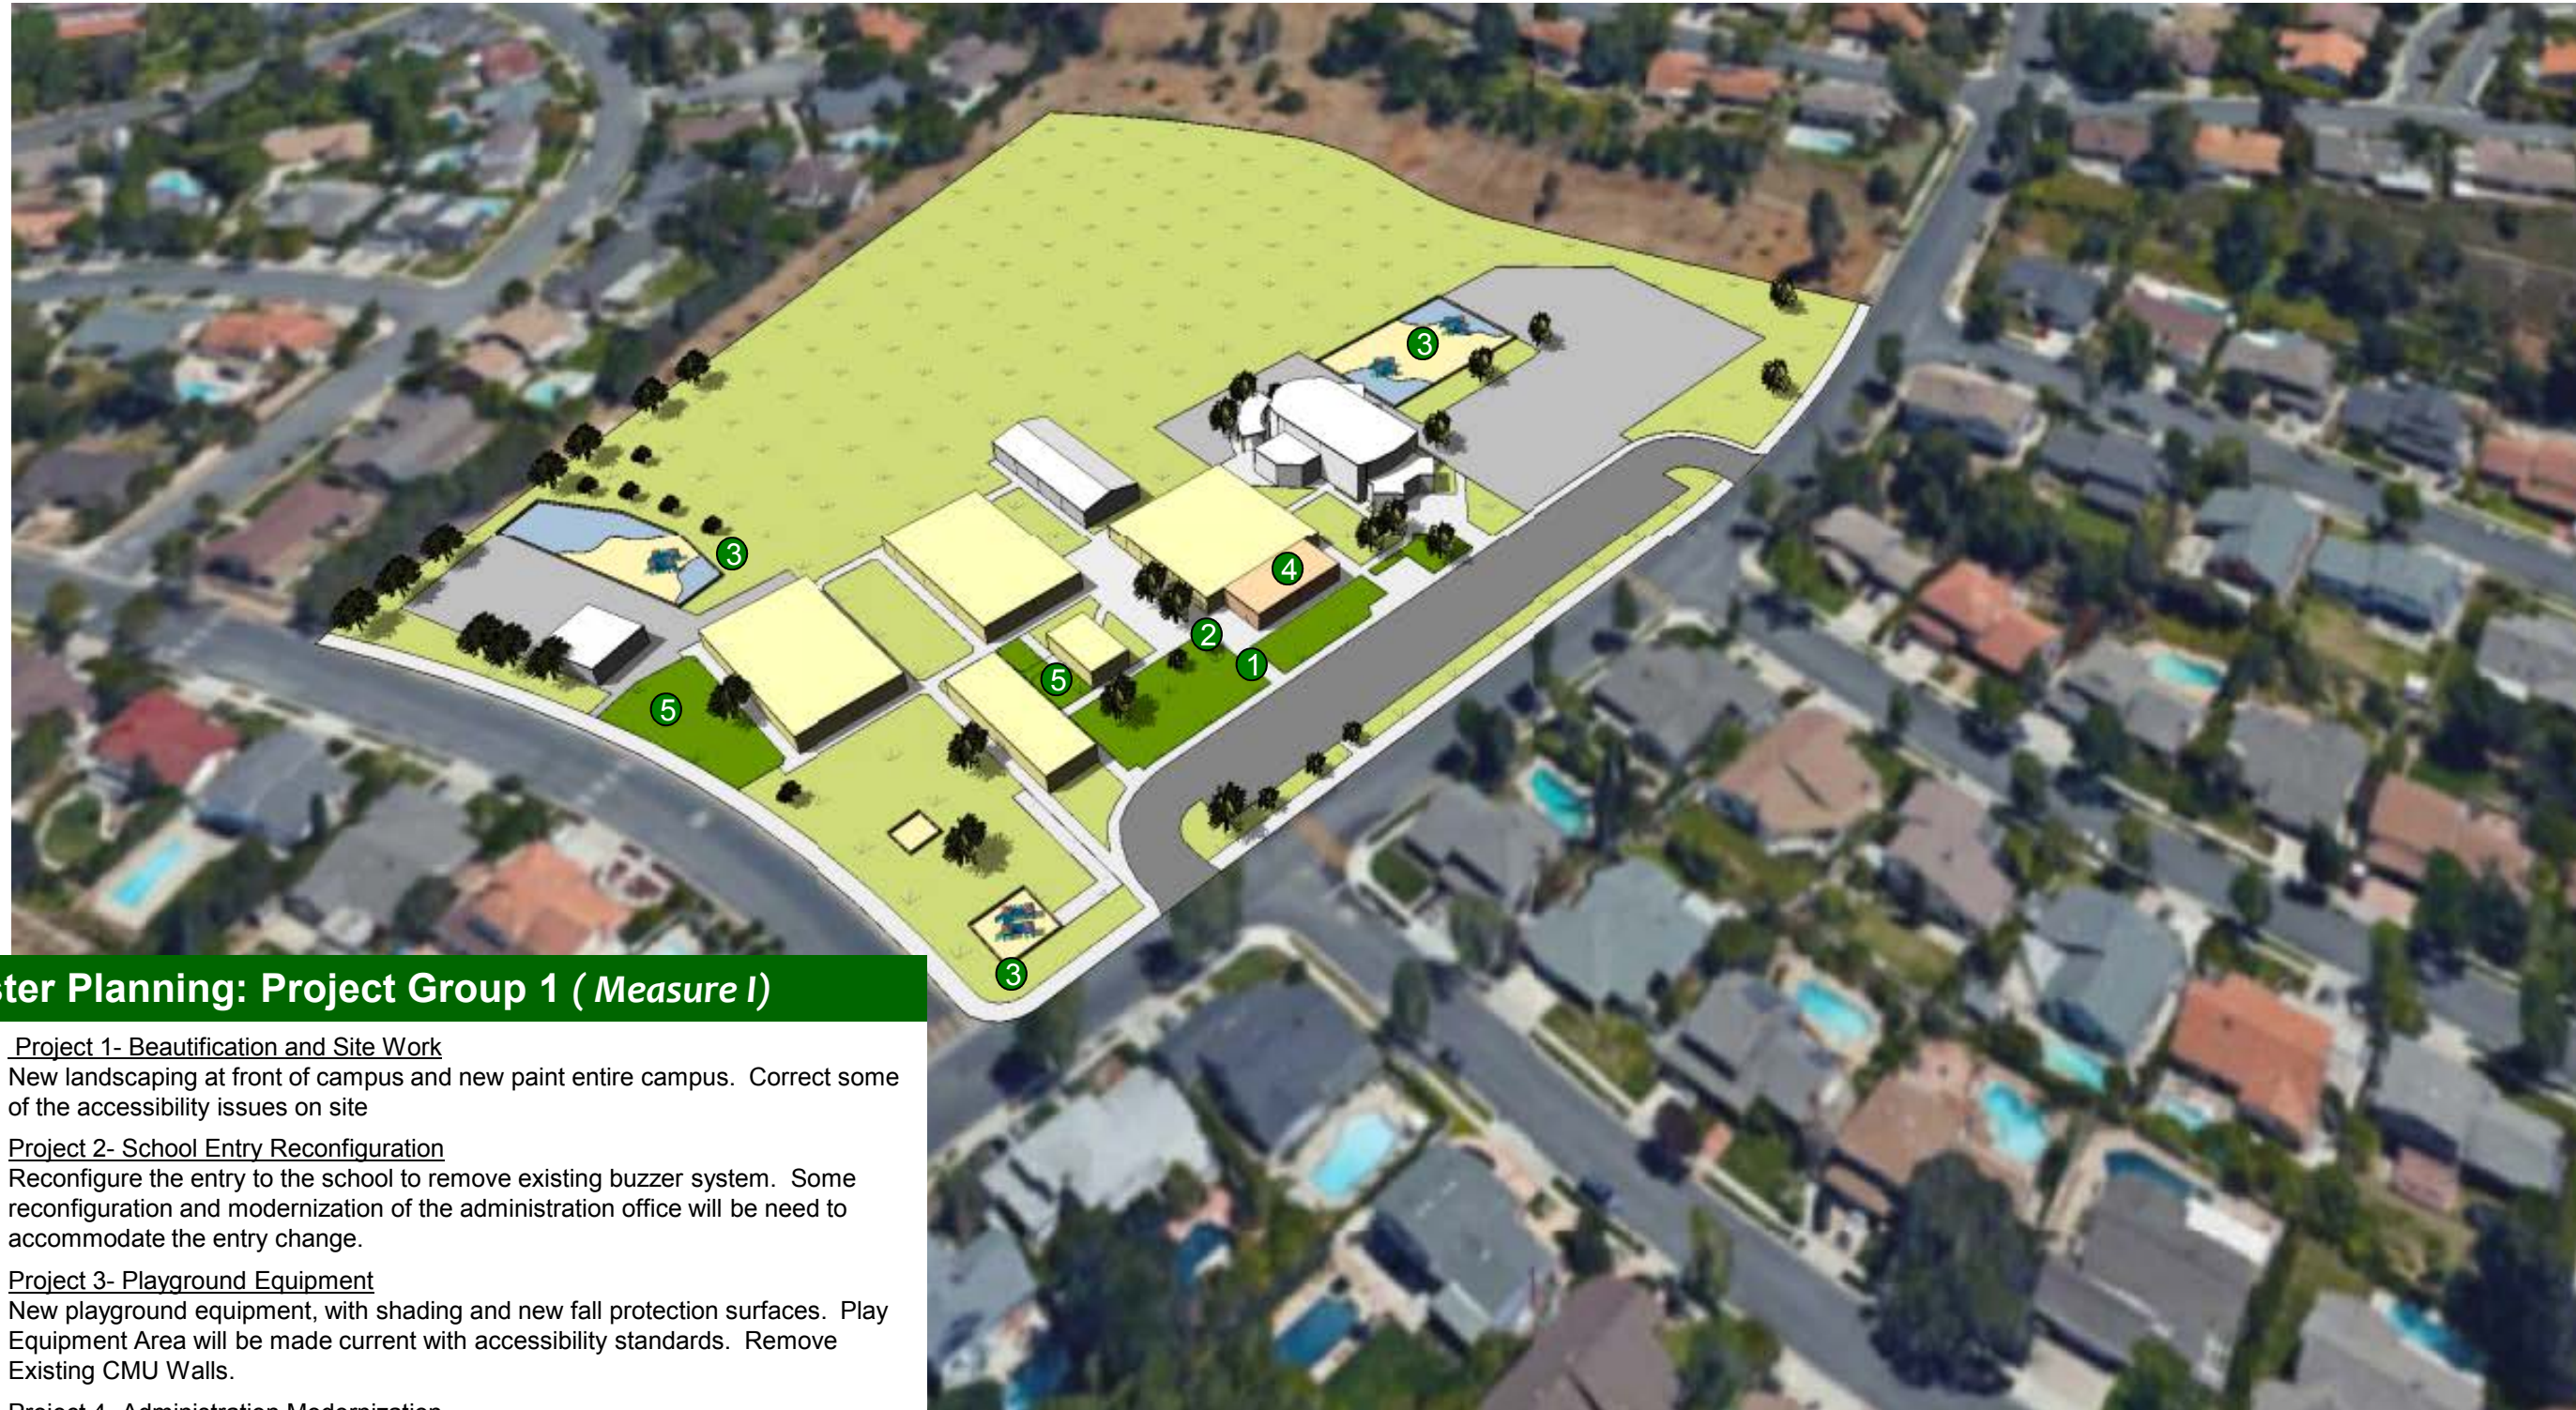
## Master Planning- Projects

- 1** Project 1- Beautification and Site Work  
New landscaping at front of campus and new paint entire campus. Correct some of the accessibility issues on site

- 2** Project 2- School Entry Reconfiguration  
Reconfigure the entry to the school to remove existing buzzer system. Some reconfiguration and modernization of the administration office will be need to accommodate the entry change.

- 3** Project 3- Playground Equipment  
New playground equipment, with shading and new fall protection surfaces. Play Equipment Area will be made current with accessibility standards. Remove Existing CMU Walls.

- 4** Project 4- Administration Modernization  
Modernization of existing library and addition of new solar tubes to increase daylight levels.
- 5** Project 5- Outdoor Learning Space  
Regrade and landscape are to resolve drainage issues and create outdoor learning space.

- 6** Project 6- New Classroom Building  
New 4000 SF classroom building to replace existing portables. The classroom building will include enhanced site work and paving around the new building.

- 7** Project 7- Removal of Portable  
Remove existing portable buildings in middle of campus after new classroom building has been completed. Provide new landscape planting after removal

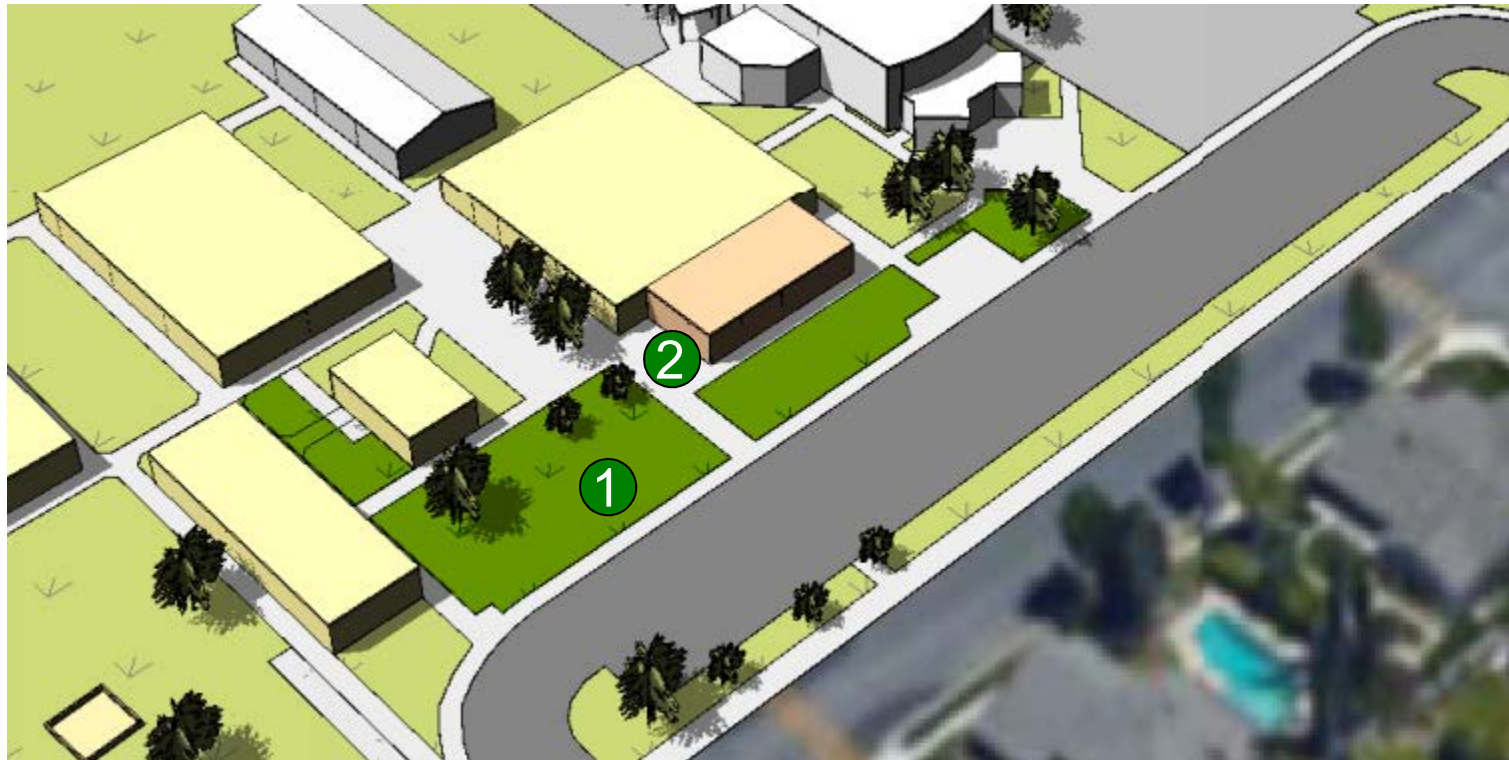
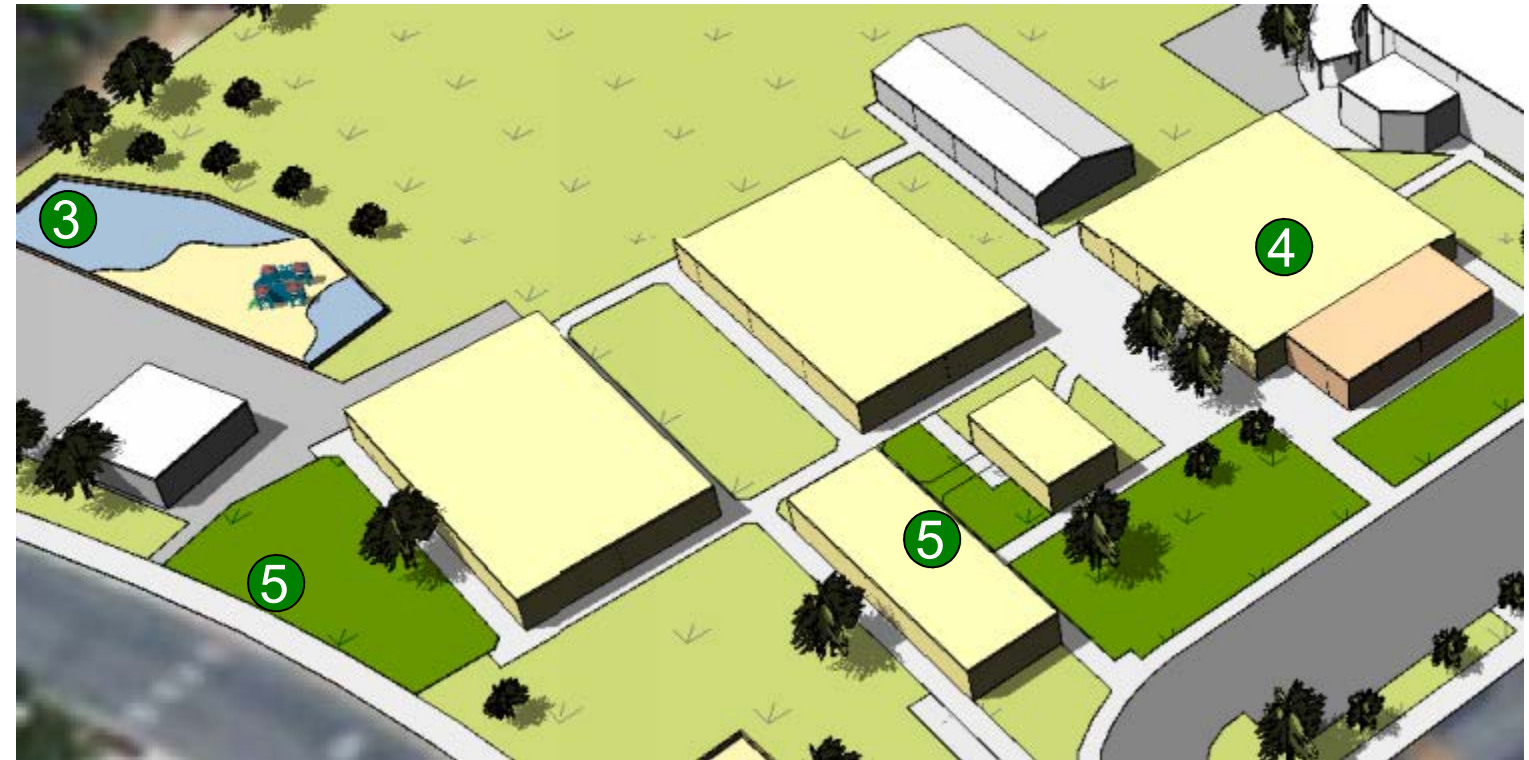
- 1** Project 1- Beautification and Site Work \$250,000  
 New landscaping at front of campus and new paint entire campus. Correct some of the accessibility issues on site
- 2** Project 2- School Entry Reconfiguration \$700,000  
 Reconfigure the entry to the school to remove existing buzzer system. Some reconfiguration and modernization of the administration office will be need to accommodate the entry change.

- 3** Project 3- Playground Equipment \$750,000  
 New playground equipment, with shading and new fall protection surfaces. Play Equipment Area will be made current with accessibility standards. Remove Existing CMU Walls.
- 4** Project 4- Administration Modernization \$250,000  
 Modernization of existing library and addition of new solar tubes to increase daylight levels. New floor safe in office.
- 5** Project 5- Outdoor Learning Space \$250,000  
 Regrade and landscape are to resolve drainage issues and create outdoor learning space.

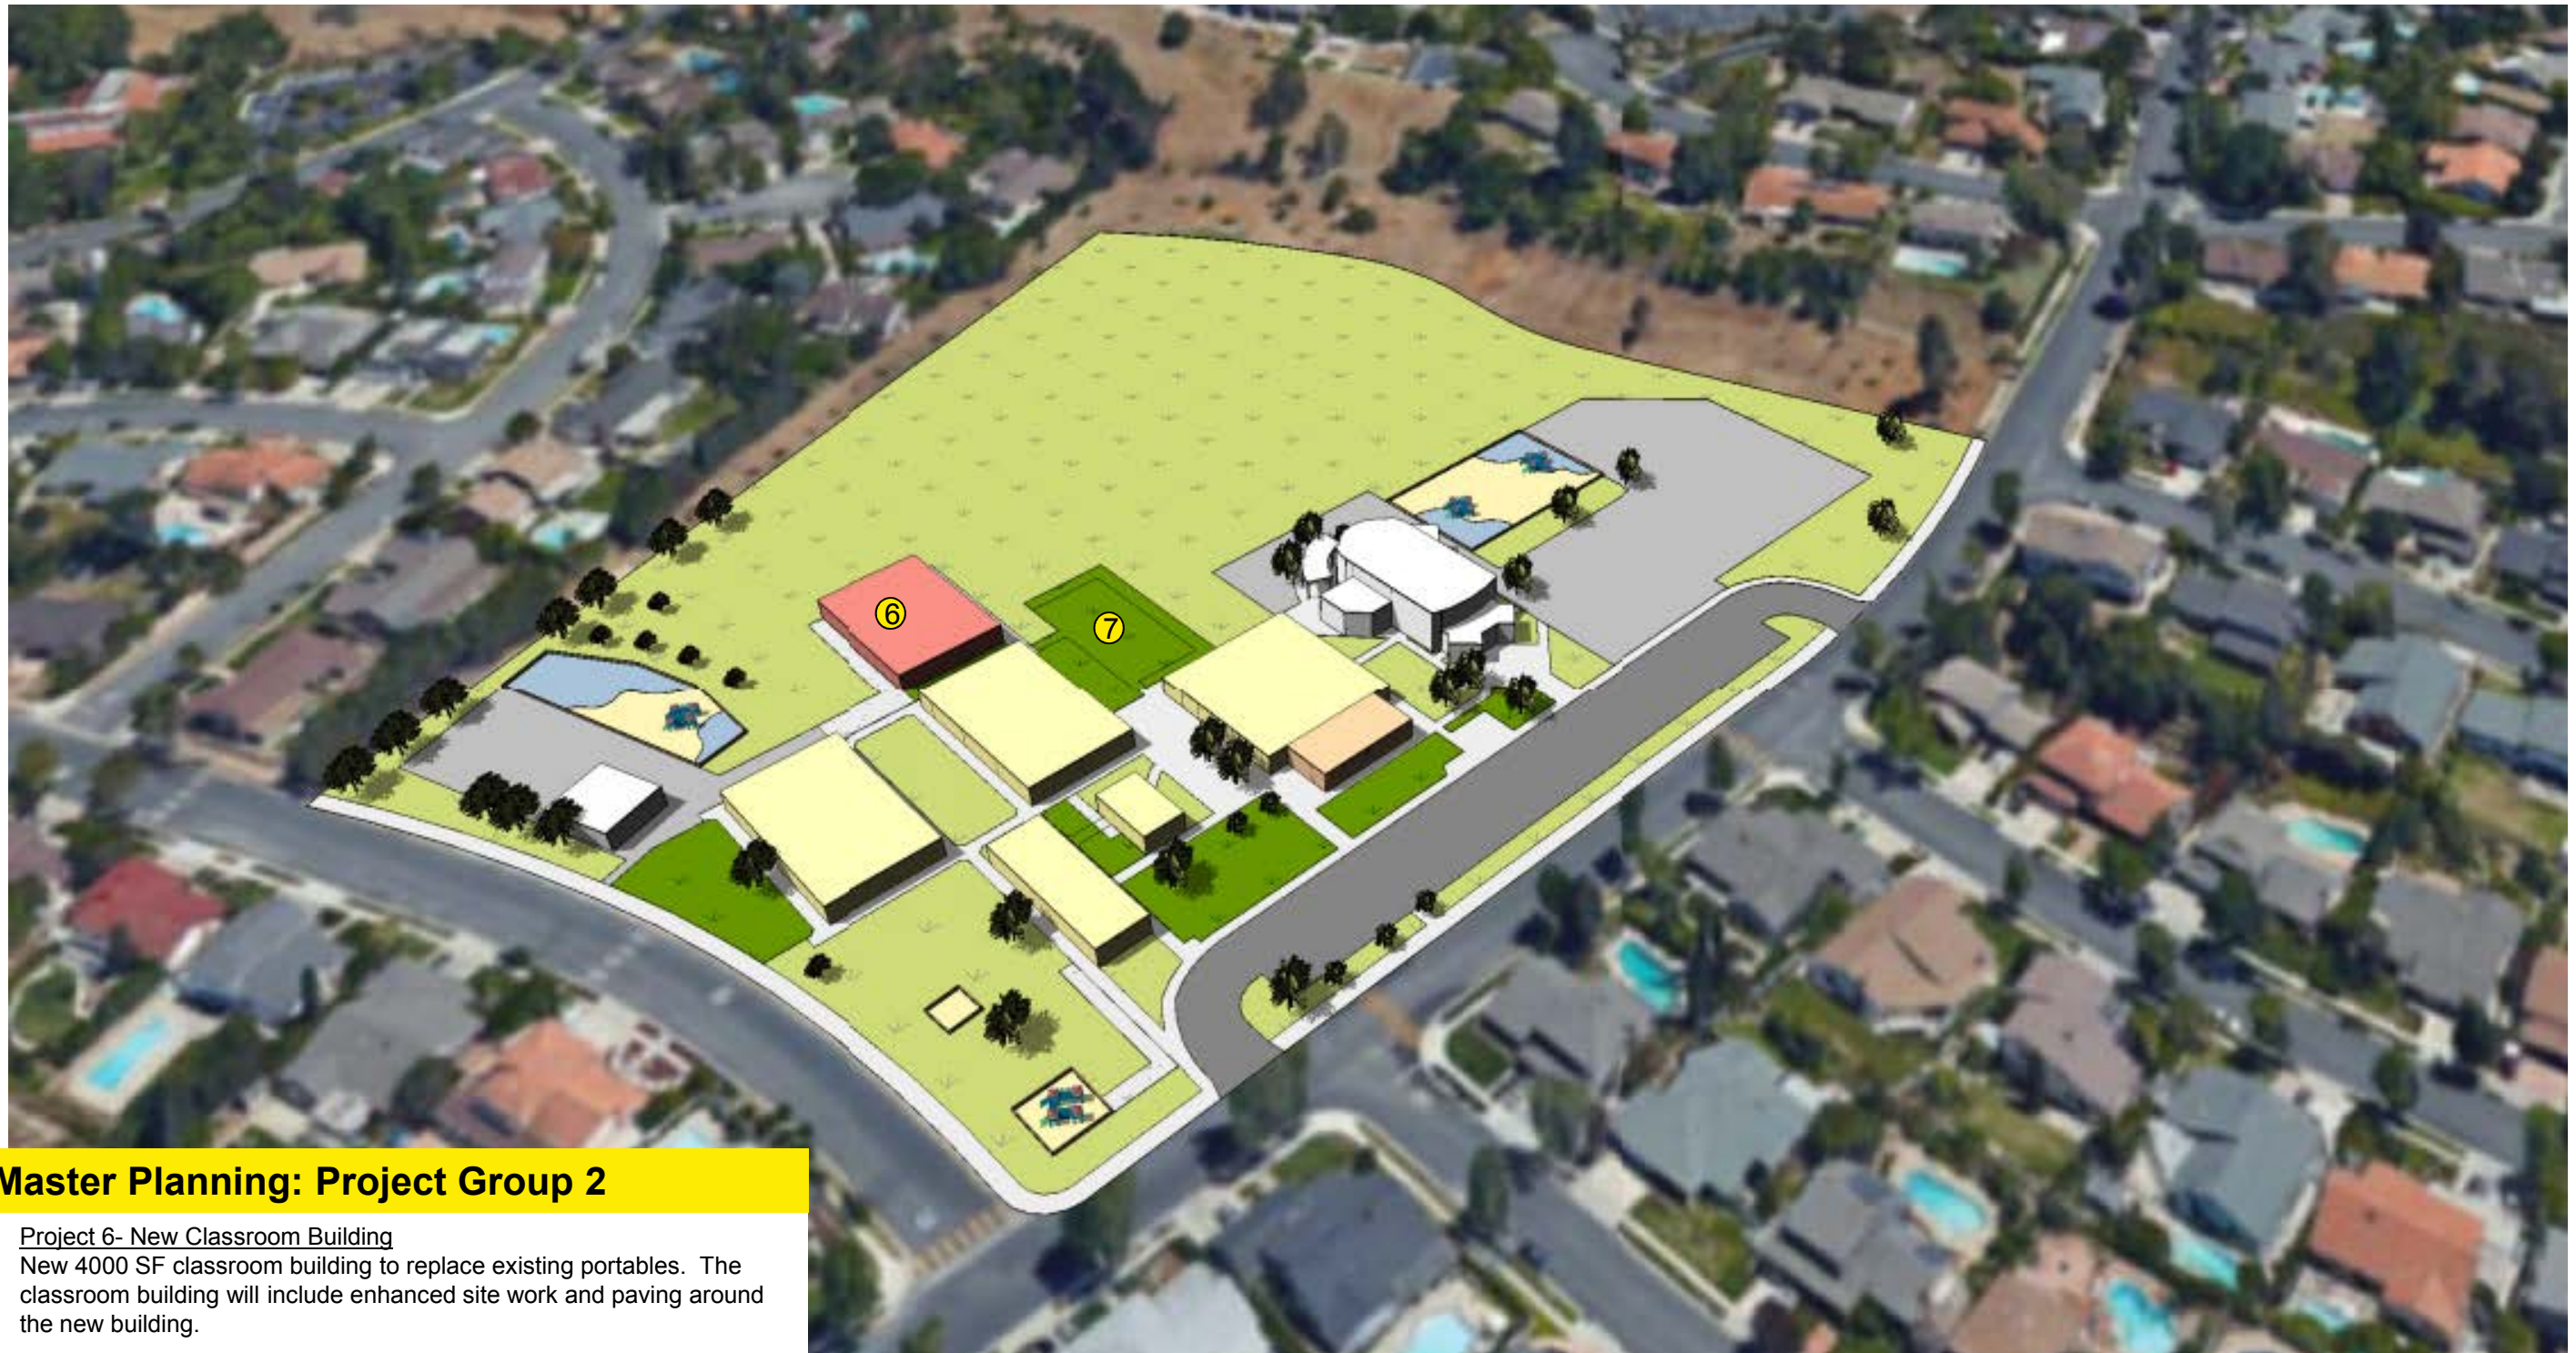
## Master Planning: Project Group 2

- ⑥ Project 6- New Classroom Building  
New 4000 SF classroom building to replace existing portables. The classroom building will include enhanced site work and paving around the new building.
- ⑦ Project 7- Removal of Portable  
Remove existing portable buildings in middle of campus after new classroom building has been completed. Provide new landscape planting after removal

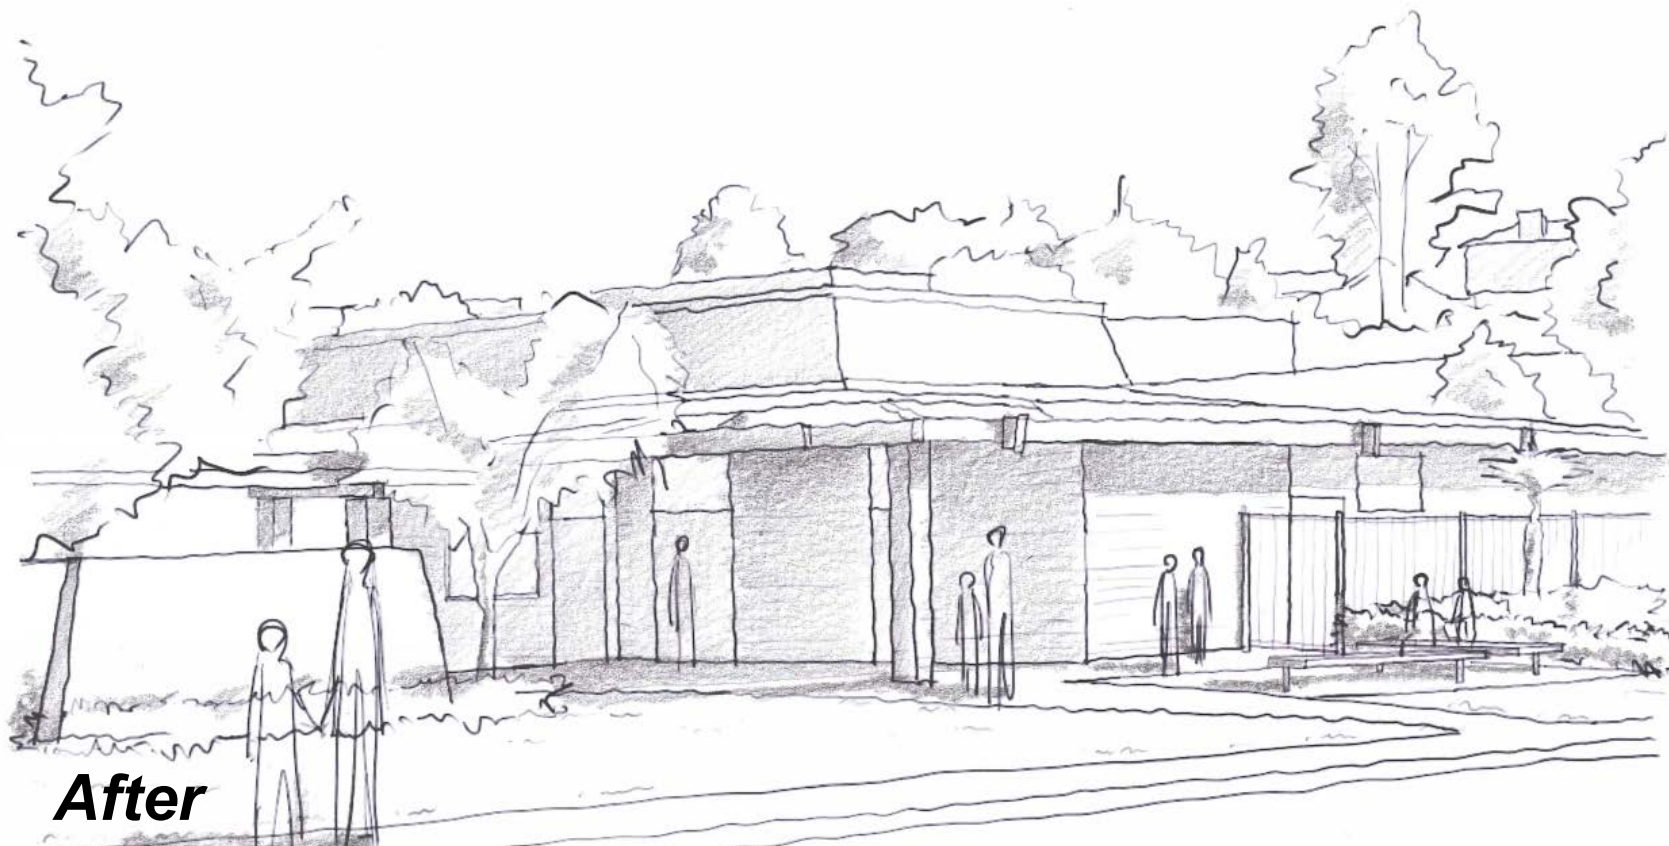
**After**

New Façade and Entry

Aspen Elementary School will receive an enhanced façade that will create a well defined entry point that is free from the confusing buzzer system and excessive fencing that is obstructing the view of the attractive architecture of the campus. The new entry configuration will create a seating area in front of the administration building as well as incorporate new paint and landscaping.
