# CVUSD | *Facilities Master Plan*

## Acacia Elementary School | *Survey*

55 W Norman Ave | Thousand Oaks, CA 91360

December 9th, 2016

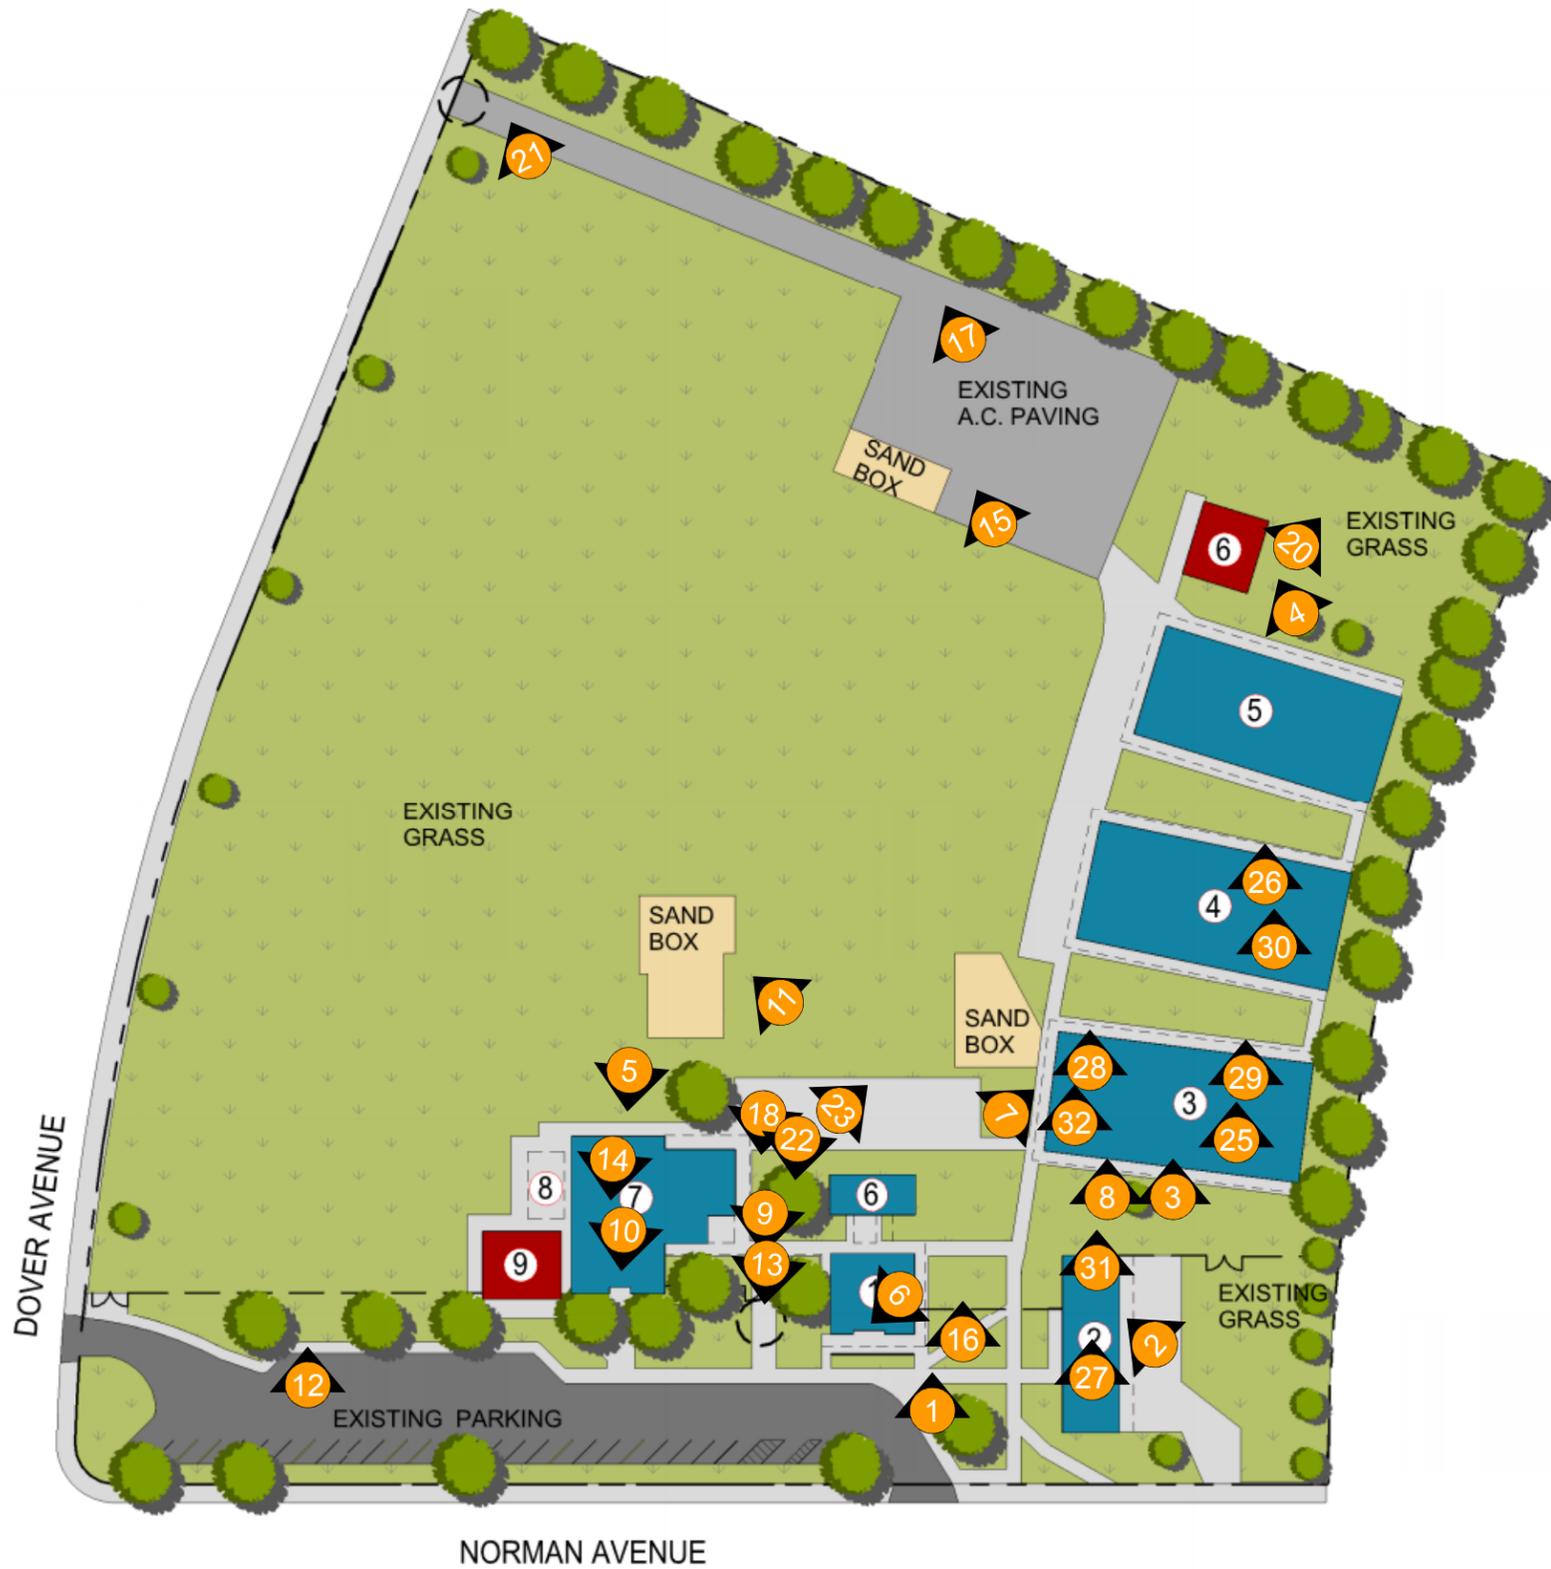
**EXISTING SITE PLAN | ACACIA ELEMENTARY SCHOOL BUILDING USE**

- 1 DRAINAGE AND CONCRETE SETTLEMENT ISSUES
- 2 DRAINAGE ISSUES AND PONDING, LOCATION NEED TO BE REWORKED
- 3 BREEZEWAY CONVERTED TO CLASSROOM WINDOWS ARE MISSING SETTING BLOCK AND HAVE LARGE GAPS
- 4 SLOPE OF GROUND TOO STEEP FOR WHEELCHAIR ACCESS TO PLAYGROUND
- 5 MAJOR ACCESS POINT TO SCHOOL NOT ACCESSIBLE. NEED TO CHANGE GATE ORIENTATION
- 6 CONCRETE SLAB SETTLEMENT AND VISIBLE CRACKING IN SLAB AND WALLS
- 7 CONCRETE WALKWAY SETTLEMENT ISSUES
- 8 PRIMARY OPORTUNITY LOCATION: REMOVE WALL AND RE-DESIGN ENTRANCE

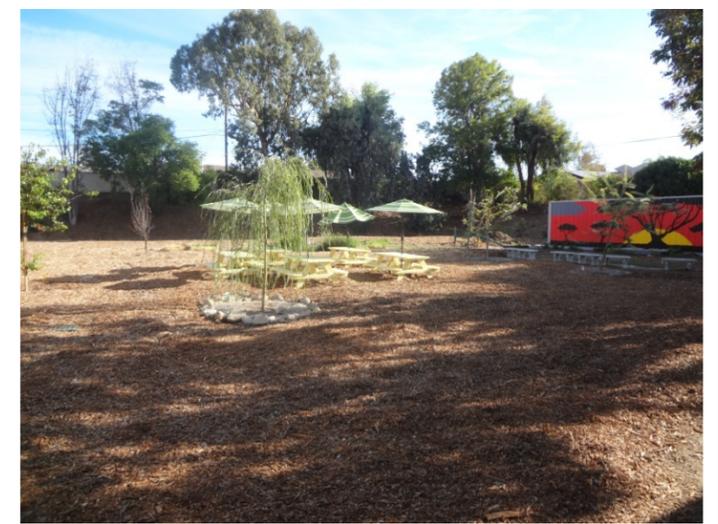
**Photo -17**  
**Alternate Point of Entry :**  
 Long A.C. Paving walkway from alternate entry location.
