# CVUSD | *Facilities Master Plan*

CVUSD – THOUSAND OAKS CLUSTER SURVEY

## Conejo Valley Unified School District Office | *Survey*

December 9, 2016

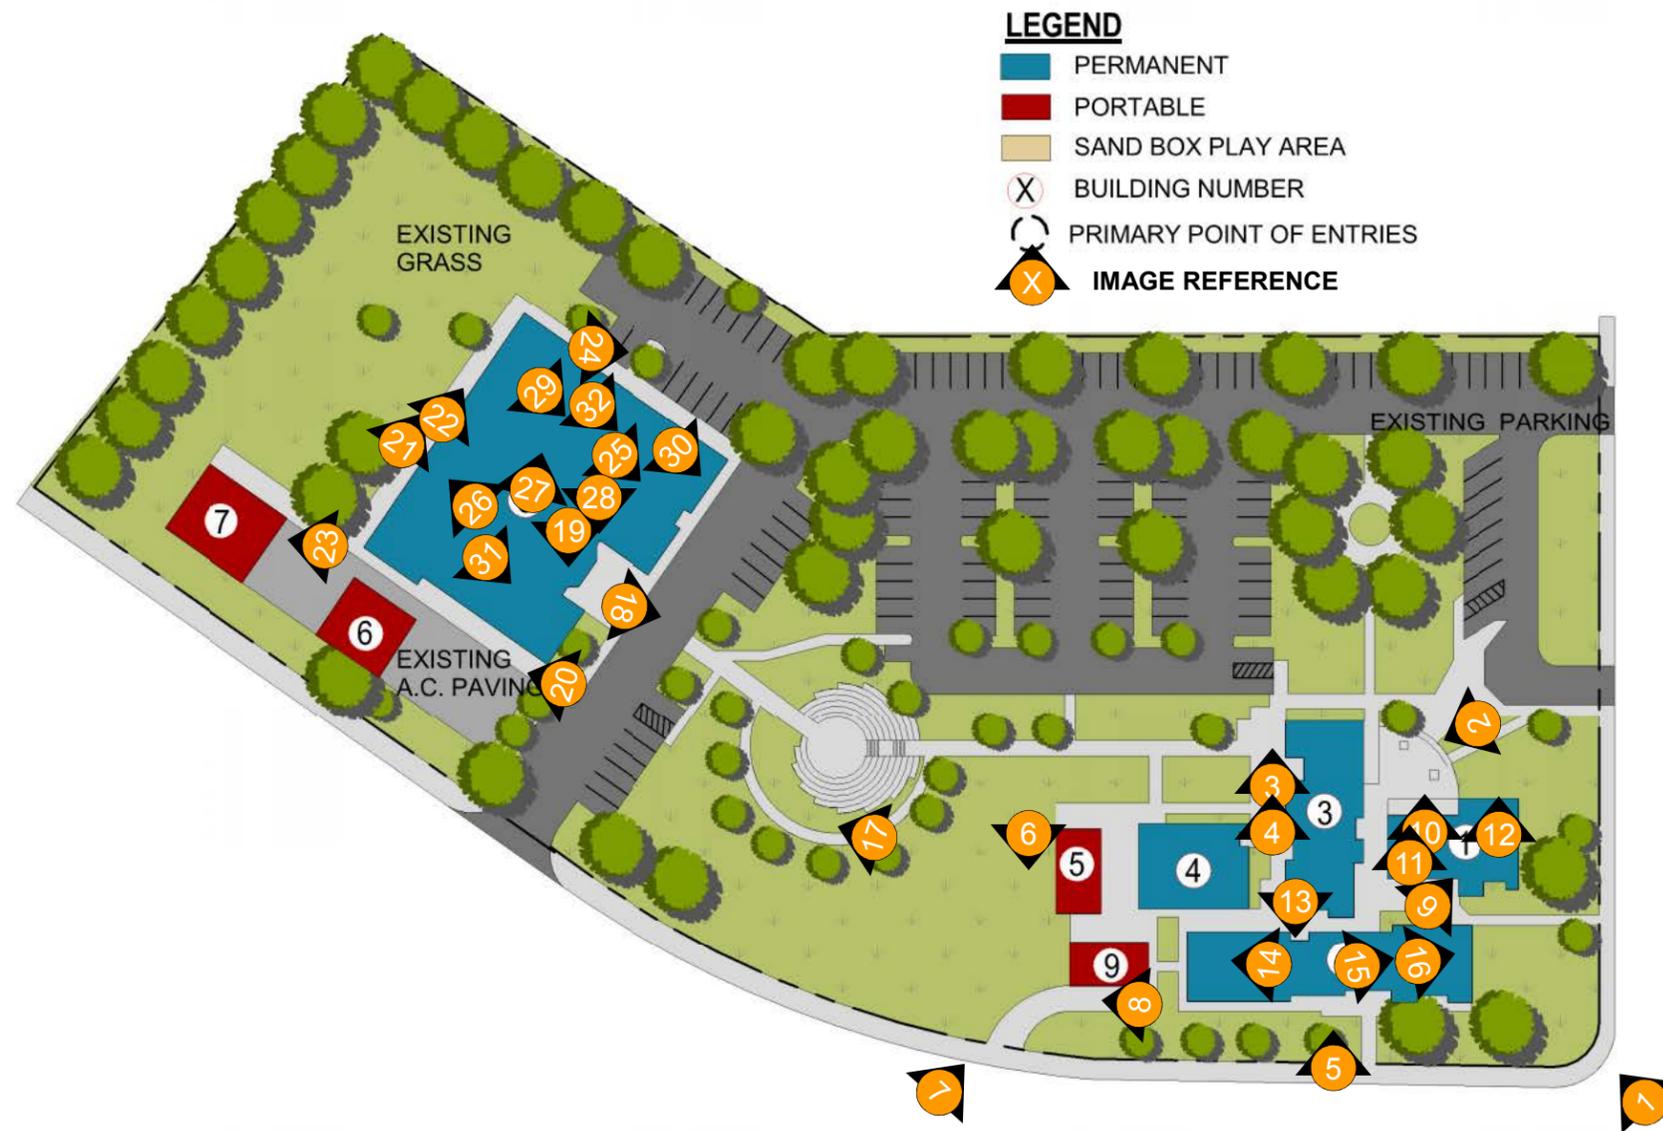
**EXISTING SITE PLAN | CONEJO VALLEY SCHOOL DISTRICT OFFICE BUILDING USE**

- ACCESSIBILITY UPGRADES THROUGHOUT SITE ON HARDWARE THRESHOLDS AND SINKS
- DRINKING FOUNTAINS WILL NEED TO BE MADE ACCESSIBLE
- ACCESSIBILITY UPGRADES NEEDED IN PARKING, GATE LOCATIONS, DOORS, AND SOME PATHWAYS
- REPLACEMENT/REPAIR OF HVAC SYSTEM
- ROOF IN NEED OF REPLACEMENT

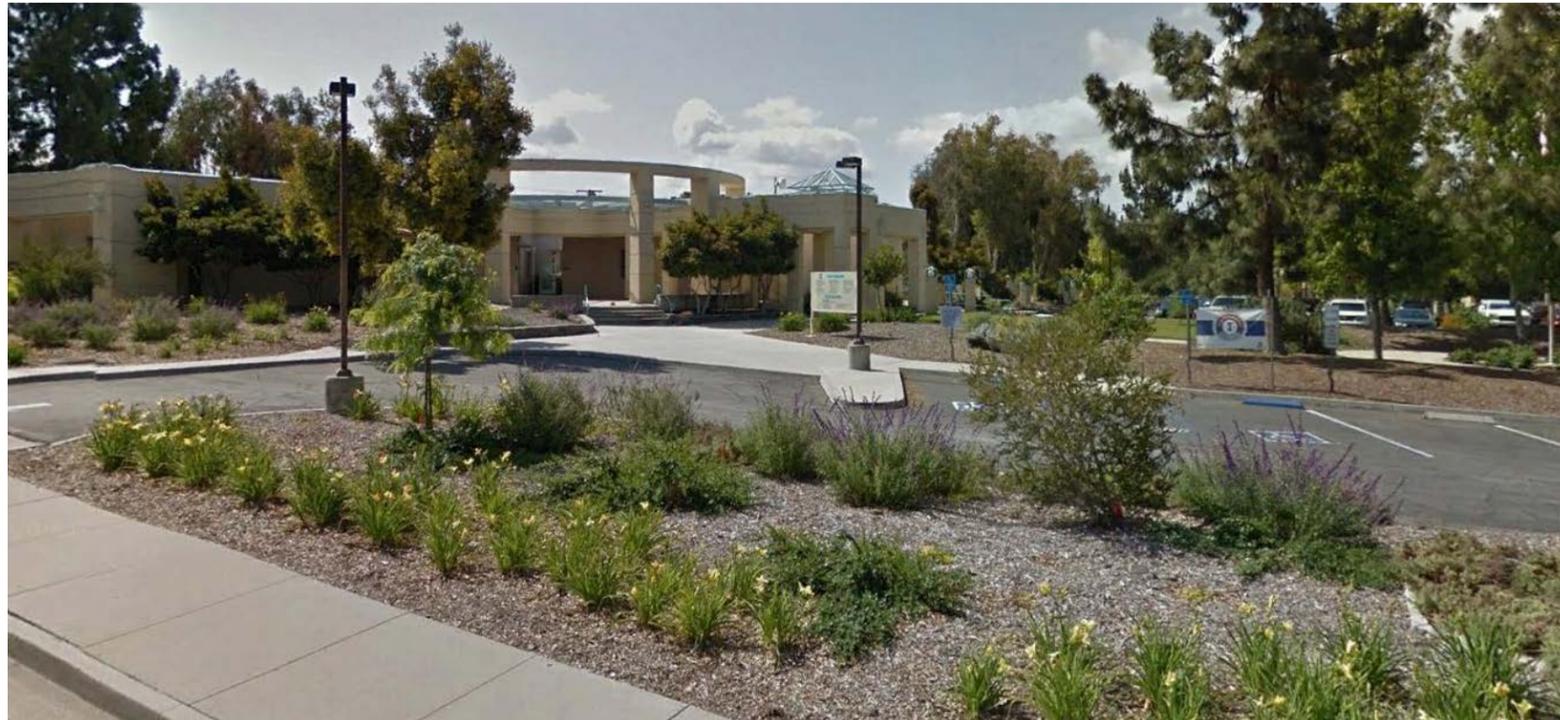
Image 1: Public Parking and Primary Entry Point for Northern Portion of Site

Photo -1  
The Northern complex of buildings has no accessible path of travel from the parking lot to the complex because it is not current to accessibility standards. The concrete slopes are greater than 5% and require handrails
