CVUSD – THOUSAND OAKS CLUSTER SURVEY

Ladera Elementary School | *Survey*

December 9th, 2016 – DRAFT v1

Dougherty + Dougherty
Architects

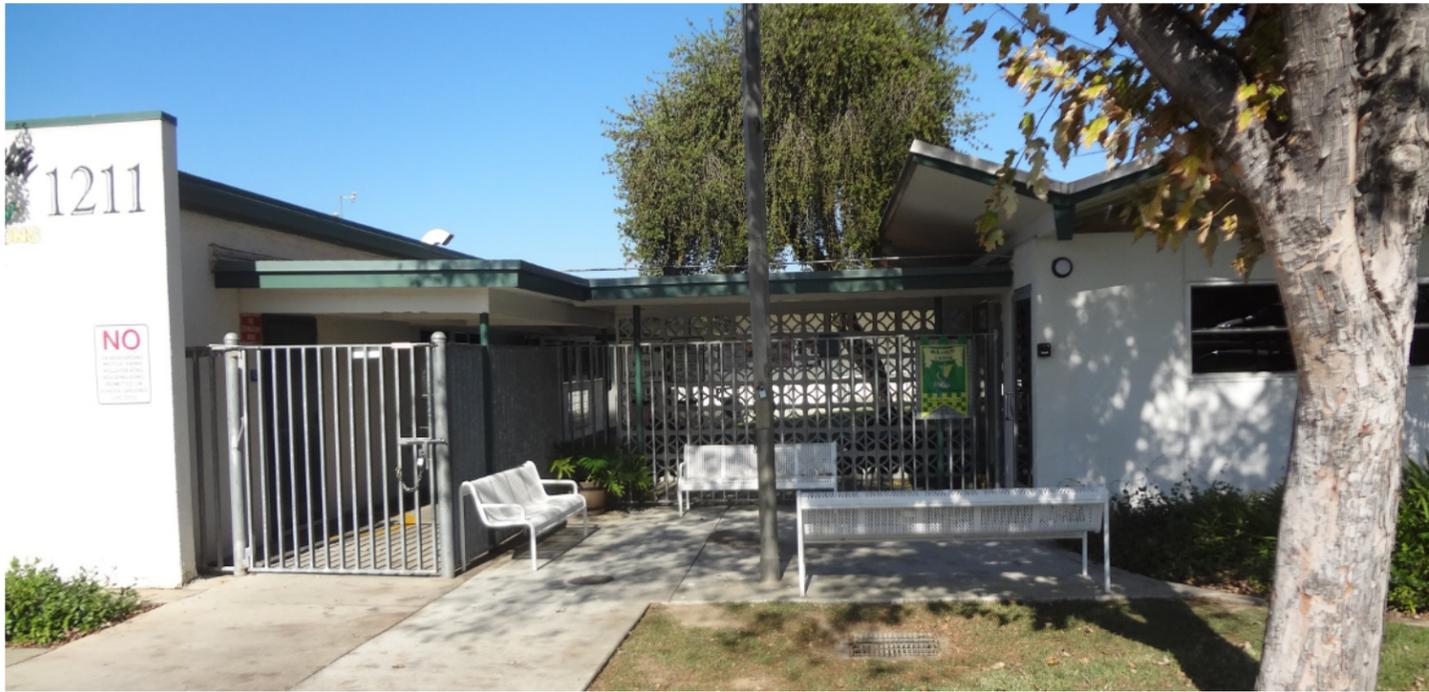
Image 1: Primary Entry to School

- Existing entry to school is not aesthetically designed well, with low overhangs and a very strong visual presence of the security gate
- Drop-off Zone not wheel chair accessible
- Larger Lunch Shelter needed
- Mechanical Systems need replacement
- Portable Buildings are very old and need to be removed
- New playground equipment needed
- Need stage for MPR
- Drainage and ponding issues next to MPR
- Need for maker space (stand Alone)
- Replacement of non-matching window glazing
