# CVUSD | *Facilities Master Plan*

## Acacia Elementary School | *Site Analysis*

55 W Norman Ave | Thousand Oaks, CA 91360

January 10th, 2017

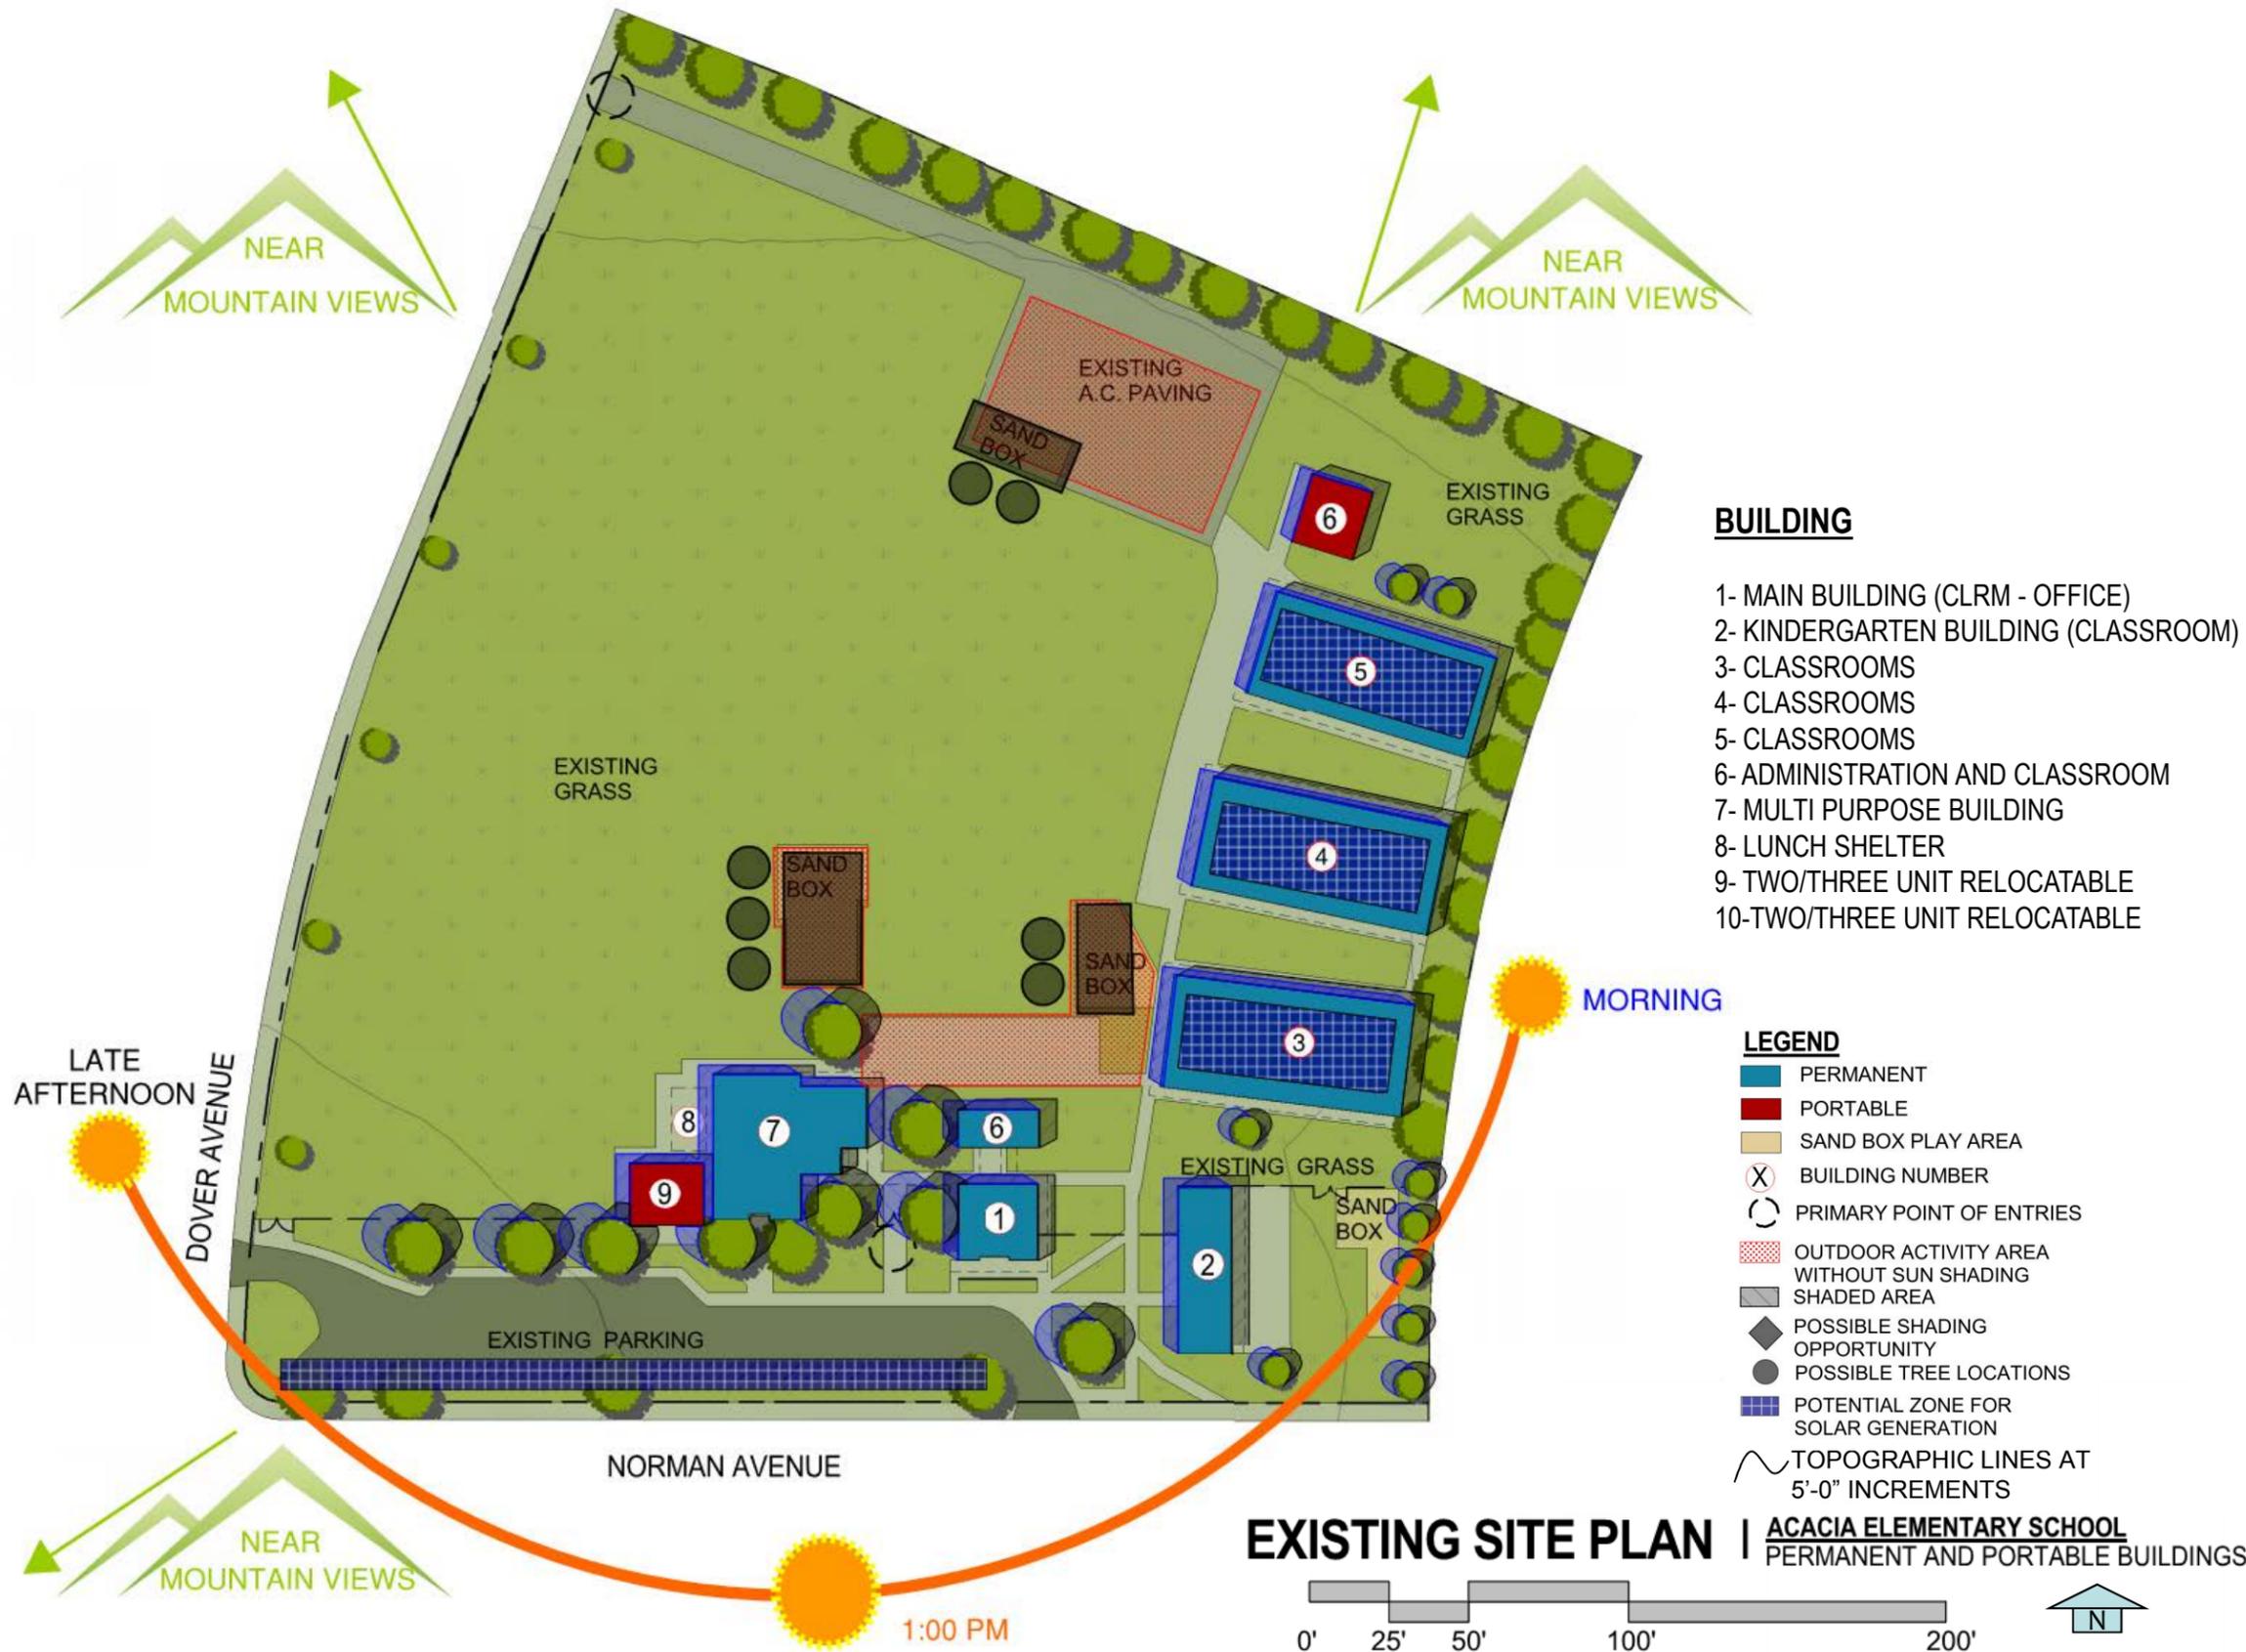
Acacia Elementary School's building alignment on the site provides little morning or afternoon shading of the playground areas. There are two possible means of providing additional shading to those outdoor activity areas.

The overall topography of the site is rather gentle comparing to other schools in the district. However, the soil condition may be affected by the movement of ground water and further geotechnical investigation is recommended at Building 7 to determine if further ground settlement might occur.

One shading opportunity is to build free-standing shading structure to shelter the playground from sun exposure. It should be noted that if free standing structure is to be built near the playground, the playground surface and equipment may be upgraded at the same time.

An alternative opportunity is to plant a row of trees at the western side of the playgrounds to provide shade in the afternoon.

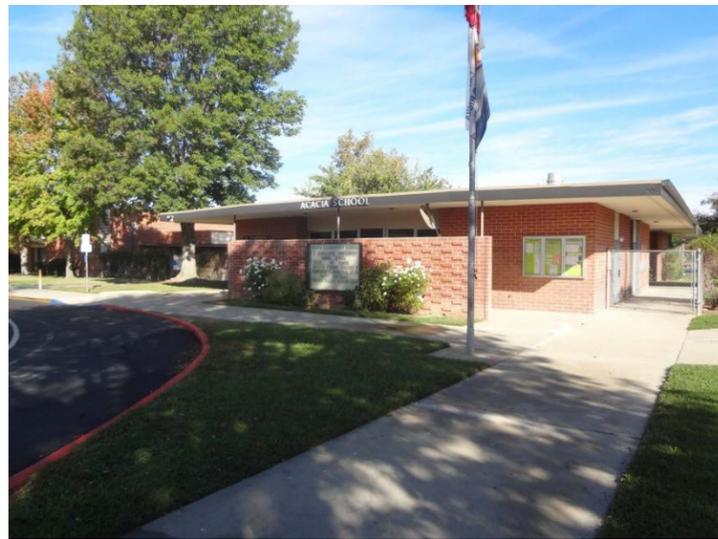
**Photo -1**  
**Curb Appeal – Administration Building**  
 Brick façade with mature landscaping and dominant horizontal lines define the primary entrance point of the school.

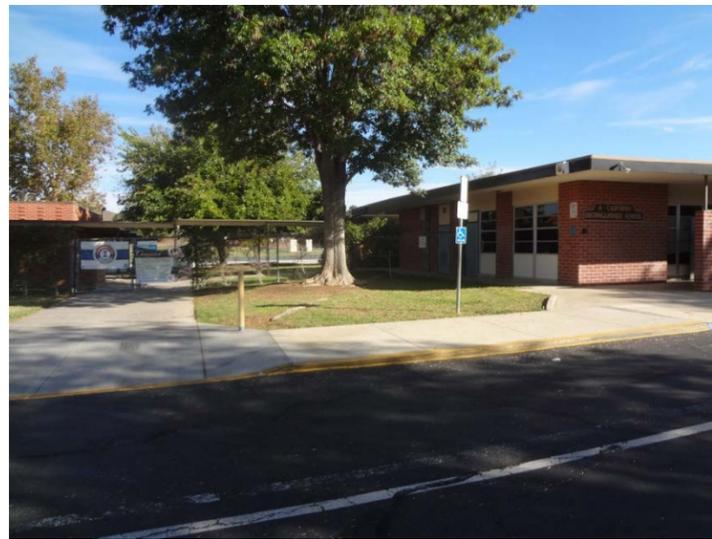
**Photo -2**  
**Curb Appeal – Landscape**  
 Landscaping and trees are mature and appear healthy. They provide shade and aesthetic appeal.

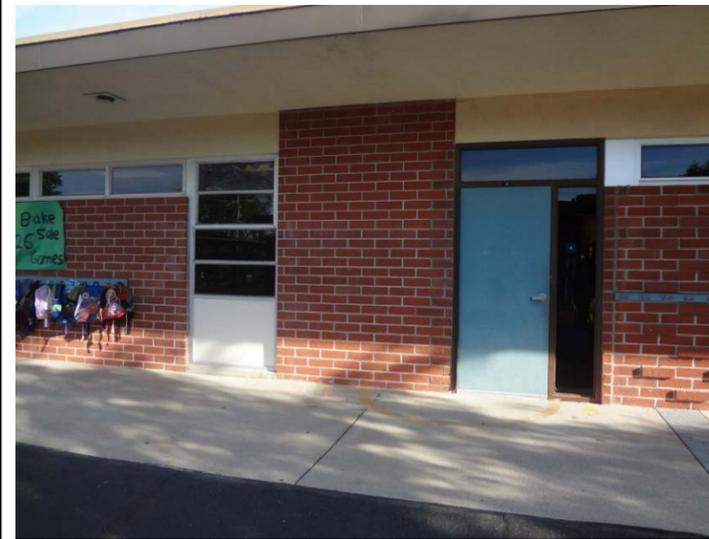
**Photo -3**  
**Curb Appeal – Classrooms**  
 Classrooms have a brick façade with clerestory windows to allow daylight in while minimizing distraction for the students on the inside.

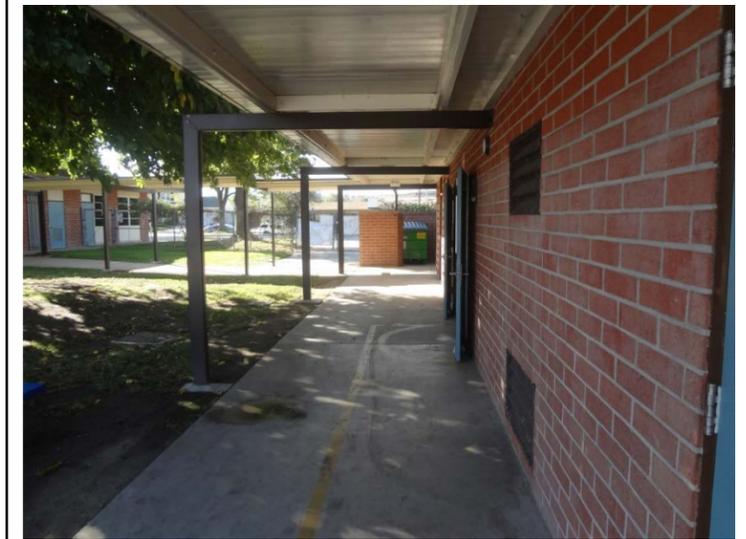
**Photo -4**  
**Curb Appeal – Covered Walkways**  
 Walkways around the campus are covered and provide protection from the elements. This, in conjunction with mature landscaping, provides shade throughout campus

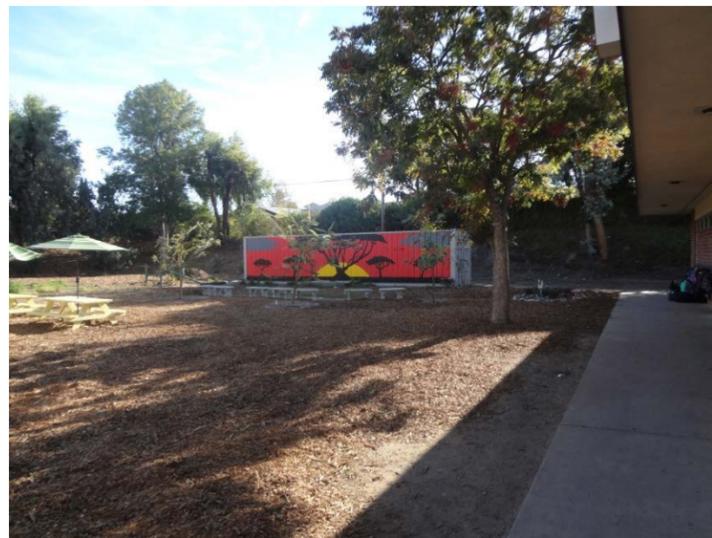
**Photo -6**  
**Curb Appeal – Play Area**  
 Large landscaped area with tables and chairs for the students' outdoor activities.

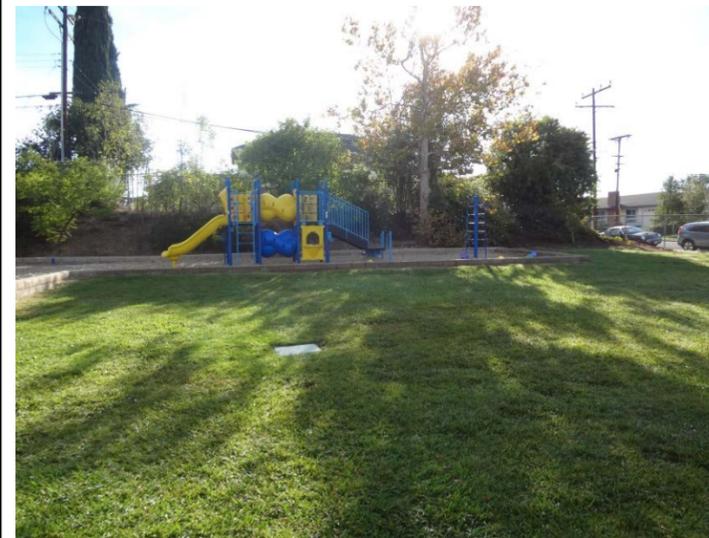
**Photo -7**  
**Curb Appeal – Play Structures**  
 Play areas and structures are well landscaped.

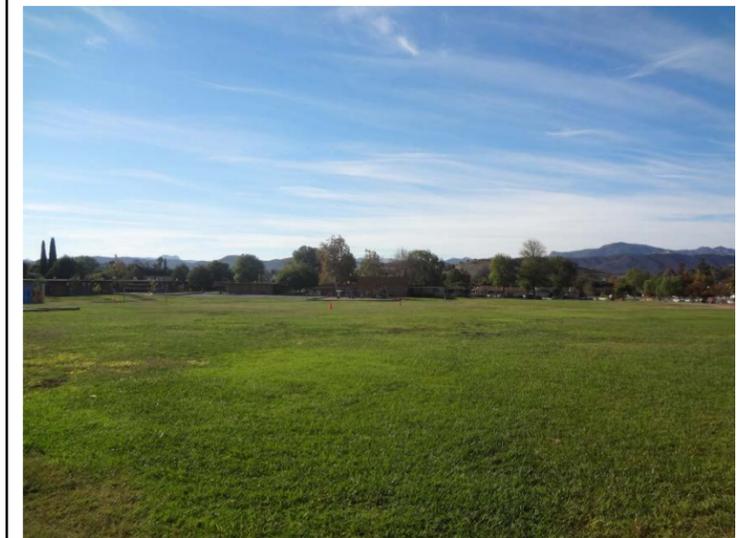
**Photo -8**  
**Curb Appeal – Playground**  
 Large expansive turf area with views of the mountains in the distance.

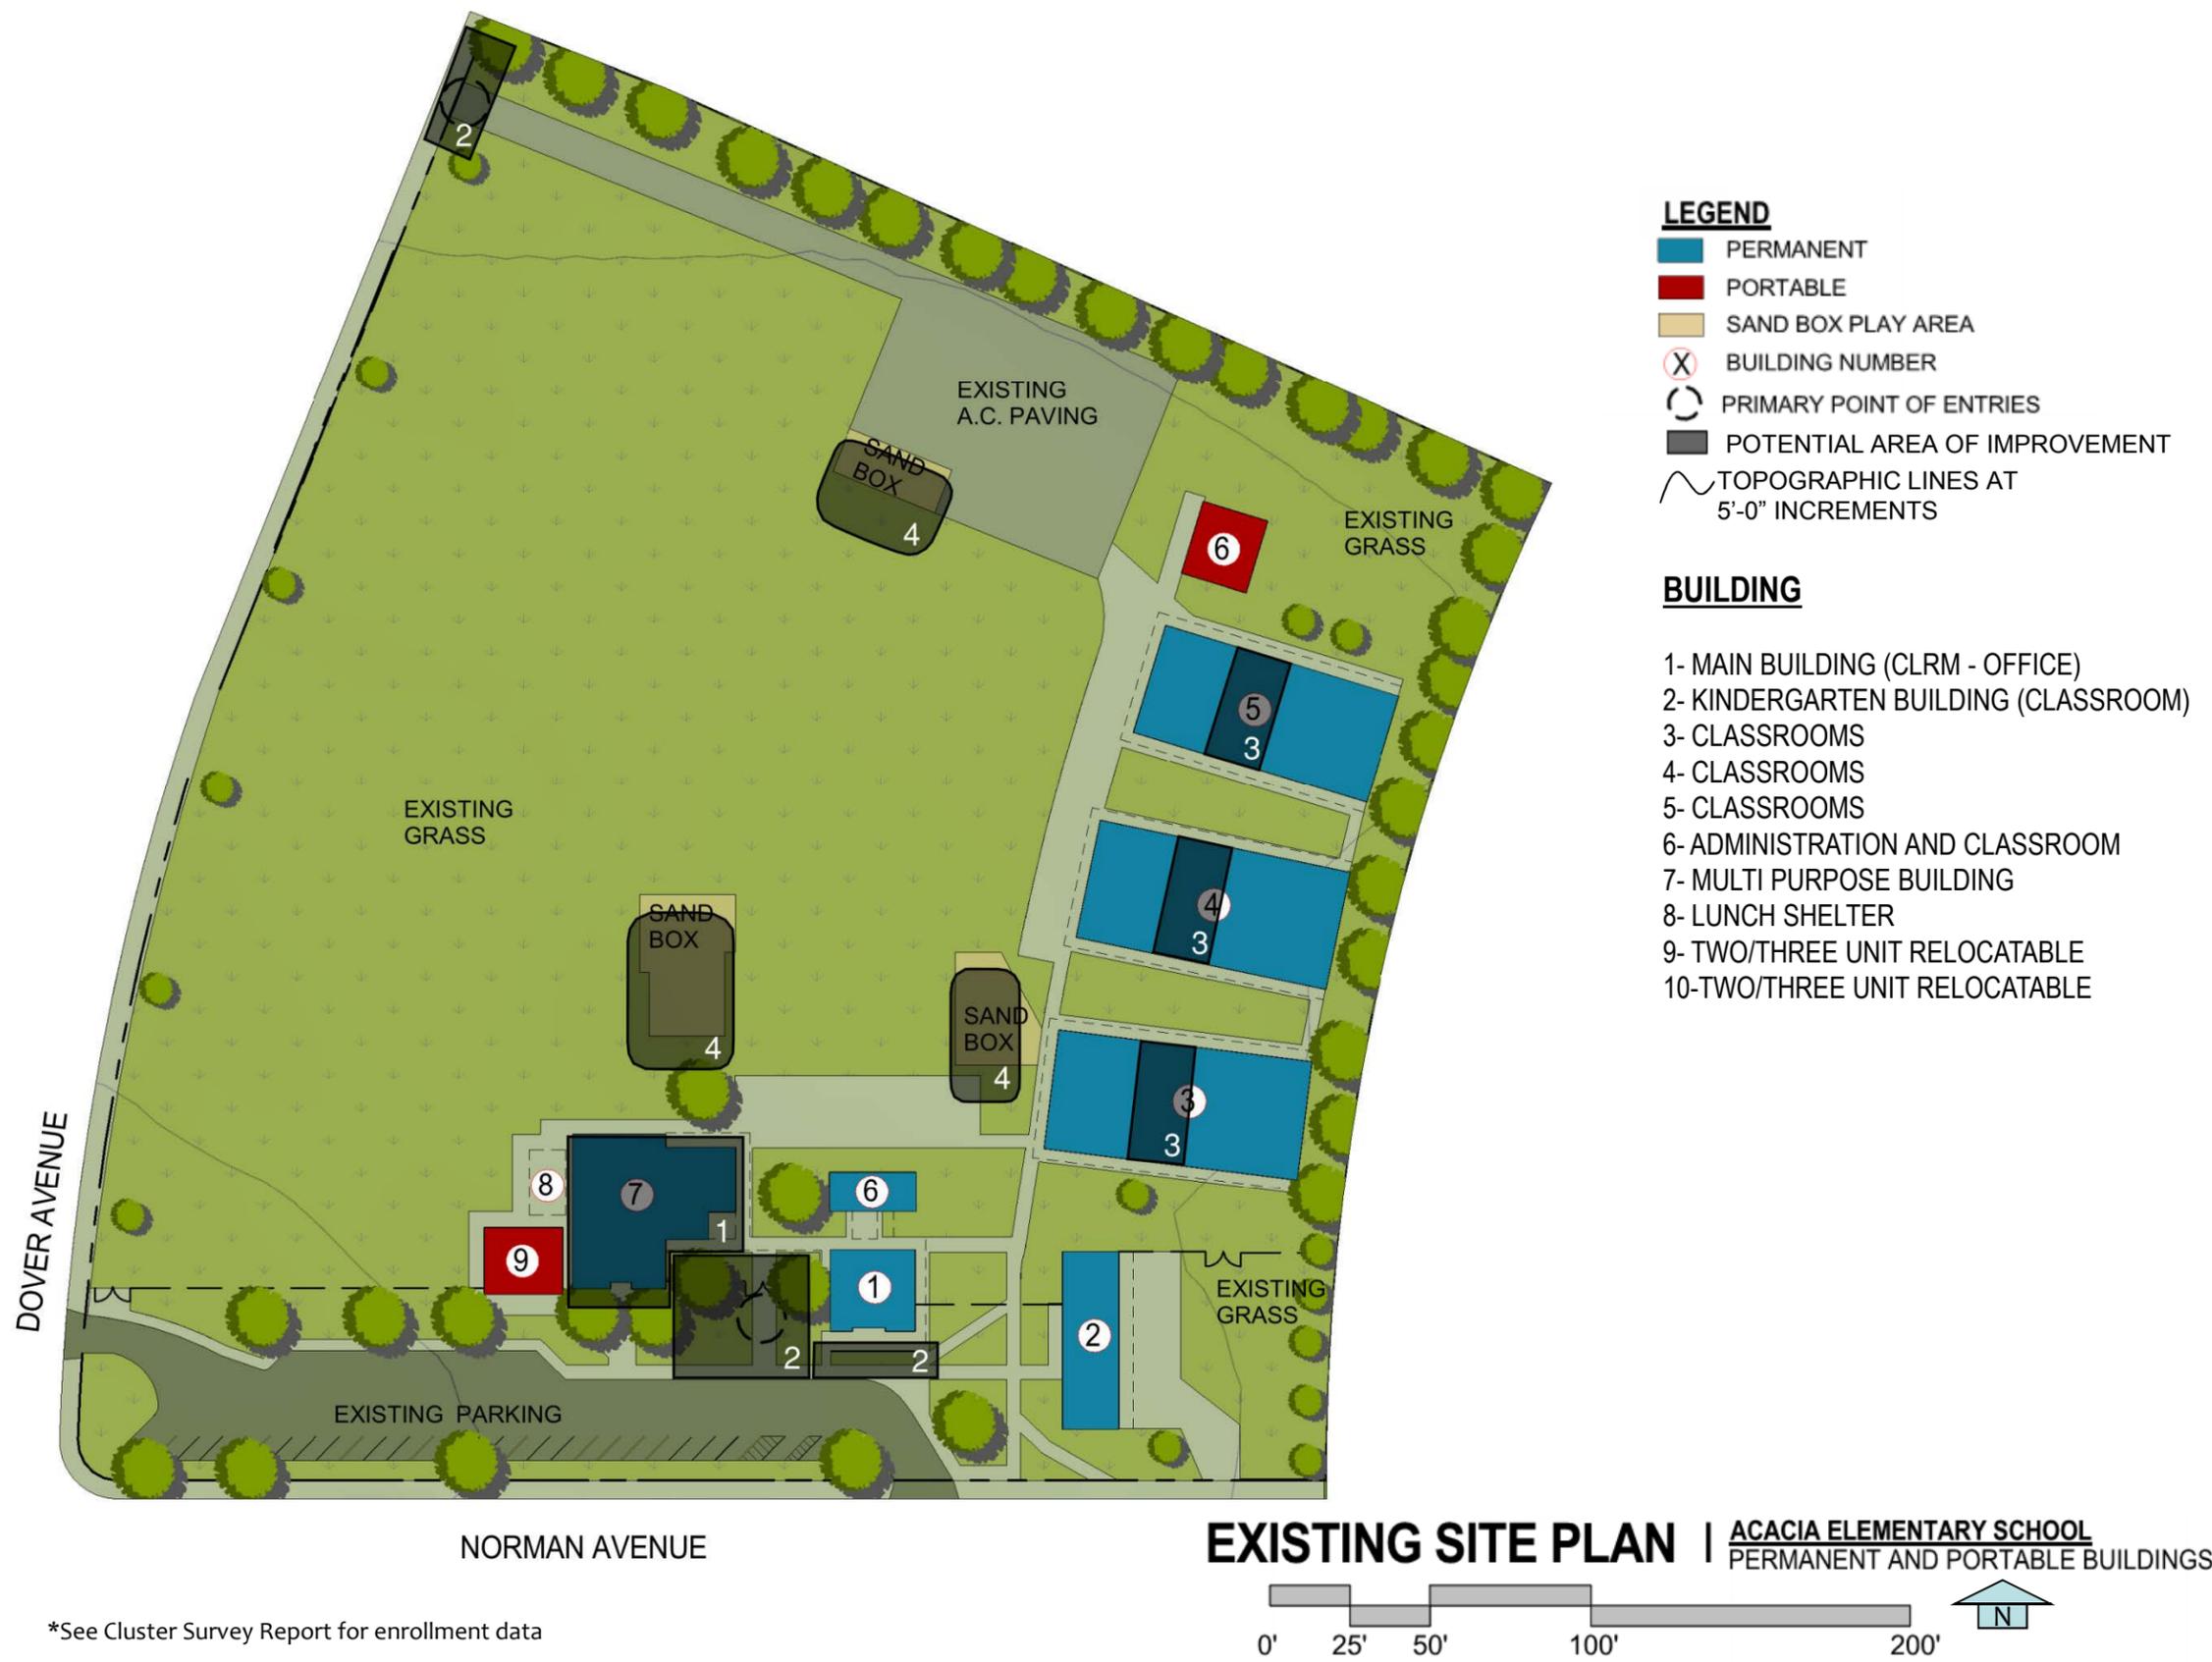
Based on analysis of circulation, environmental factors and current building usages, Acacia Elementary School has many areas of potential improvement.

Area 1: Investigation into the source of ground settlement should be conducted as soon as possible. Pending the result of the investigation, the school may be entitled to additional funding to retrofit the building. Works occurring inside building 7 may include both structural improvement, and refinishing of interior spaces.

Area 2: The area of improvement includes the possibility to improve line of sight from the administration office to the parking and drop-off area. In addition, site elements surrounding the main entry gate may be re-configured and refreshed to provide barrier free approach and aesthetically pleasing curb appeal. At north east entry point, possible improvement should reconfigure the gate and surrounding paving to comply with accessibility standard.

Area 3: To accommodate Schoolwide Enrichment Model program, additional flexible learning spaces may be created in Classroom Building 3 and 4.

Area 4: Additional shading and replacement of ground surface and equipment may improve the longevity and quality of the play area. Shading opportunities may be accomplished by either structure or landscaping.
