# CVUSD | *Facilities Master Plan*

## Glenwood Elementary School | *Site Analysis*

Conejo Valley Unified School District

January 10th, 2017

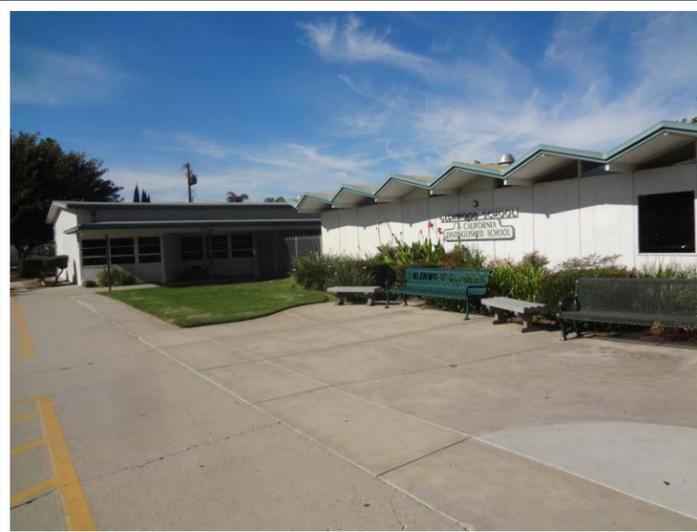
**Photo -1**  
**Curb Appeal – Administration**  
 The administration building has a unique repeating roof configuration with windows allow natural light into the interior of the space.

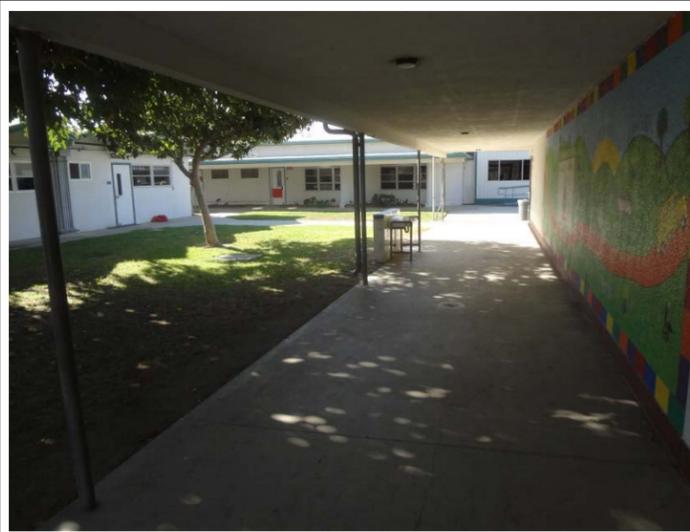
**Photo -2**  
**Curb Appeal – Covered Walkways**  
 The walkways throughout the campus are covered and have large mature trees shading the entire space throughout the day.

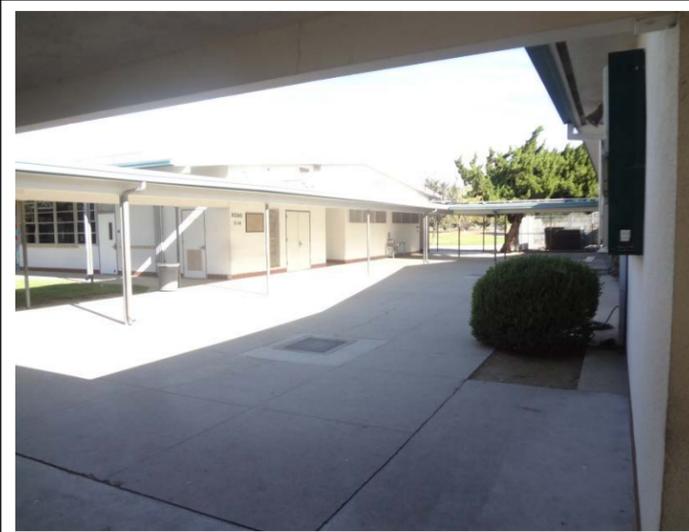
**Photo -3**  
**Curb Appeal – Courtyards**  
 The covered walkways throughout the campus create enclosed courtyards.

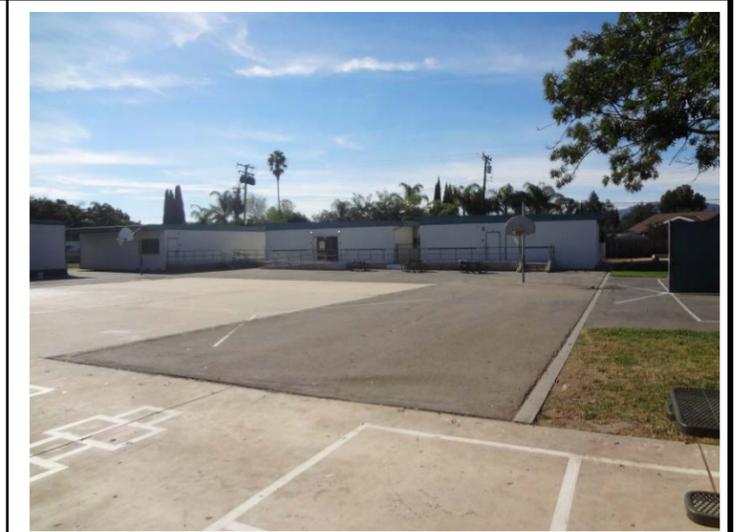
**Photo -4**  
**Curb Appeal – View of Black Top**  
 Large blacktop and concrete area that is sufficient to the needs of the campus.

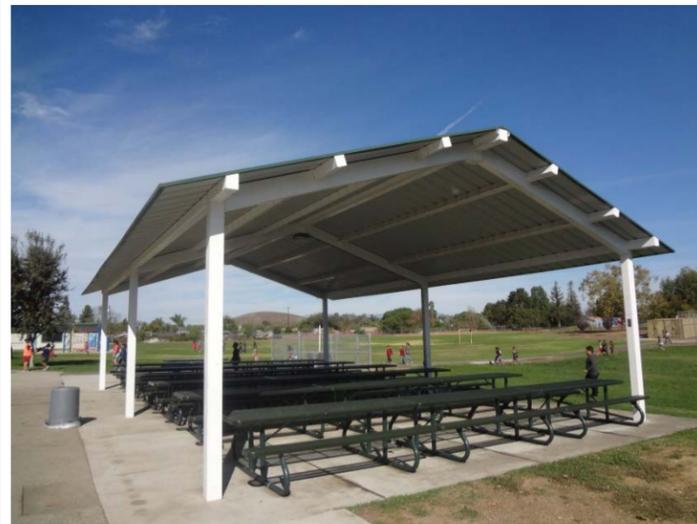
**Photo -5**  
**Curb Appeal – Lunch Shelter**  
 Relatively new lunch shelter provides protection for the students from the elements during meal and break periods.

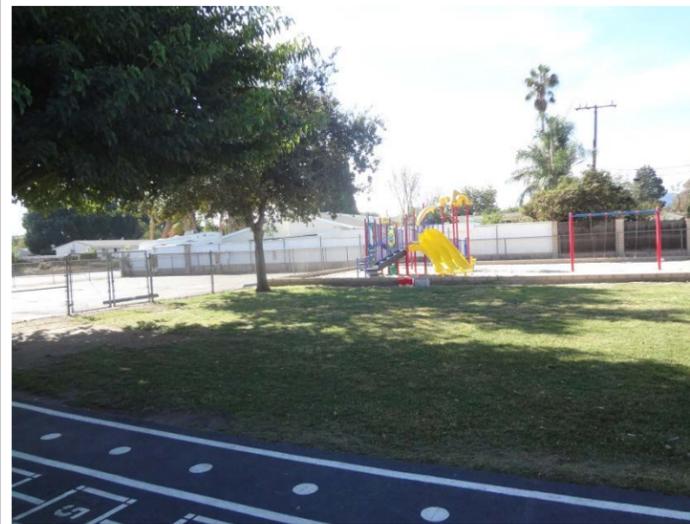
**Photo -6**  
**Curb Appeal – Kindergarten Play Area**  
 Kindergarten play area has large mature trees that provide excellent shading for the students.

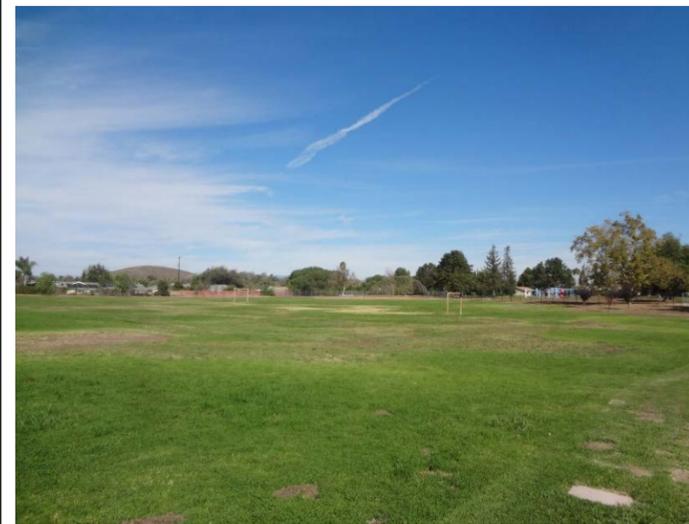
**Photo -7**  
**Curb Appeal – Play Field**  
 Large relatively flat turf area that borders a park and offers ample room for the students to play.

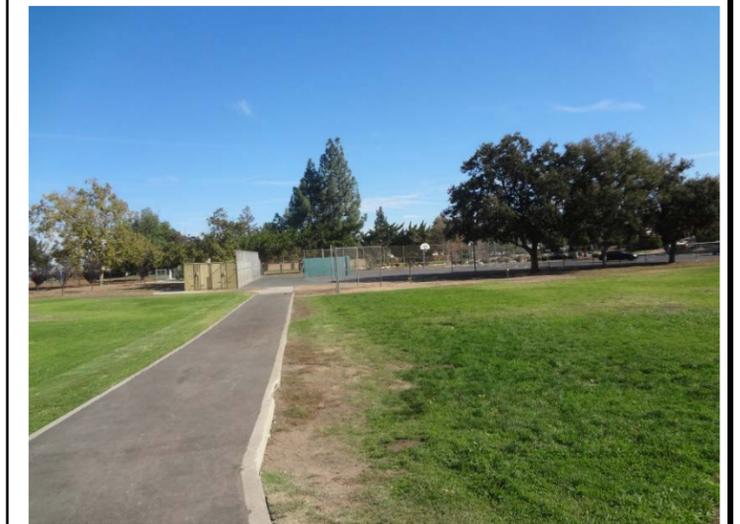
**Photo -8**  
**Curb Appeal – View of Park**  
 School borders a park which makes the school site feel large and expansive with large amounts of open space.
