CVUSD – THOUSAND OAKS CLUSTER SITE ANALYSIS

Ladera Elementary School | *Site Analysis*

1211 Calle Almedro | Thousand Oak, CA 91360

January 10th, 2016

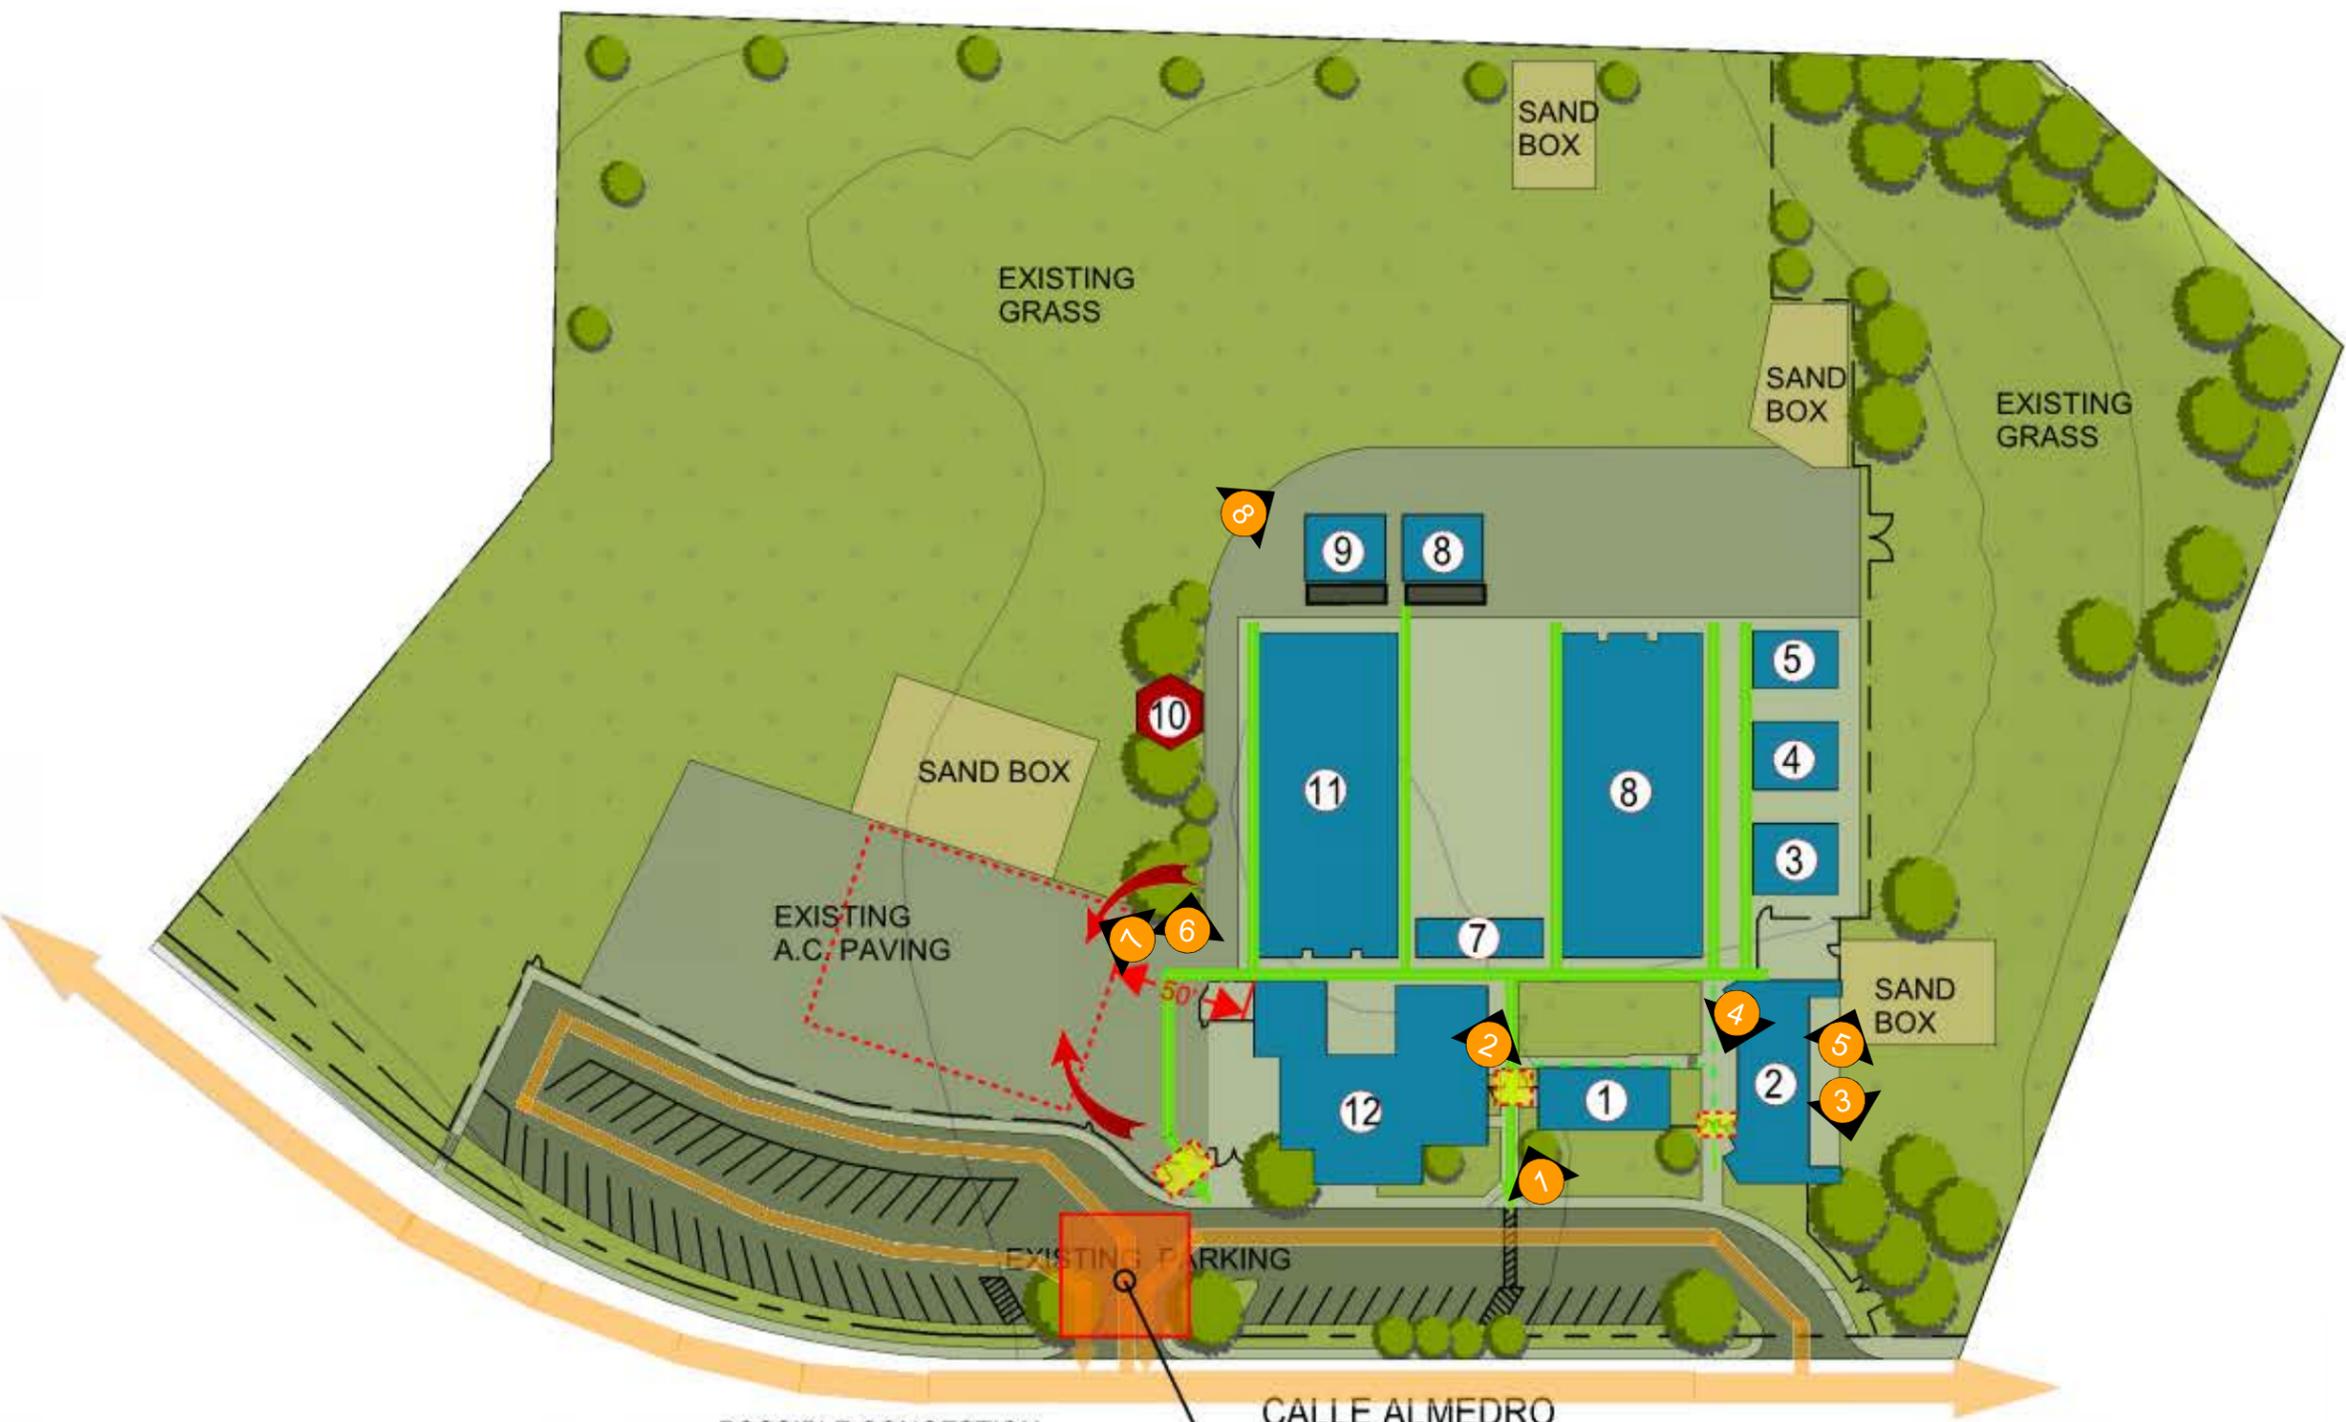
**EXISTING SITE PLAN | LADERA ELEMENTARY SCHOOL
DSA CERTIFICATION REQUIREMENTS**

POSSIBLE CONGESTION
ISSUES DURING DROP OFF
AND PICK UP
