# CVUSD | *Facilities Master Plan*

CVUSD - WESTLAKE CLUSTER

## Lang Ranch Elementary | *Site Analysis*

2450 Whitechapel Place | Westlake, CA 91362  
Conejo Valley Unified School District  
March 31, 2017

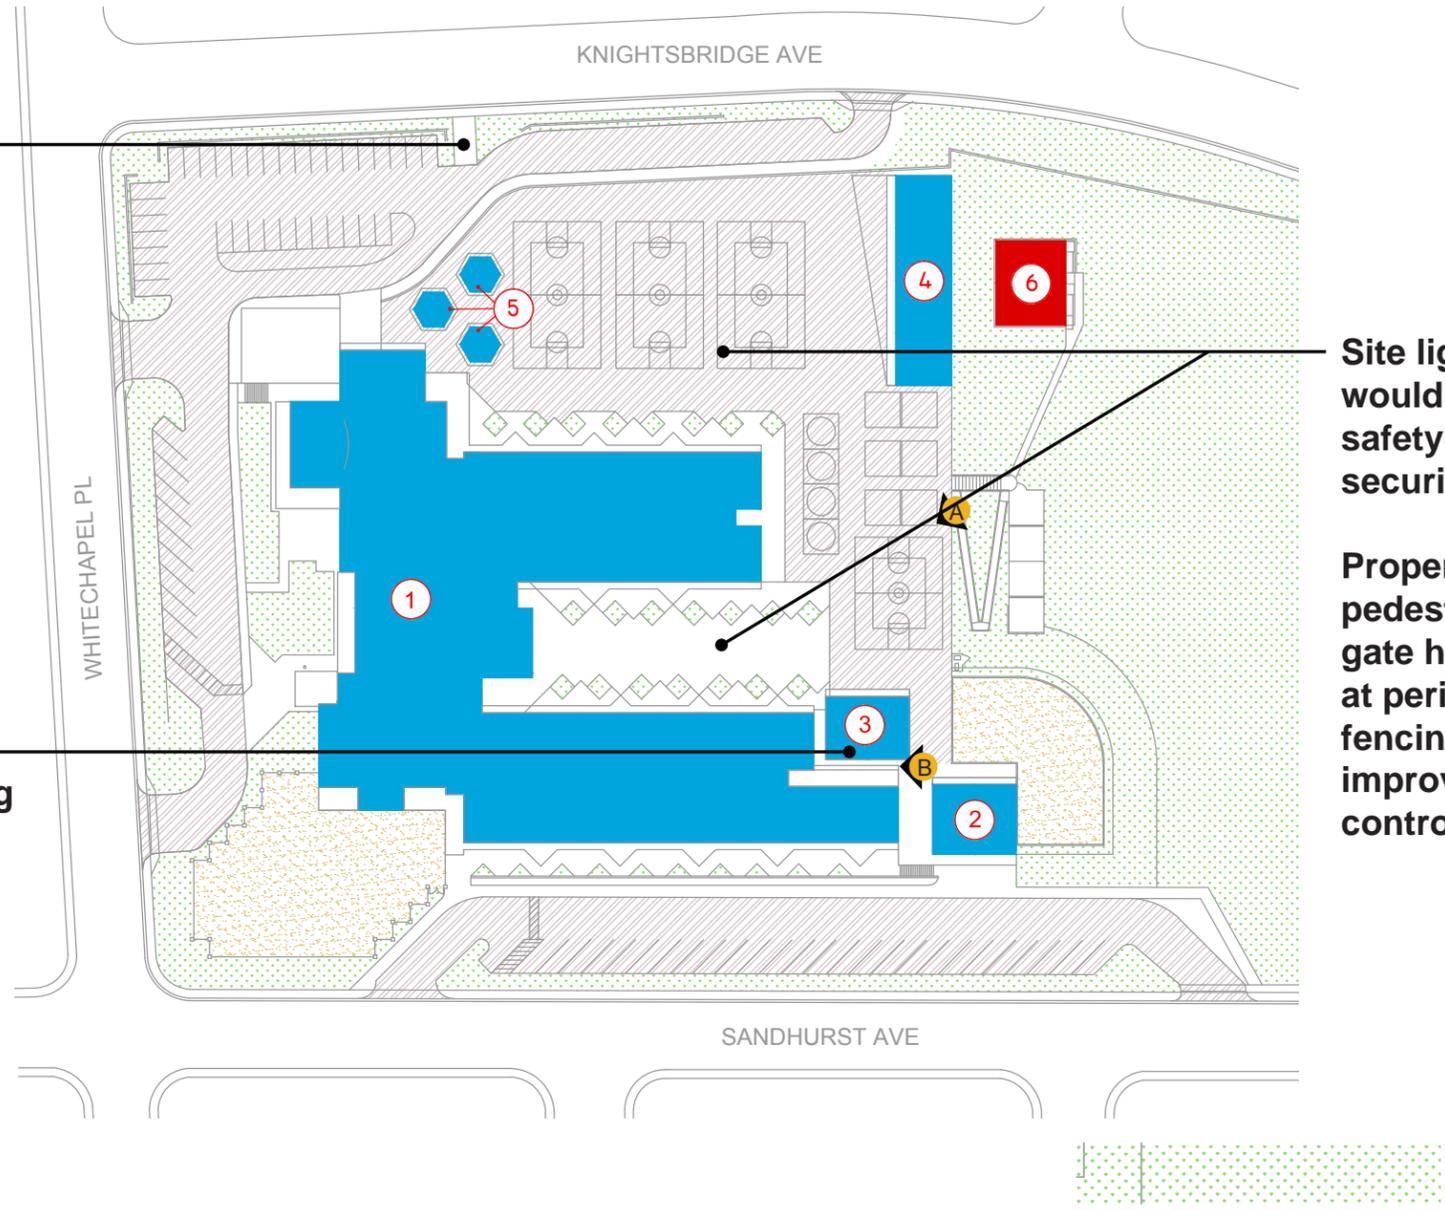
Pedestrian access from Knightsbridge Avenue requires the use of stairs. Accessibility here may be improved.

The close placement of Building 3 to Building 1 causes supervision concerns. Relocating Building 3 computer classrooms and removal of the structure may improve general safety and security.

Provide accessible pedestrian access from Knightsbridge

Relocating/removing Building 3 would relieve supervision concerns and improve safety and security

Site lighting would improve safety and security

Proper pedestrian gate hardware at perimeter fencing would improve access control.

The addition of site lighting to illuminate the hardcourts adjacent to Knightsbridge Avenue and the courtyard at Building 1 would improve safety and security. Proper pedestrian gate hardware at perimeter fencing would improve access control.

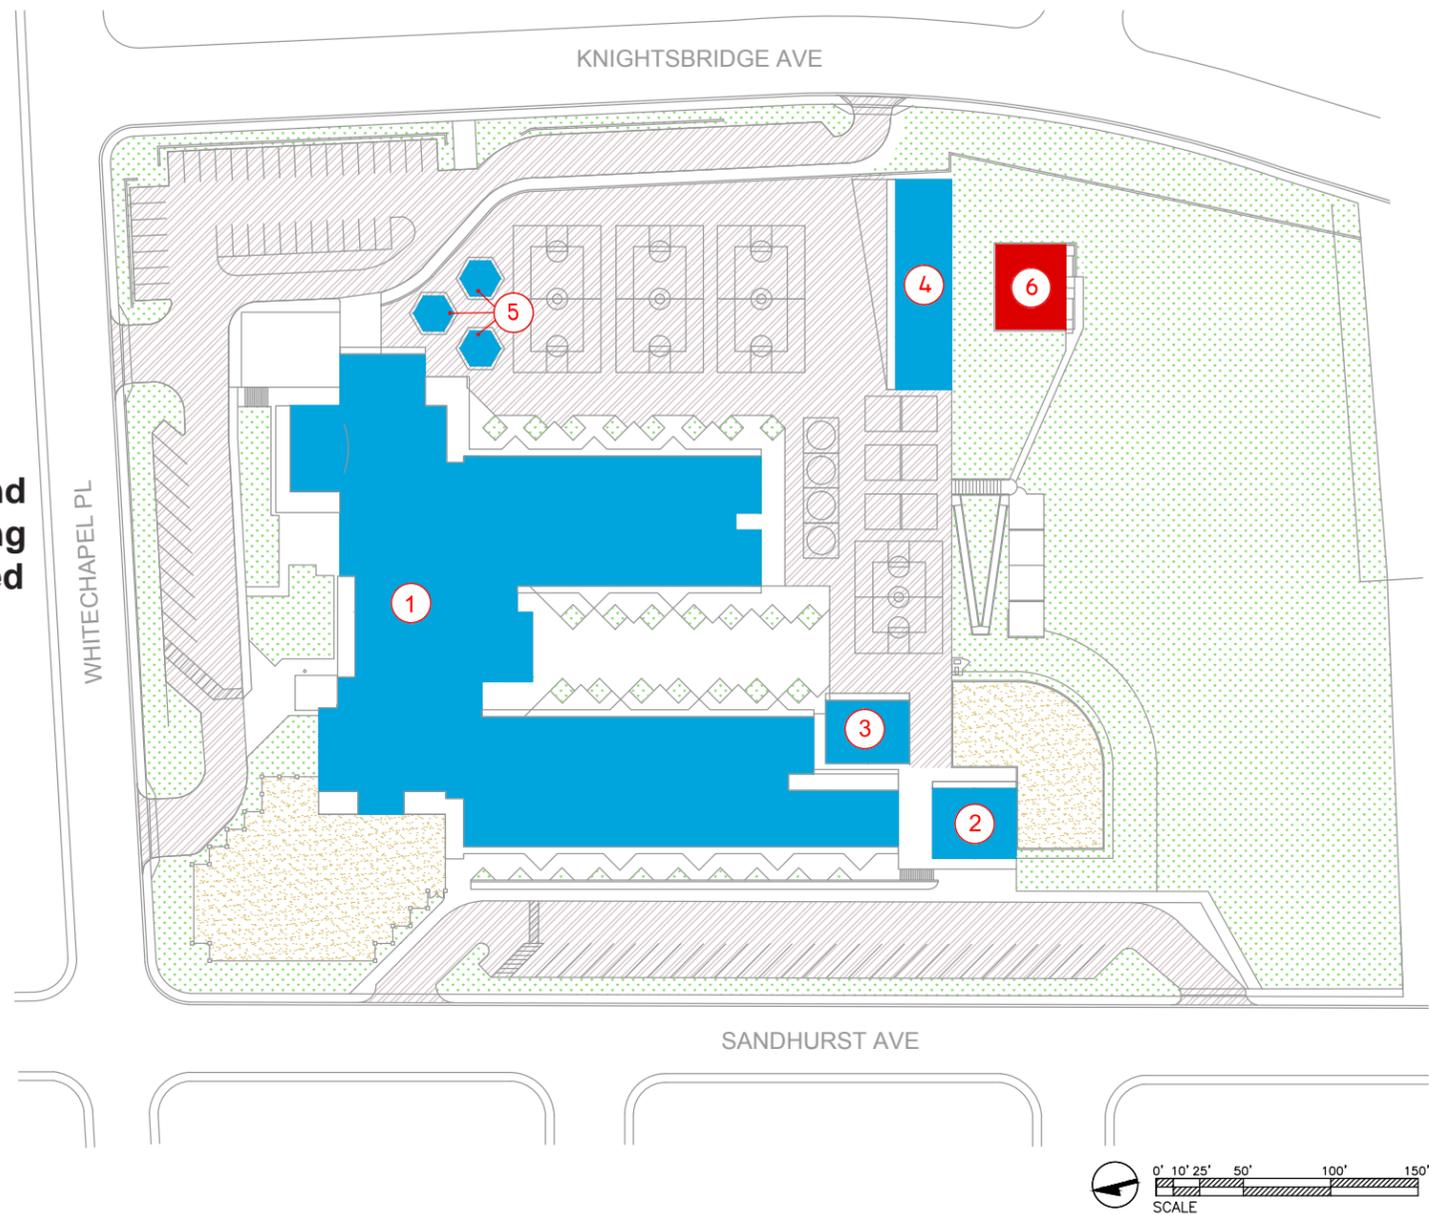
Water intrusion was noted to occur behind the campus buildings' exterior insulation and finish system (EIFS). Chipped exterior tile requires replacement. General maintenance of exterior finishes would benefit the school greatly.

- Repair water intrusion behind exterior building finish & chipped exterior tile
- Improve classroom environment with better electrical distribution & HVAC controls
