# CVUSD | *Facilities Master Plan*

## Madrona Elementary School | *Site Analysis*

Conejo Valley Unified School District

January 10th, 2017

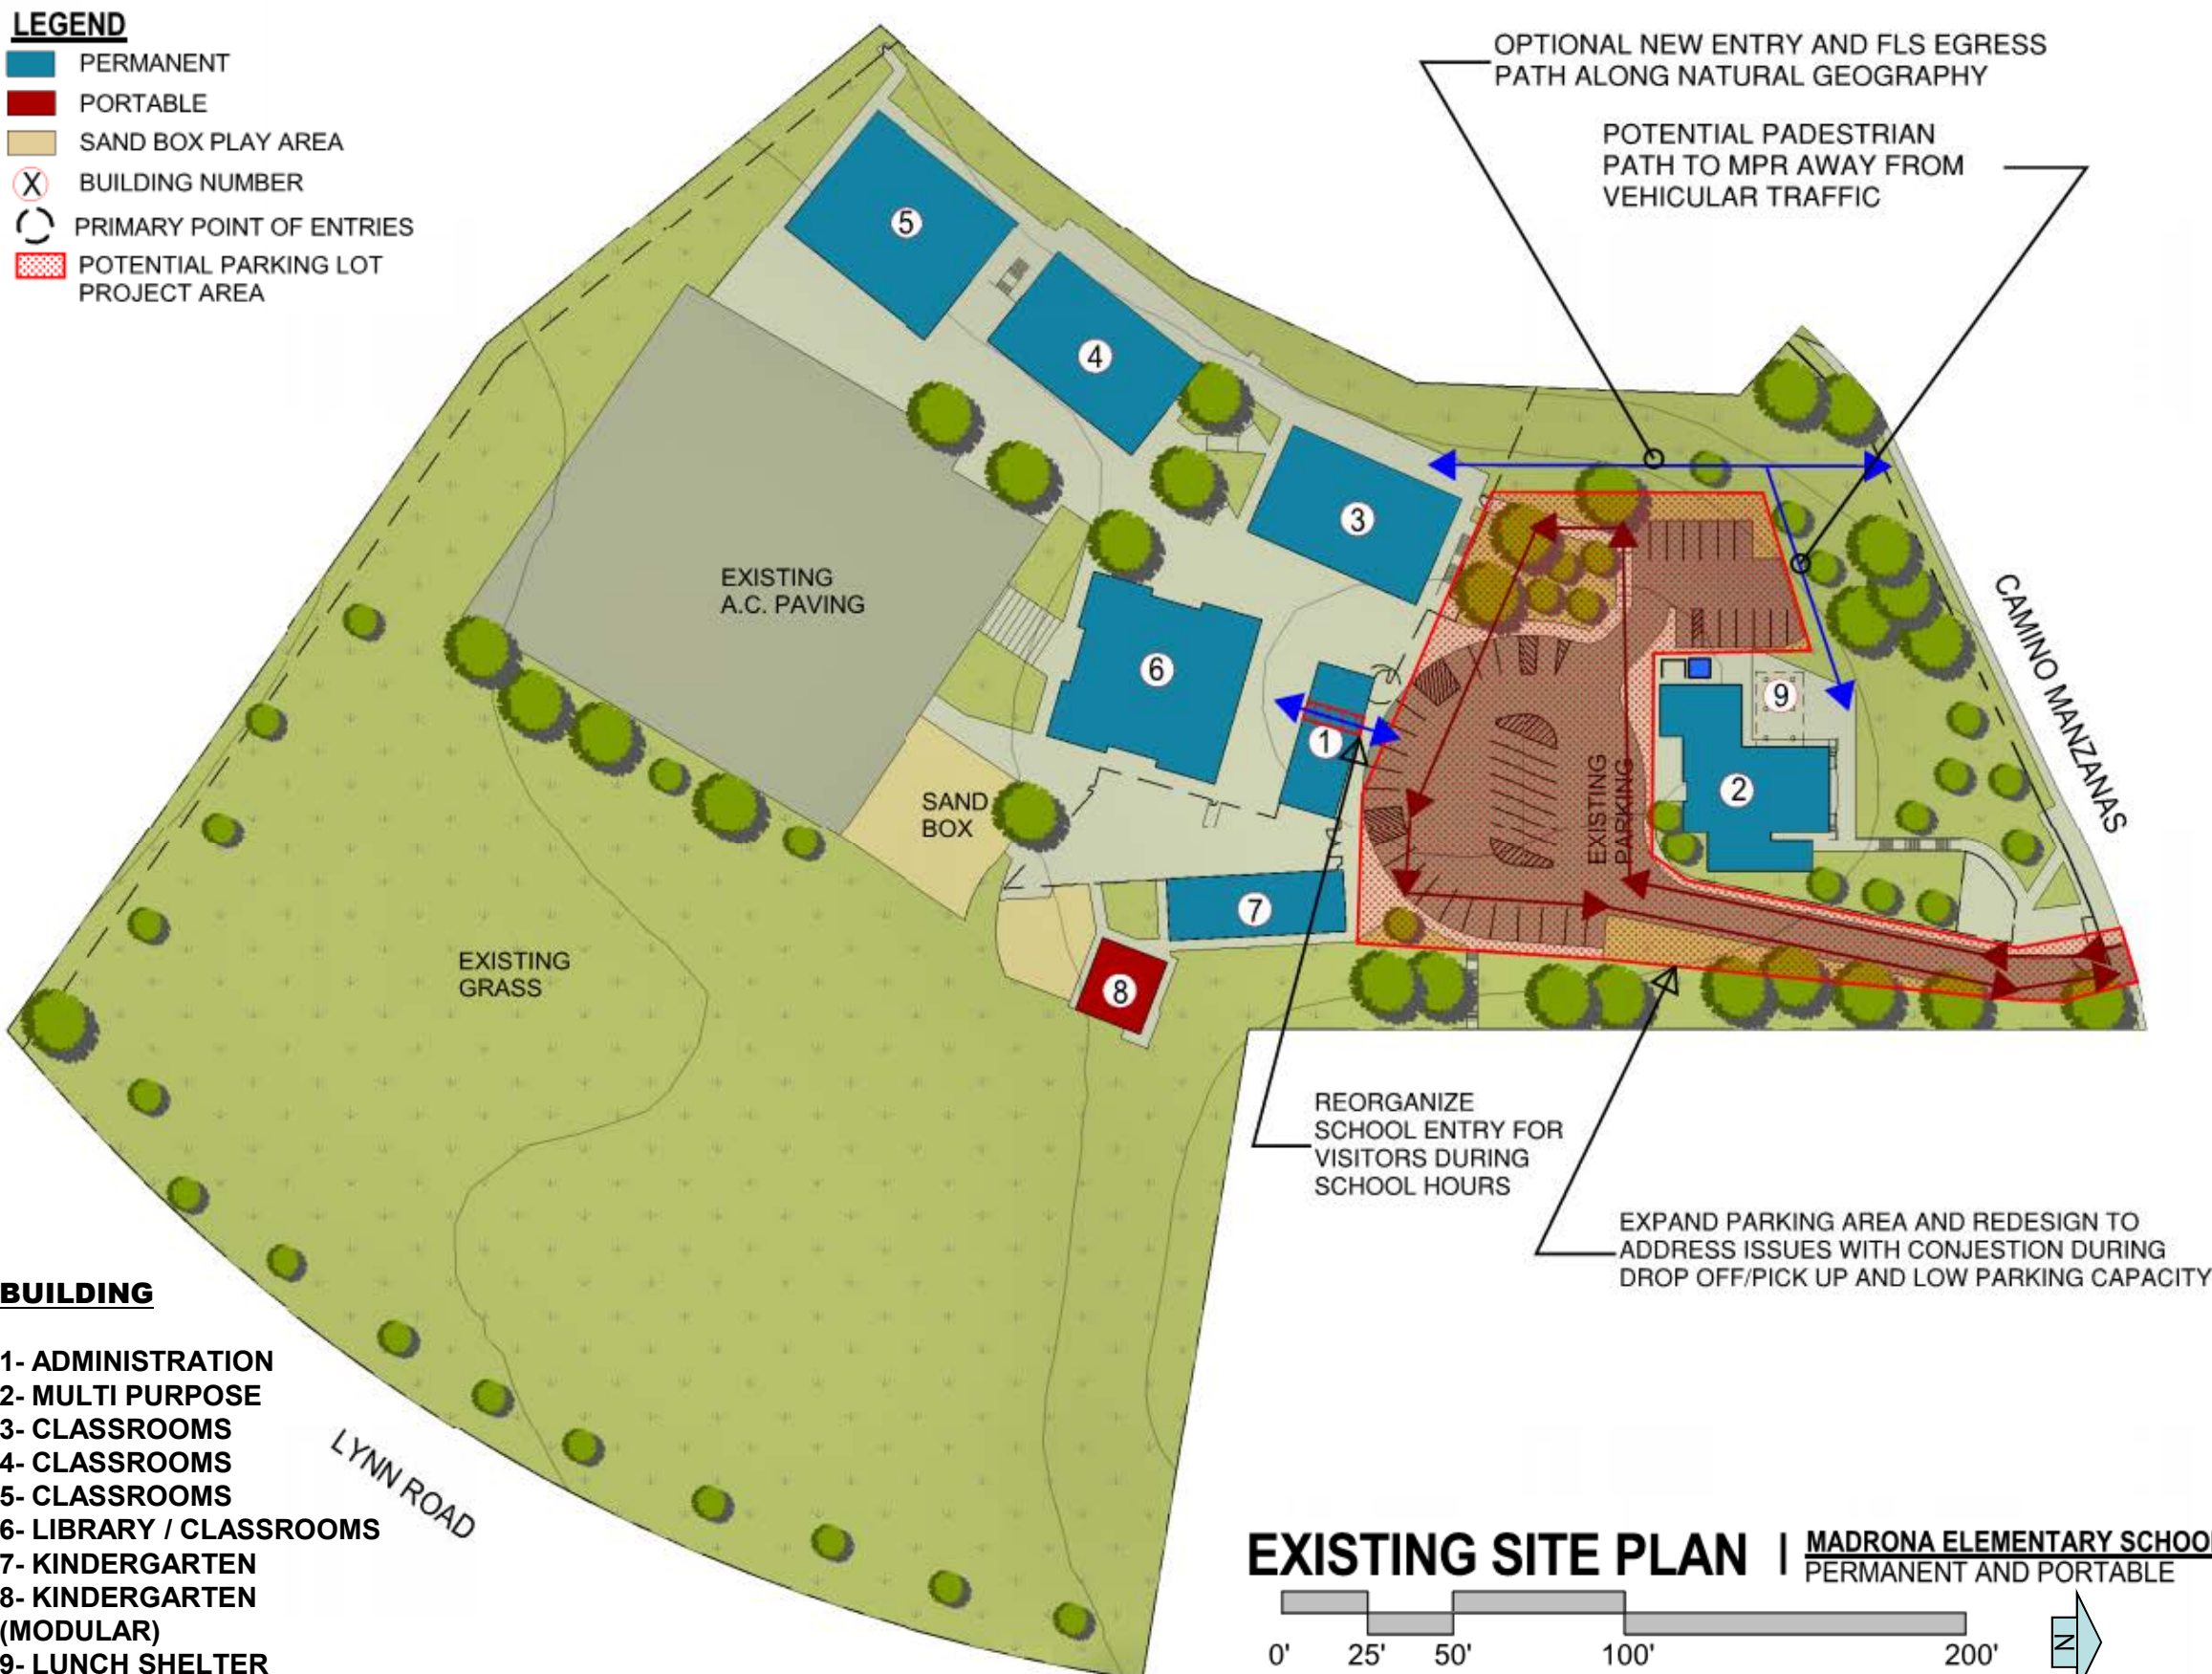
Madrona Elementary School’s current parking and drop off layout is inefficient. The layout causes large amounts of traffic during drop off and pick up. In addition, the parking capacity is insufficient to the needs of the campus.
