CVUSD – THOUSAND OAKS CLUSTER SURVEY

Madrona Elementary School | *Survey*

December 9th, 2016 – DRAFT v1

Dougherty + Dougherty
Architects

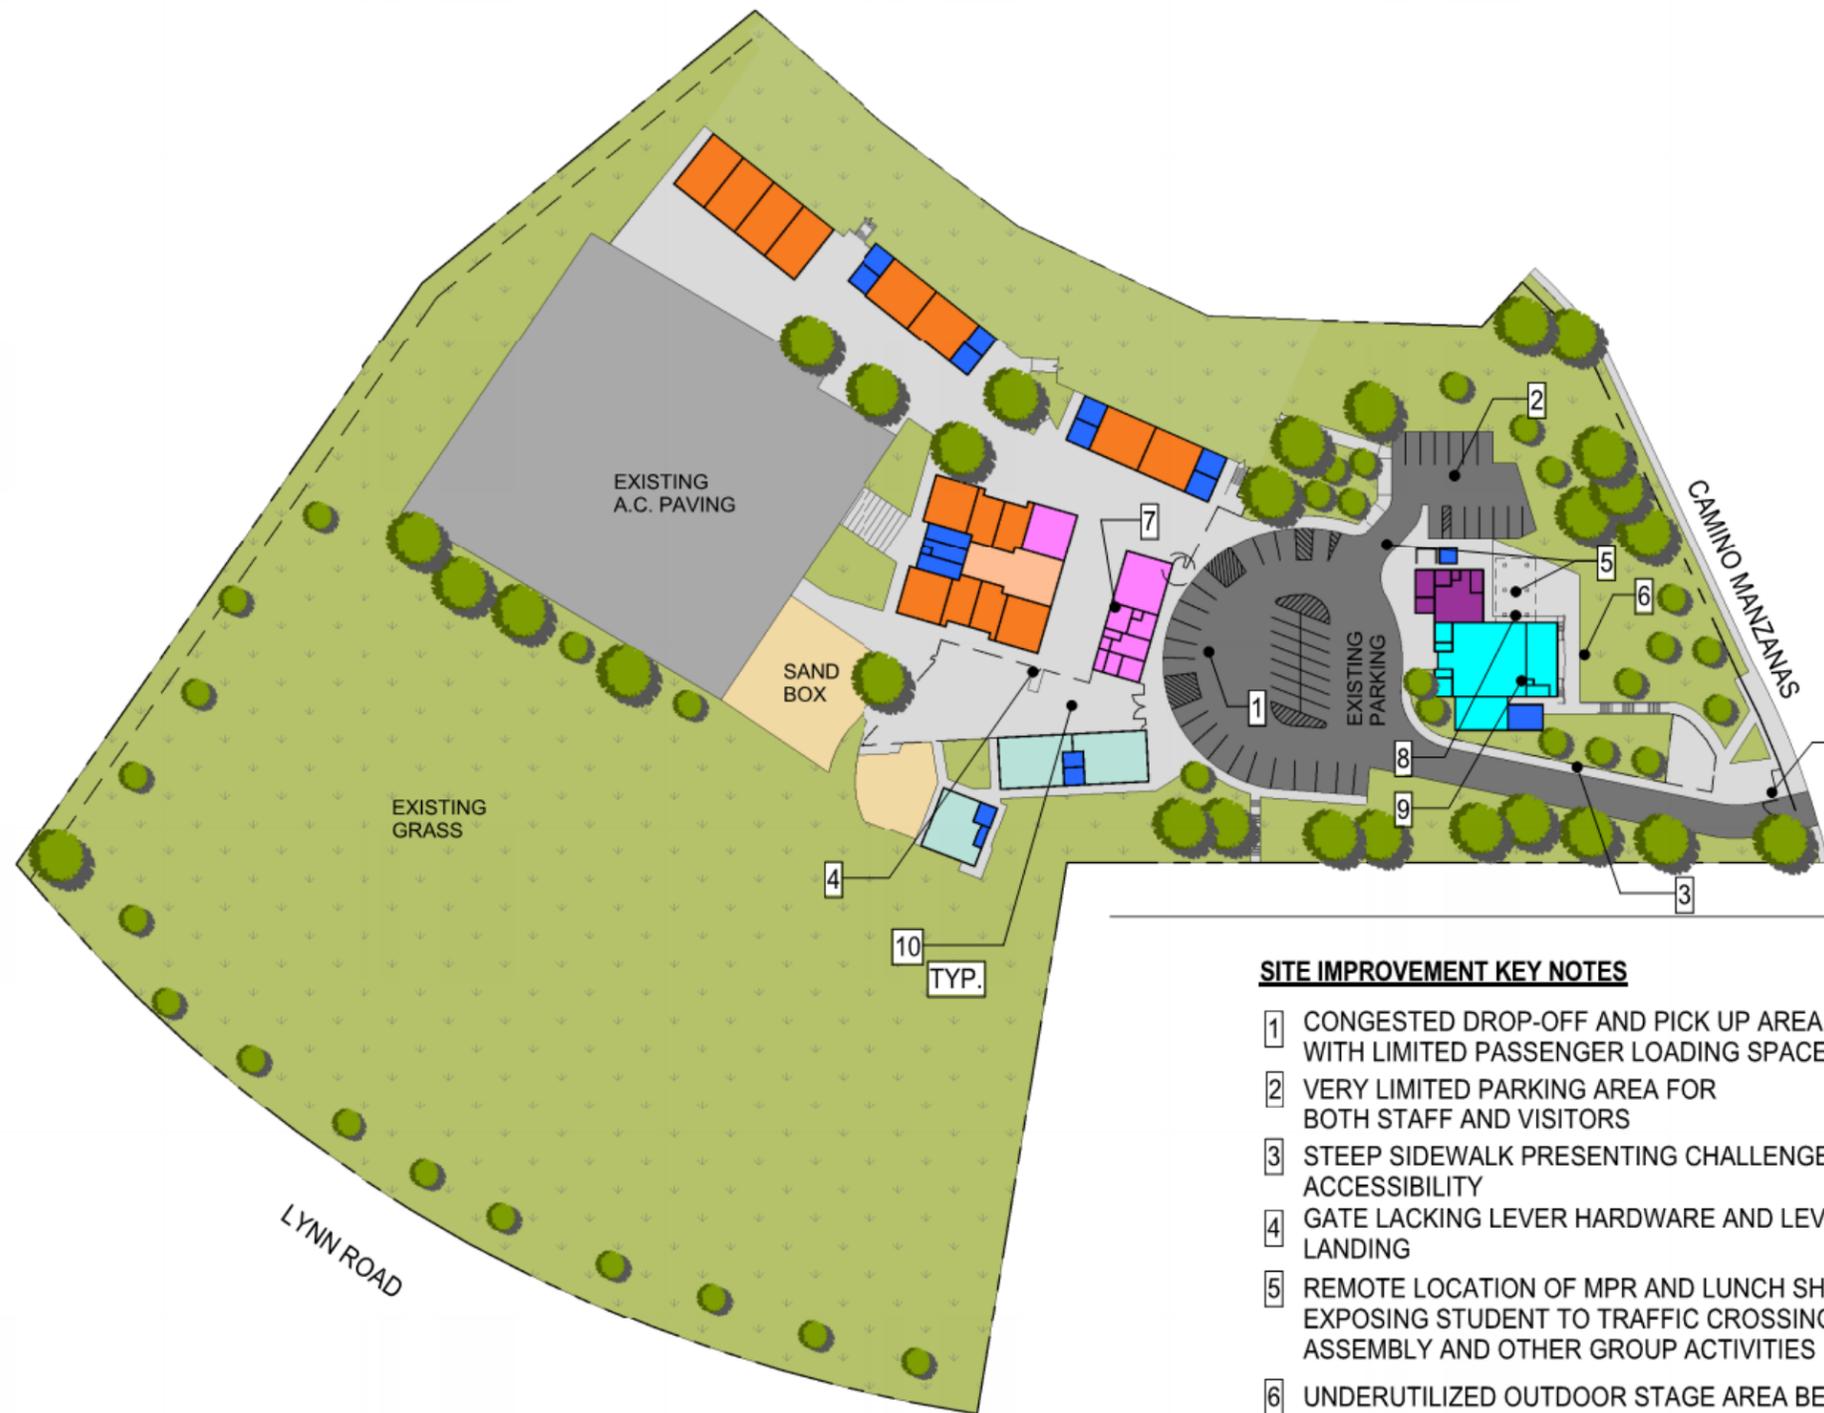
EXISTING SITE PLAN | MADRONA ELEMENTARY SCHOOL
BUILDING USE-FIRST FLOOR

- 8 DETERIORATING CHAINLINK FENCING BETWEEN LUNCH SHELTER AND PARKING AREA
- 9 NO WHEEL CHAIR LIFT FOR MPR PLATFORM
- 10 INSUFFICIENT SHADING AT PLAYGROUND AREA ESPECIALLY OUTSIDE THE KINDERGARTEN
- 11 WOOD HANDRAIL ON SECOND FLOOR BALCONIES SHOW SIGNS OF WATER DAMAGES AND WEAKENING SUPPORT

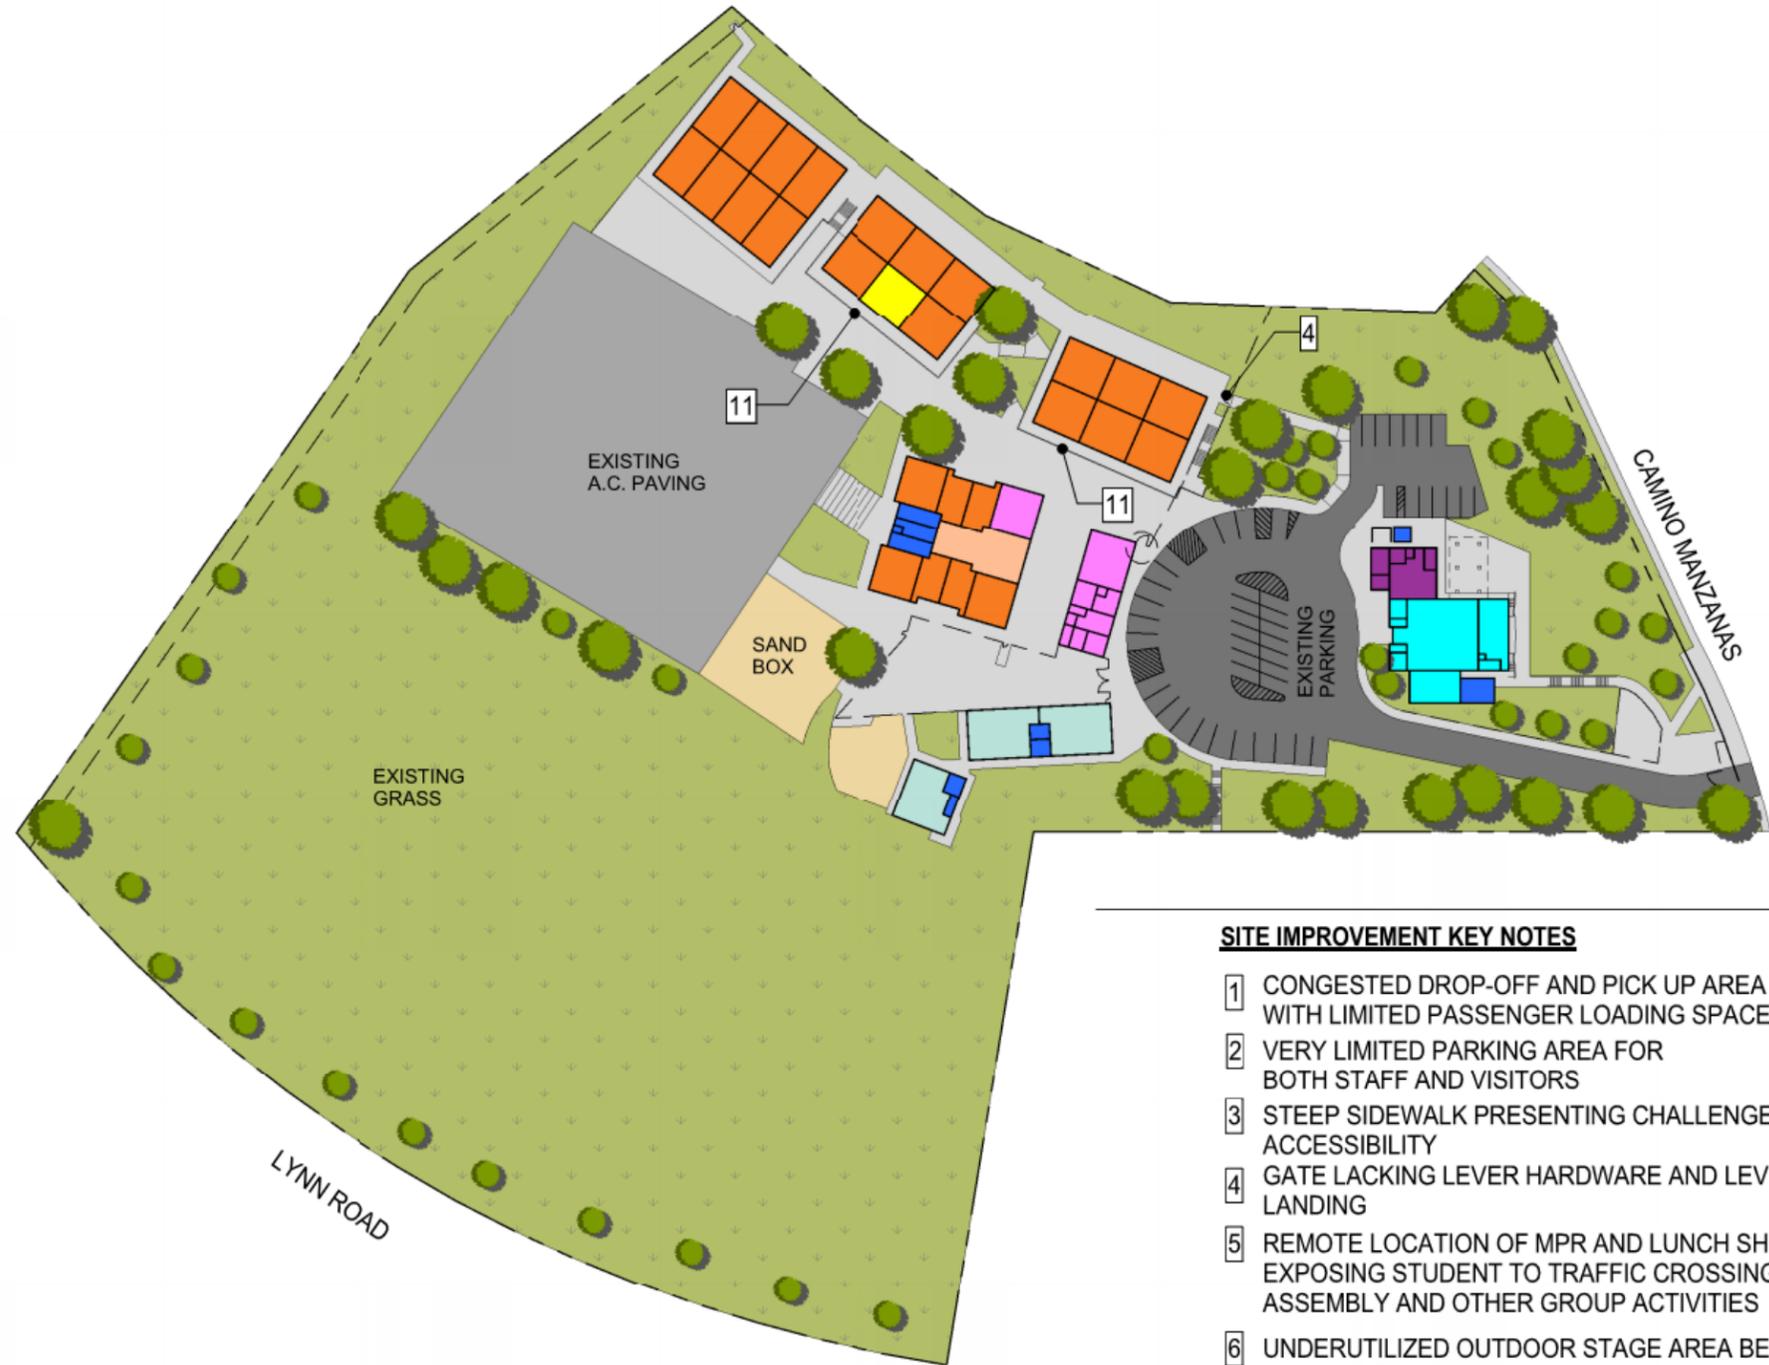
EXISTING SITE PLAN | MADRONA ELEMENTARY SCHOOL BUILDING USE-SECOND FLOOR

- 8 DETERIORATING CHAINLINK FENCING BETWEEN LUNCH SHELTER AND PARKING AREA
- 9 NO WHEEL CHAIR LIFT FOR MPR PLATFORM
- 10 INSUFFICIENT SHADING AT PLAYGROUND AREA ESPECIALLY OUTSIDE THE KINDERGARTEN
- 11 WOOD HANDRAIL ON SECOND FLOOR BALCONIES SHOW SIGNS OF WATER DAMAGES AND WEAKENING SUPPORT

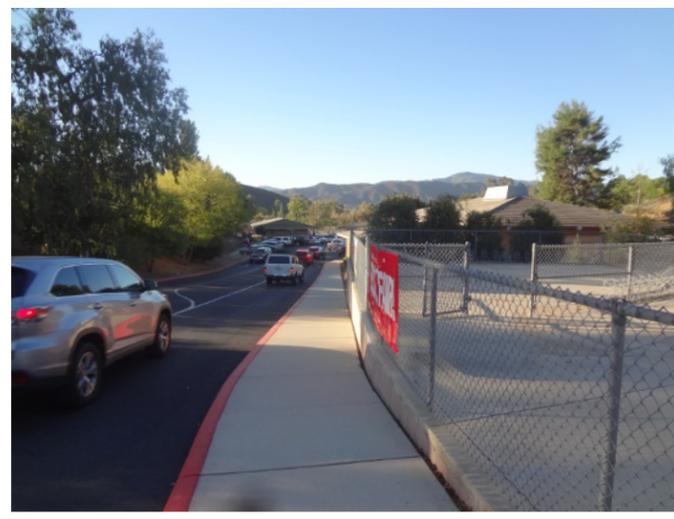
Photo -2
School Parking Entry
Current school entry down to parking lot

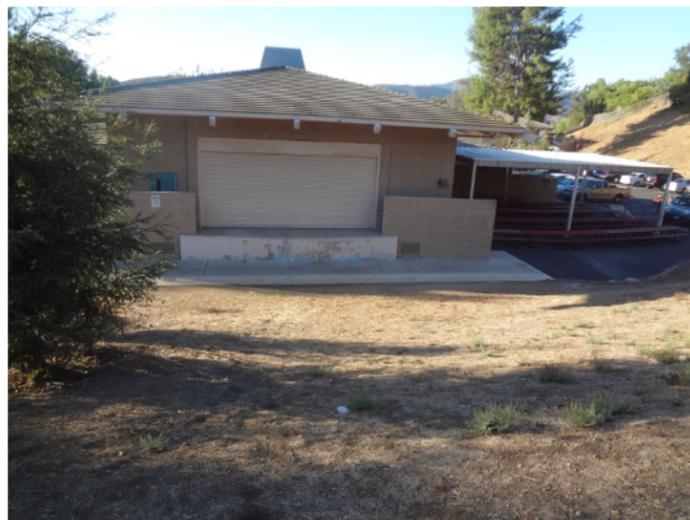
Photo -5
Building 2
Back side of multi purpose stage has rolling doors

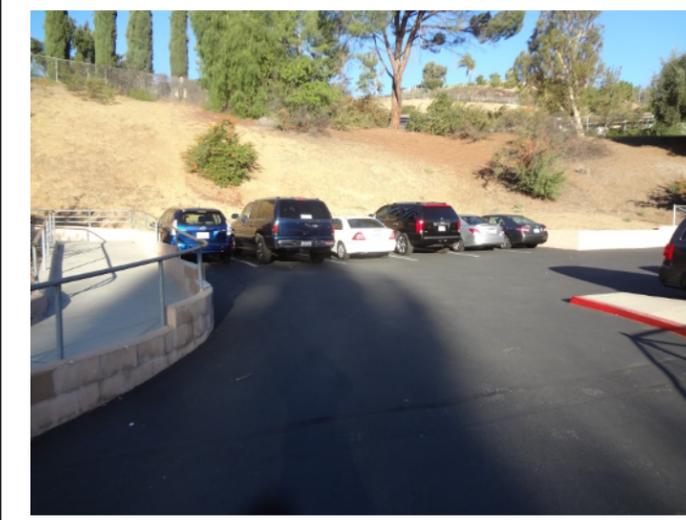
Photo -7
Additional Staff Parking Lot
Additional staff parking next to multi purpose building.

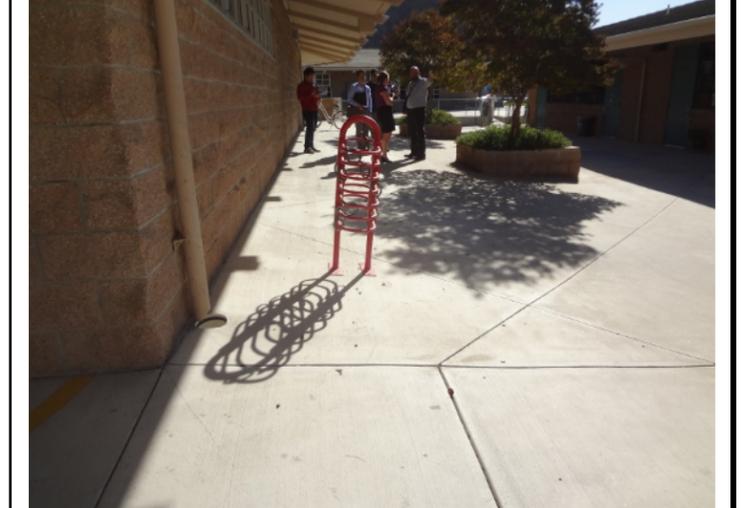
Photo -16
Building 1
Backside of administration building, desired location for new entry door to pass through administration building.

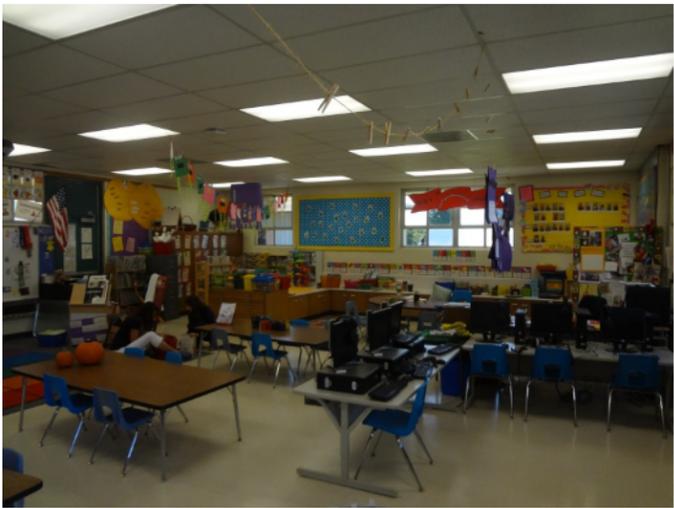
Photo -21
Building 8
 Portable kindergarten classroom, no longer needed based on current enrollment levels

Building 8 is a portable building that is approaching 20 years of age. Due to current enrollment and projected enrollment the building is not needed and may be removed.

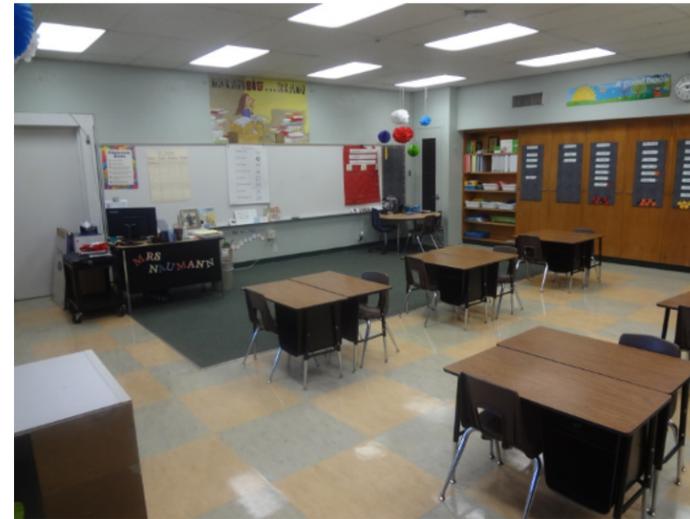
Photo -34
Building 3
Typical permanent classroom in older 2 story building

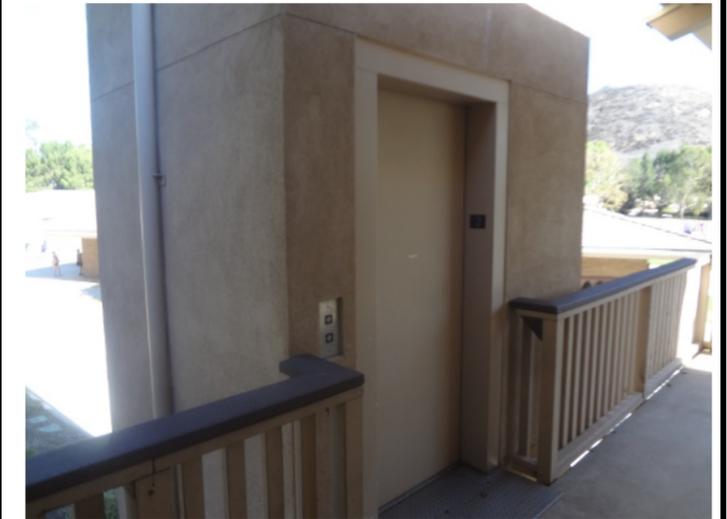
Photo -36
Building 4
Elevator from lower level to upper level for 2 story buildings.

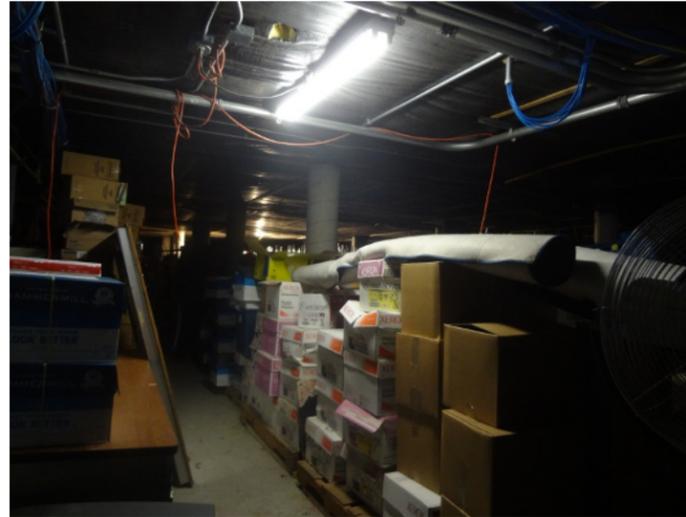
Photo -42
Building 5
Storage beneath building 5

- Portable building, is old and should be removed based on current enrollment
- Large storage space under building 5 needs to be investigated for fire life safety code compliance

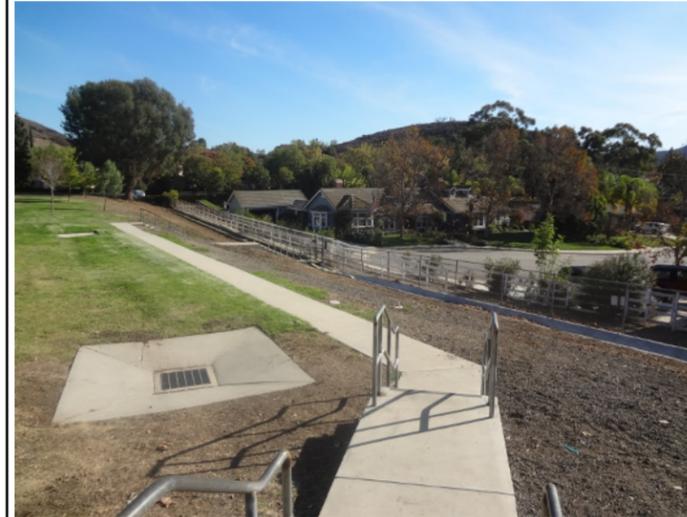
Photo -43
Building 5
Exterior stair case and walkway toward base of campus. Currently used as secondary entrance to campus for drop off/pick up

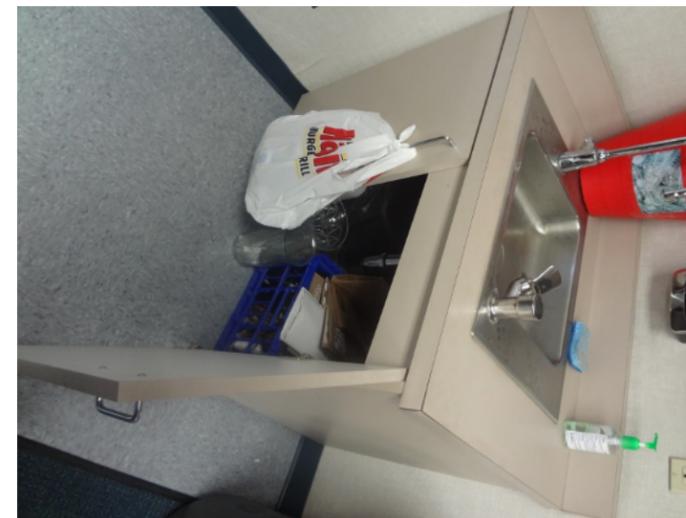
Photo -46
Building 5
Typical classroom sink in building 5 is current with accessibility standards.

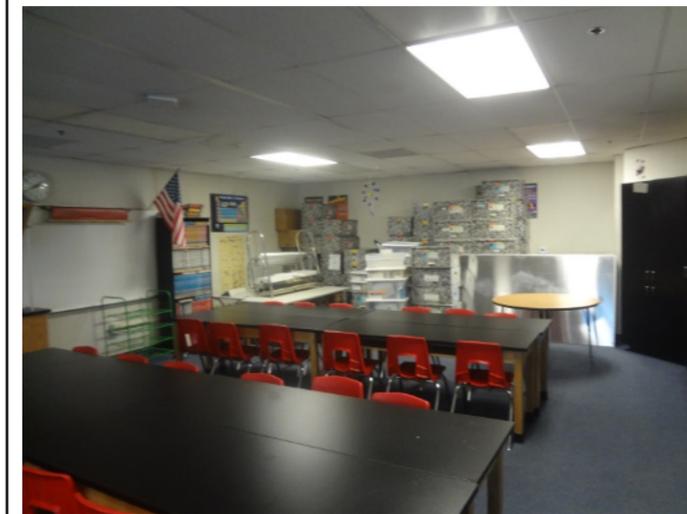
Photo -47
Building 5
Typical second floor classroom in building 5.

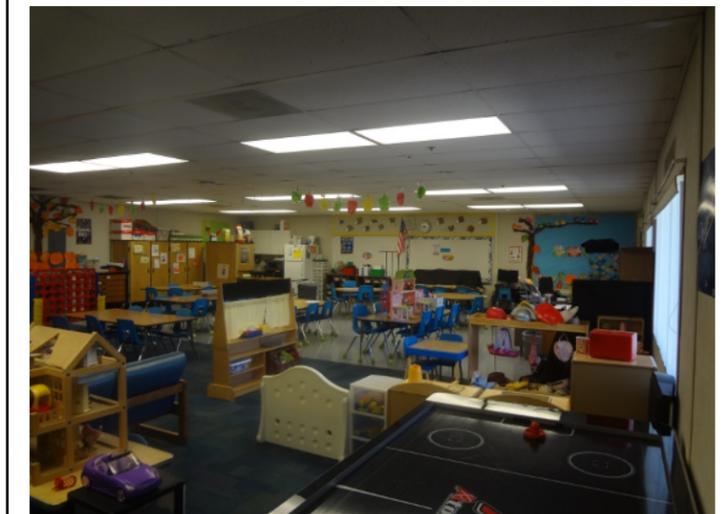
Photo -48
Building 4
Ground floor classroom in building 4 is used as a day care facility.

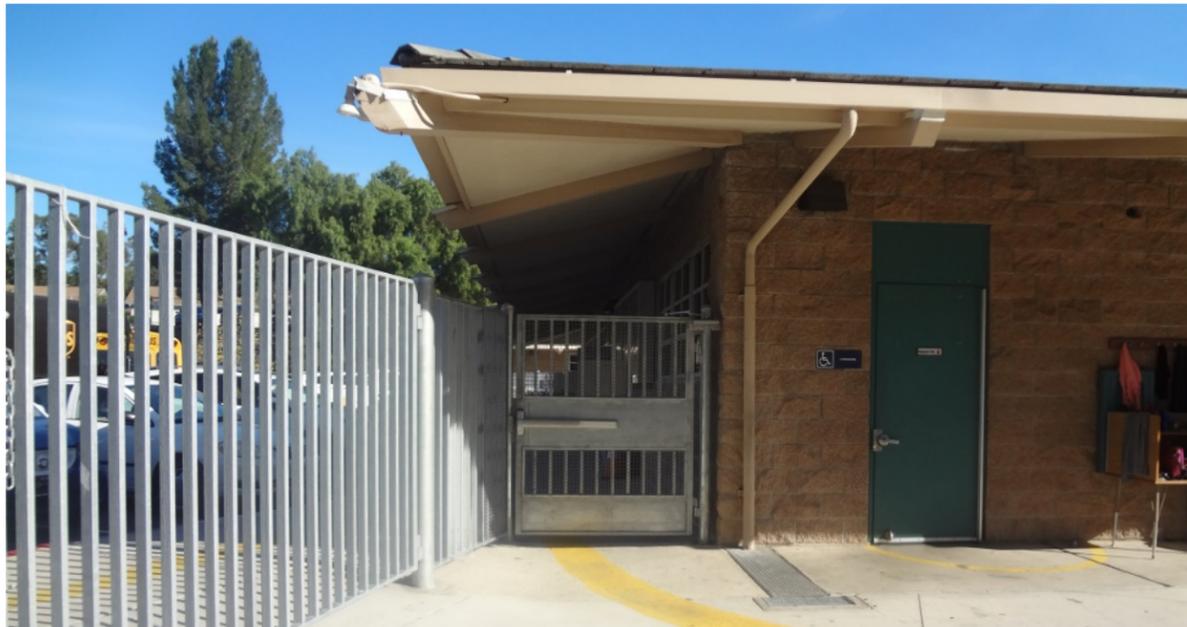
Image 2: The main entrance gate is open during morning drop-off and afternoon pick-up hours. A smaller pedestrian swing gate is situated next to the entrance gate for all day visitor access
